HALRB Meeting October 16, 2024, CoA 24-24

4102 N. Glebe Rd.: Request to remove two trees.

Walker Chapel Historic Cemetery

APPLICATION FOR A CERTIFICATE OF APPROPRIATENESS FOR THE REMOVAL OF TWO TREES

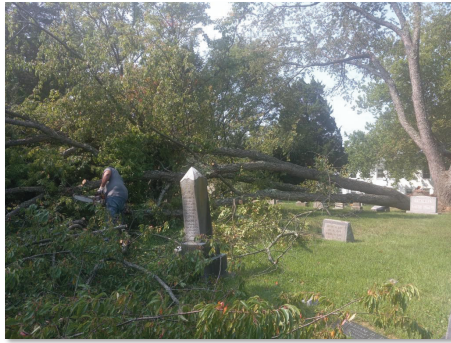
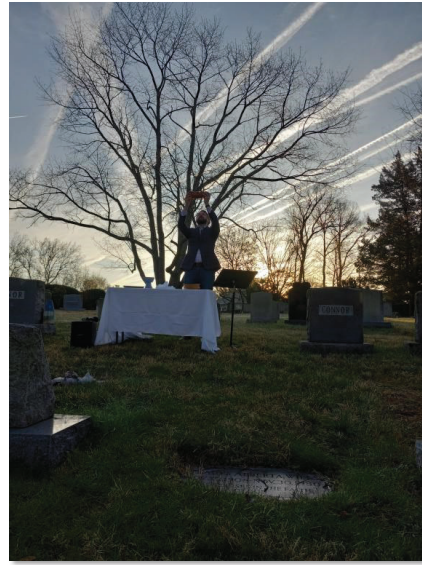
Tree #1: A multi-trunk black cherry tree. Very large, prominent, loved, and old as seen on Easter Sunday.

Two trees were planted, developed multiple trunks and grew tall. But they did not grow together. This past August the larger tree pushed over the smaller tree, which was hardly small.

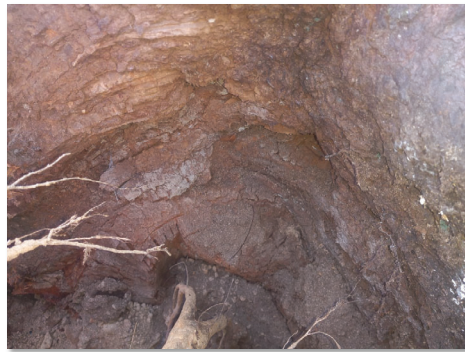
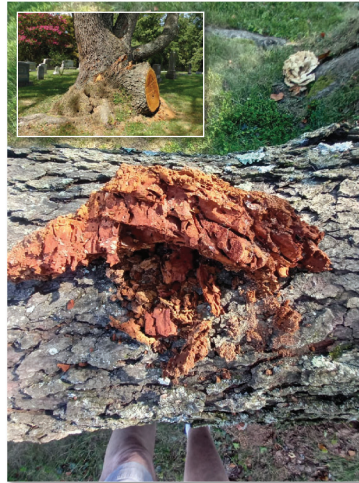
We were left with a huge stump, huge twisted roots just below ground, and a cavity in the standing tree where the fallen section had been. The cavity was lined with soft, crumbling, rotting wood. Here you see a section pulled out by hand, compromised, and crumbling to the touch.

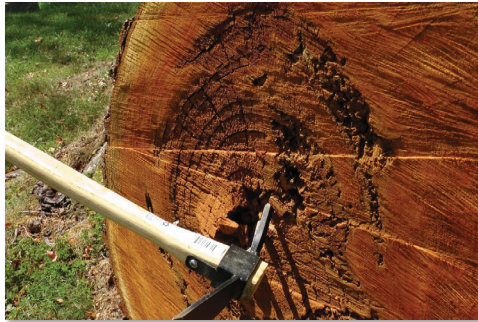
Mushrooms surround the base signifying rot, and the limbs are covered with some sort of mold or fungus.

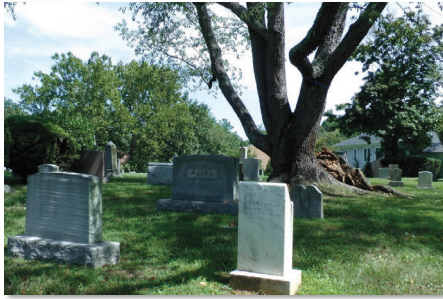
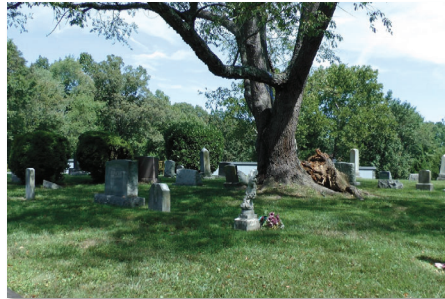
On closer inspection, the main trunk before branching into three trunks has a rotten core. A core easily penetrated with a hand tool and broken off in pieces.

The roots of both trees are visible for many feet underground but have been badly twisted and ripped apart by the the section that fell to the ground miraculously missing every gravestone.

Our concern is the remaining tree will fall and damage the many gravestones and gravesites within its reach. While we lament the loss of the tree, we can always plant another tree. We have planted 19 trees in the past year. We cannot replace artistic one-of-a-kind stones carved in soft marble.

We have consulted two noteworthy tree companies who employ arborists to advise us and the staff on the proper removal of large trees while caring for the surrounding gravesites. JL Tree Service even described the task as one of bringing down a large, compromised tree in a mine field.

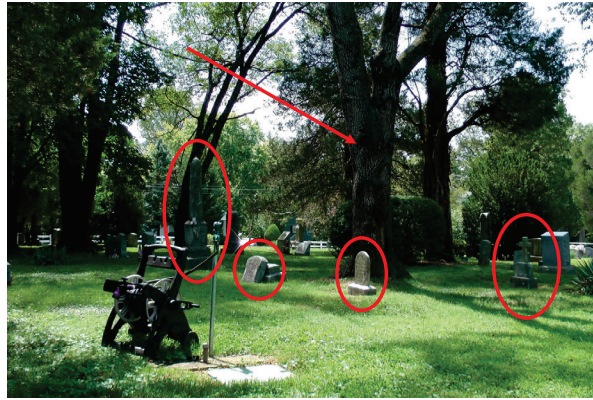
Tree #2: A single-trunk black cherry tree. Tall but hidden among many other trees in a forested area of the cemetery.

The top of the tree has leaves and is higher than most of the other trees. Coming down the trunk there is nothing but dead branches that are rotting and falling to the ground almost every day.

The base of the tree has split open and suffered deep holes from carpenter bees. Nearby, an old limb has rotted deep into the core of the tree.

On the other side of the tree there is a long split where the two trunks appear to be separating, further compromising the tree.

Our concern is the tree will fall and damage the many gravestones and gravesites within its reach. Four ancient gravestones are shown circled in red. An obelisk with two large cracks, a small cross on an infant that was "budded on Earth, Blooming in Heaven," a broken stone, and a soft stone that would disintegrate if hit by the tree. This is not a tree we would miss and we have planted 19 trees in the past year. We would miss the four irreplaceable stones.

We have consulted two noteworthy tree companies who employ arborists to advise us and their staff on the proper removal of large trees while caring for the surrounding gravesites. Both have assured us they can lower the tree down in pieces with ropes with no damage to the stones or ground.
