Washington Blvd Safety Audit

Department of Environmental Services
Transportation Engineering & Operations
N Vernon St to N Wayne St

Audit: July 2023

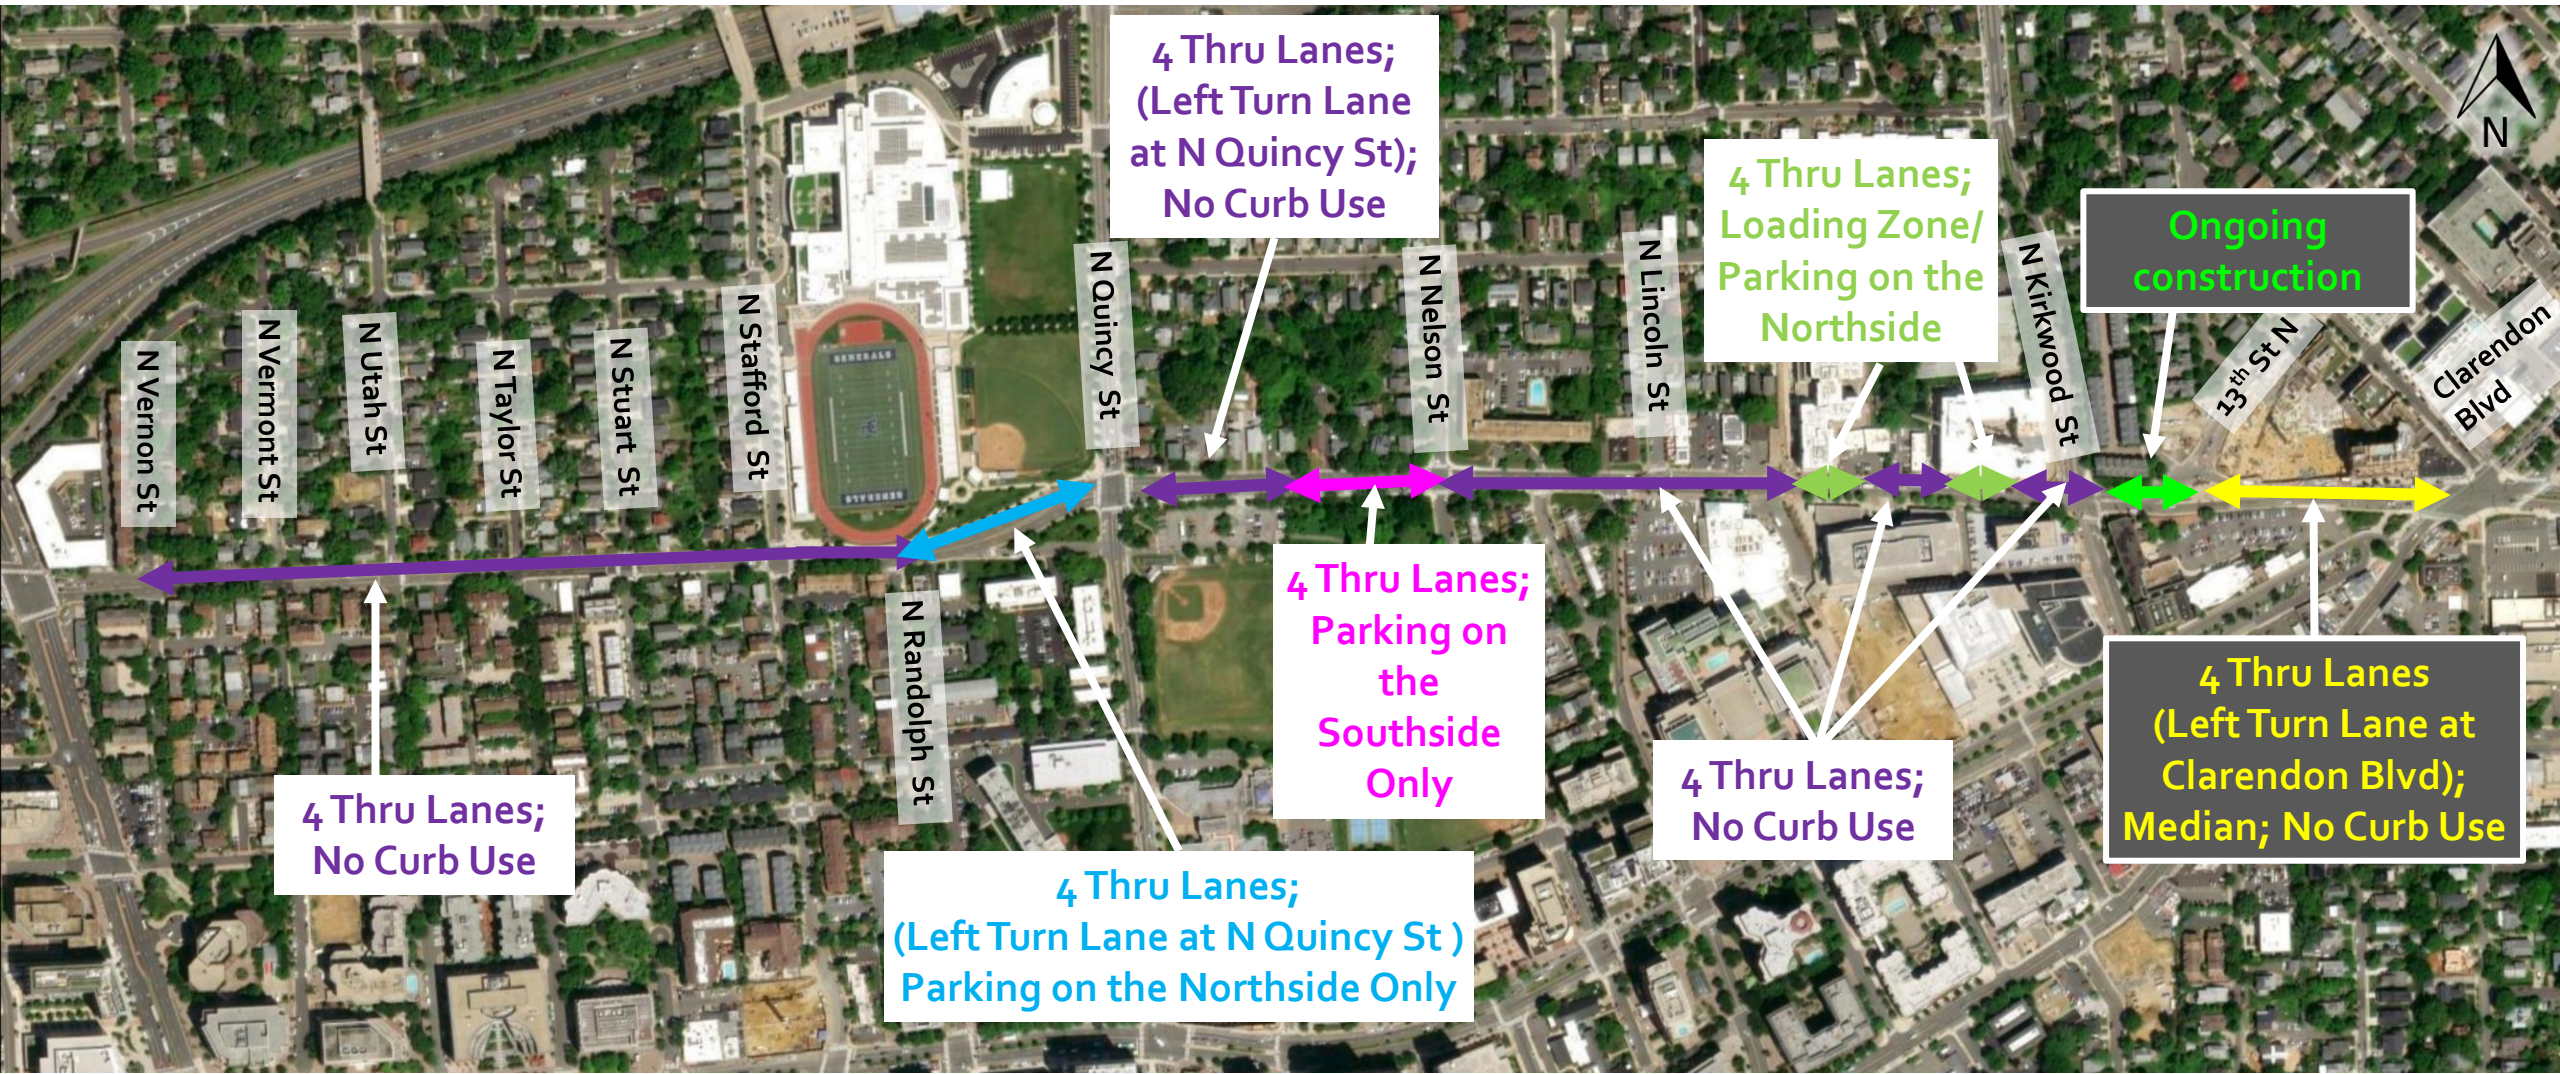
Vehicle Travel Lanes & Curb Space (west of Clarendon Blvd)

4 Thru Lanes;
No Curb Use

4 Thru Lanes;
(Left Turn Lane at N Quincy St)
Parking on the Northside Only

4 Thru Lanes;
Parking on
the
Southside
Only

4 Thru Lanes;
(Left Turn Lane
at N Quincy St);
No Curb Use

4 Thru Lanes;
Loading Zone/
Parking on the
Northside

4 Thru Lanes
(Left Turn Lane at
Clarendon Blvd);
Median; No Curb Use

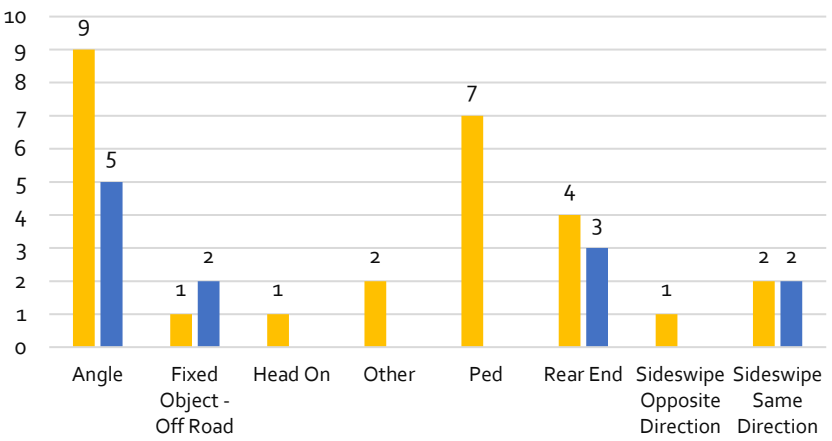
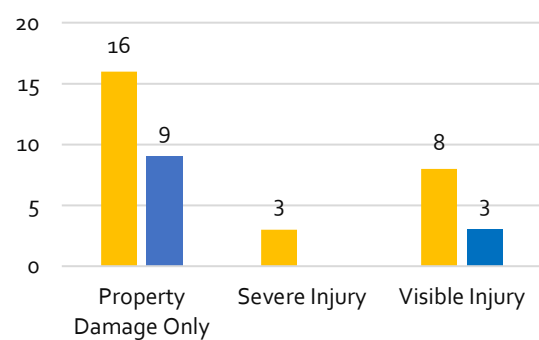
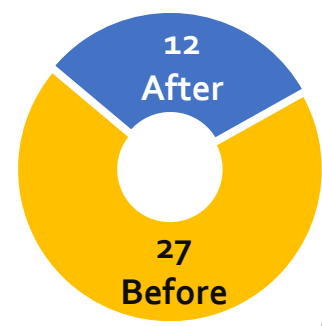
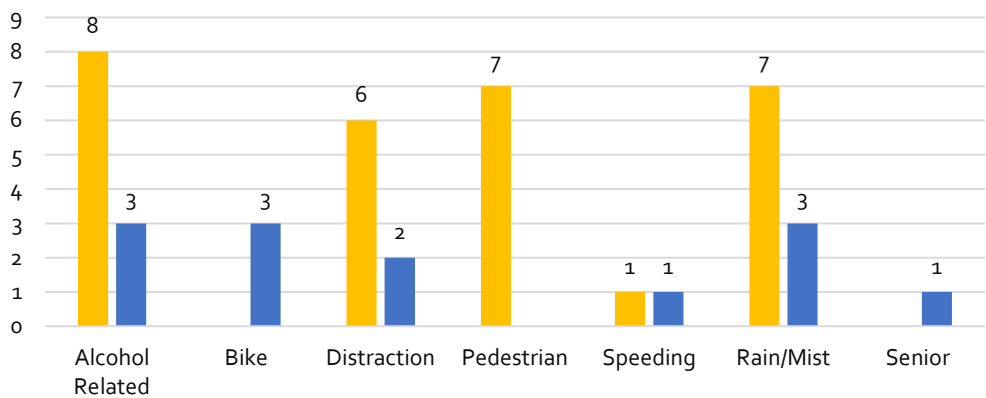
Collisions Before and After: Clarendon Circle

Intersection improvements at [Clarendon Circle](#) were completed in March 2020 as part of the [Clarendon Sector Plan](#) and the [Clarendon Multimodal Transportation Study](#). Improvements include road realignments to reduce intersection size and shorten pedestrian crossing distances, upgrading traffic signals and lighting, closing N Irving St, and adding new curb extensions and bike lanes. **The average number of collisions per year decreased from 4.5 in 2014-2020 (before the project) to 4 in 2020-2022 (after the project).**

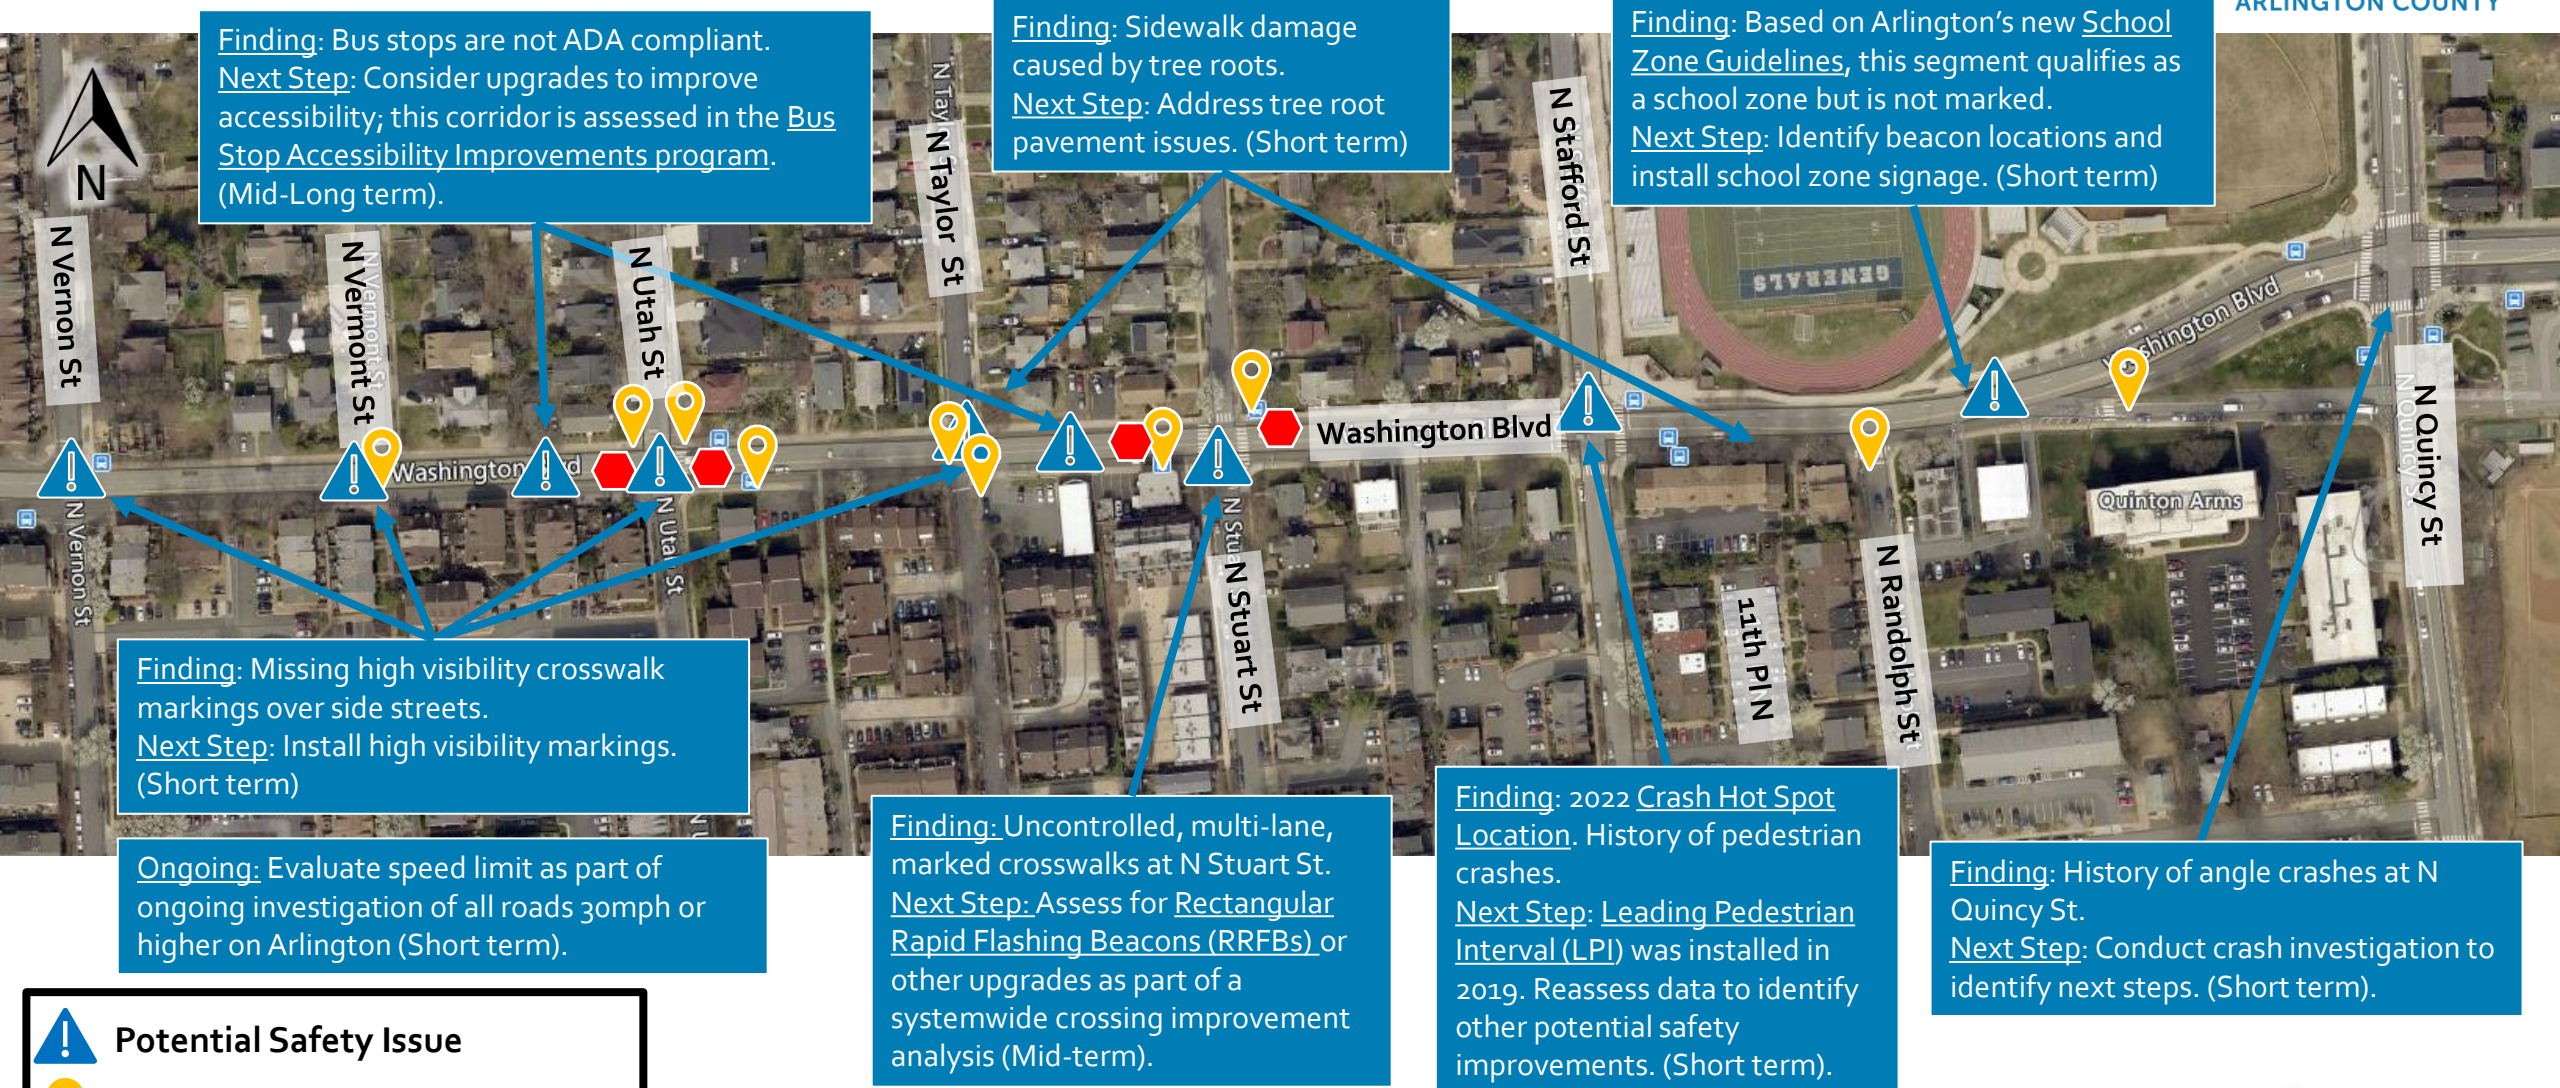
Field Observations: Key Findings & Next Steps From N Vernon St to N Quincy St

Finding: Bus stops are not ADA compliant.
Next Step: Consider upgrades to improve accessibility; this corridor is assessed in the [Bus Stop Accessibility Improvements program](#). (Mid-Long term).

Finding: Sidewalk damage caused by tree roots.
Next Step: Address tree root pavement issues. (Short term)

Finding: Based on Arlington's new [School Zone Guidelines](#), this segment qualifies as a school zone but is not marked.
Next Step: Identify beacon locations and install school zone signage. (Short term)

Finding: Missing high visibility crosswalk markings over side streets.
Next Step: Install high visibility markings. (Short term)

Finding: Uncontrolled, multi-lane, marked crosswalks at N Stuart St.
Next Step: Assess for [Rectangular Rapid Flashing Beacons \(RRFBs\)](#) or other upgrades as part of a systemwide crossing improvement analysis (Mid-term).

Finding: 2022 [Crash Hot Spot Location](#). History of pedestrian crashes.
Next Step: [Leading Pedestrian Interval \(LPI\)](#) was installed in 2019. Reassess data to identify other potential safety improvements. (Short term).

Finding: History of angle crashes at N Quincy St.
Next Step: Conduct crash investigation to identify next steps. (Short term).

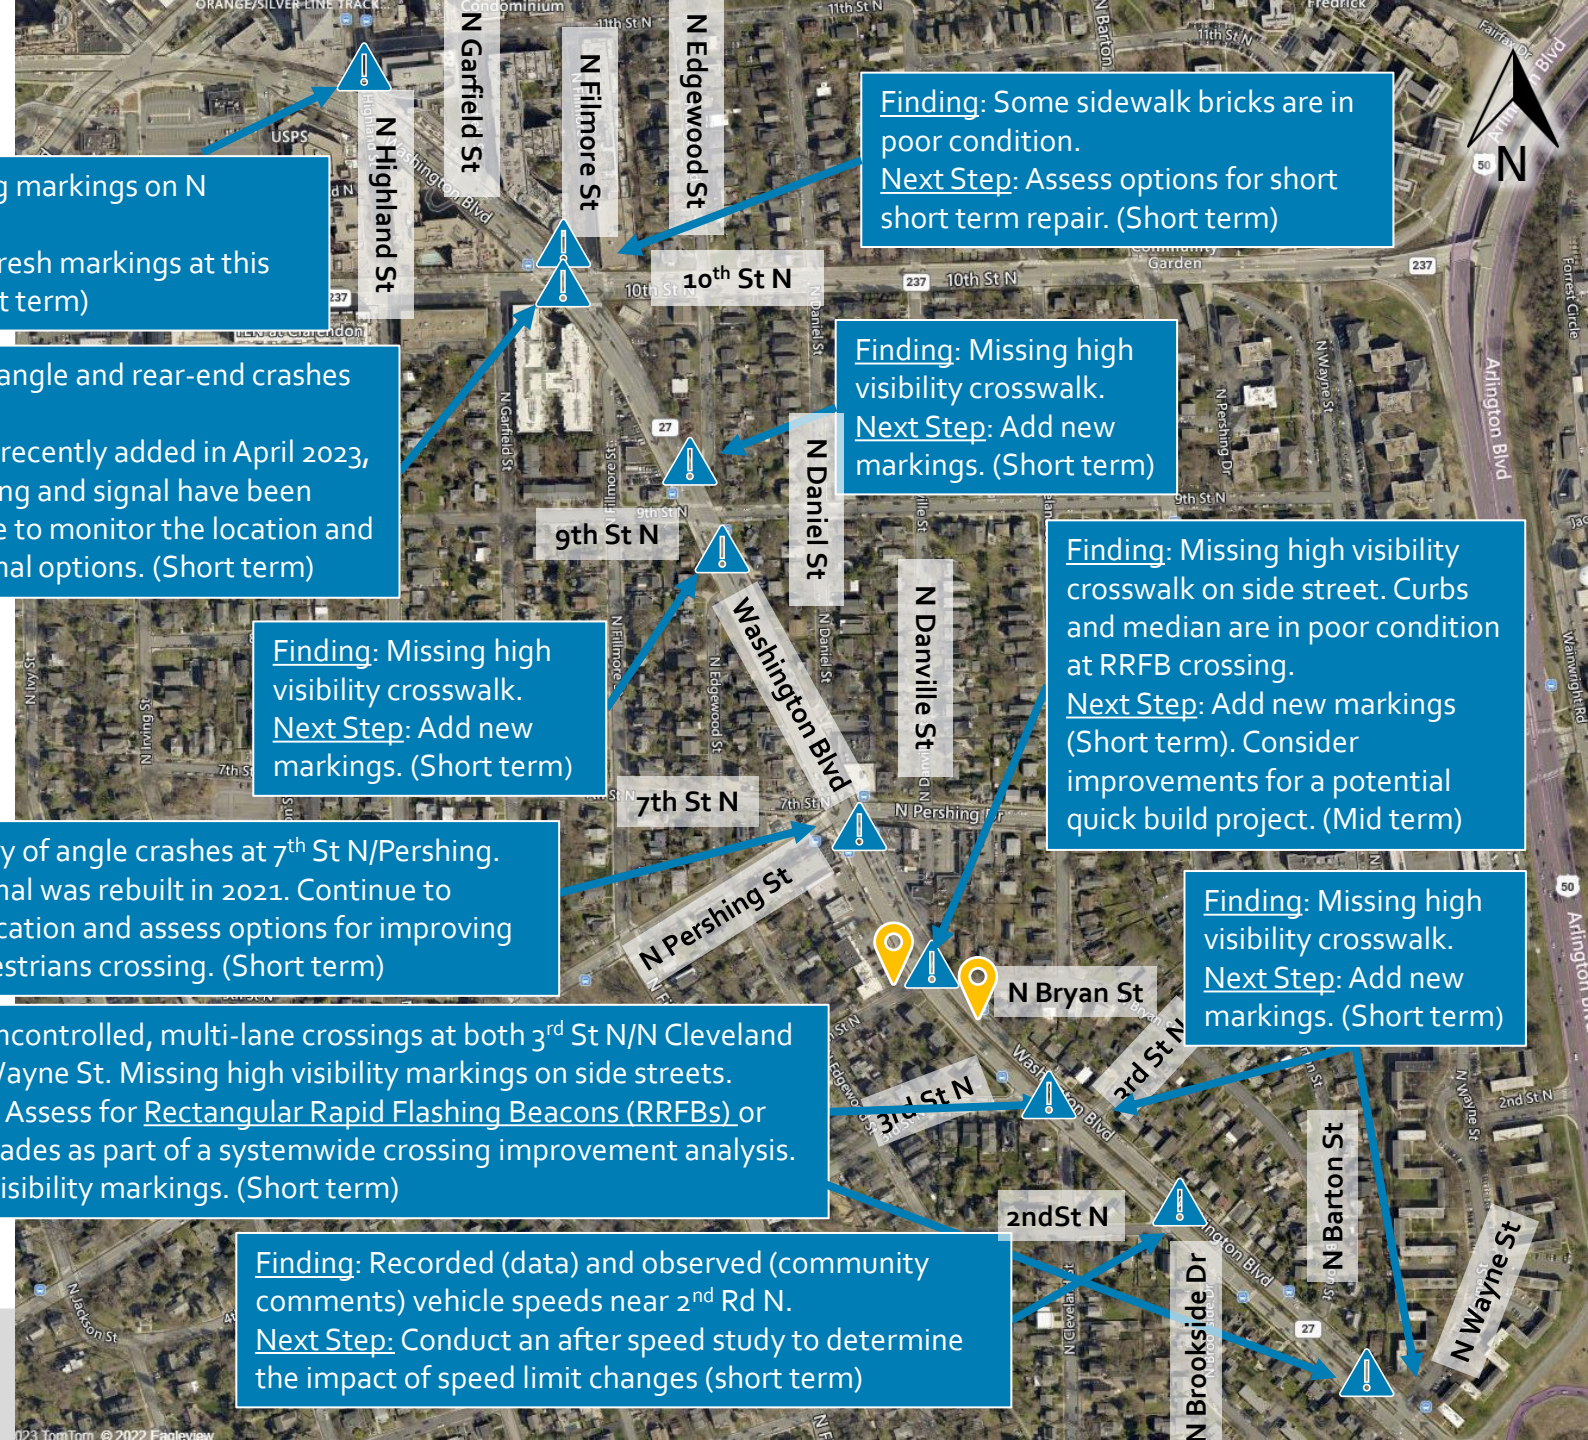
Field Observations: Key Findings & Next Steps From Clarendon Circle to N Wayne St

Finding: Fading markings on N Highland St.
Next Step: Refresh markings at this location. (Short term)

Finding: Some sidewalk bricks are in poor condition.
Next Step: Assess options for short short term repair. (Short term)

Finding: History of angle and rear-end crashes at 10th St N.
Next Step: LPI was recently added in April 2023, and signage, marking and signal have been improved. Continue to monitor the location and investigate additional options. (Short term)

Finding: Missing high visibility crosswalk.
Next Step: Add new markings. (Short term)

Finding: Missing high visibility crosswalk on side street. Curbs and median are in poor condition at RRFB crossing.
Next Step: Add new markings (Short term). Consider improvements for a potential quick build project. (Mid term)

Finding: History of angle crashes at 7th St N/Pershing.
Next Step: Signal was rebuilt in 2021. Continue to monitor the location and assess options for improving safety for pedestrians crossing. (Short term)

Finding: Uncontrolled, multi-lane crossings at both 3rd St N/N Cleveland St and N Wayne St. Missing high visibility markings on side streets.
Next Step: Assess for Rectangular Rapid Flashing Beacons (RRFBs) or other upgrades as part of a systemwide crossing improvement analysis. Add high visibility markings. (Short term)

Finding: Recorded (data) and observed (community comments) vehicle speeds near 2nd Rd N.
Next Step: Conduct an after speed study to determine the impact of speed limit changes (short term)
