# Reeves Farmhouse Renovation Concept DRC Submission

April, 2023

Cover1
Existing Conditions - Site2-3
Existing Conditions - Building4-8
Site Plan9
3D Views10-14
Ramp Options15-16
Demolition and Proposed Plans17-21
Elevations22-23

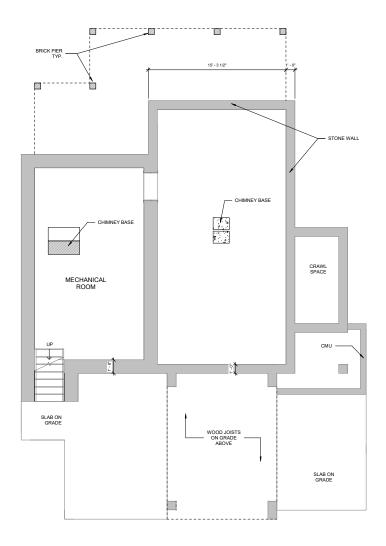
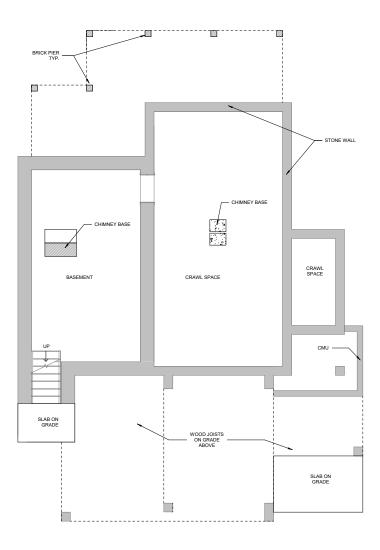
Demolition and Proposed Cellar Plans

Area Summary			
<u>Floor</u>	<u>Existing</u> <u>Area</u> ( <u>gsf)</u>	<u>Addition</u> <u>Area</u> ( <u>gsf)</u>	<u>Total</u> <u>Area</u> ( <u>gsf)</u>
Cellar	367	0	367
1st Floor	1,382	1,312	2,694
2nd Floor	1,293	370	1,663
3rd Floor	351	0	351
Total	3,393	1,682	5,075

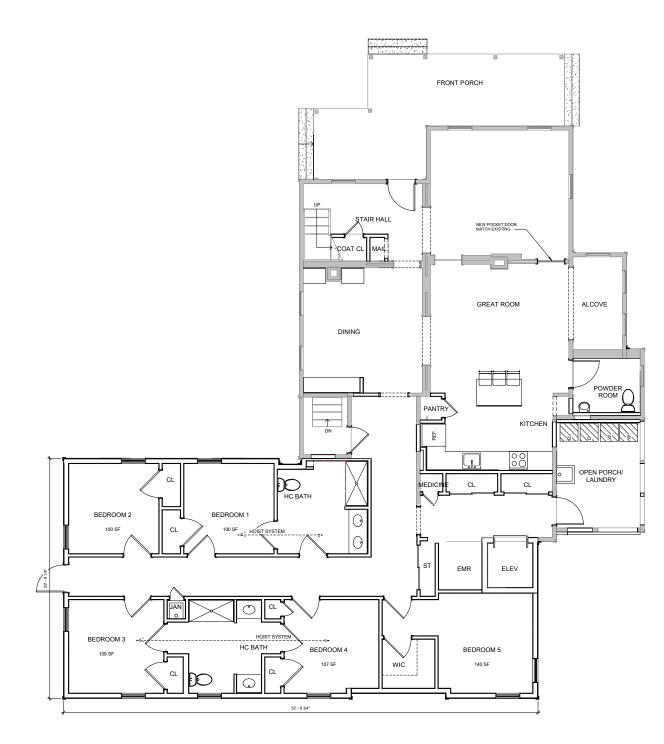
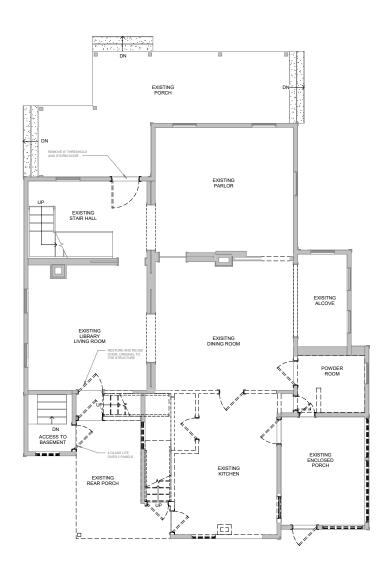
Demolition and Proposed 1st Floor Plans

Area Summary			
<u>Floor</u>	<u>Existing</u> <u>Area</u> ( <u>gsf)</u>	<u>Addition</u> <u>Area</u> ( <u>gsf)</u>	<u>Total</u> <u>Area</u> ( <u>gsf)</u>
Cellar	367	0	367
1st Floor	1,382	1,312	2,694
2nd Floor	1,293	370	1,663
3rd Floor	351	0	351
Total	3,393	1,682	5,075

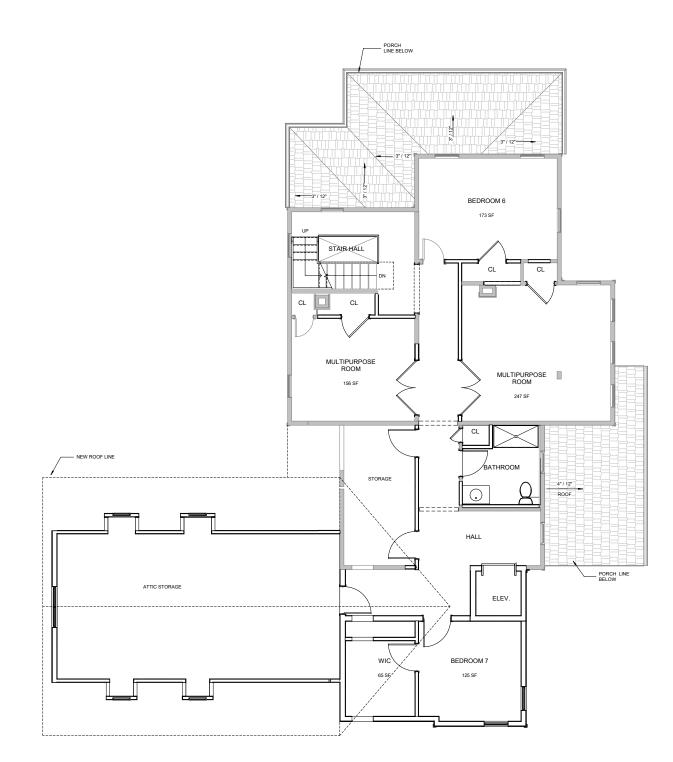
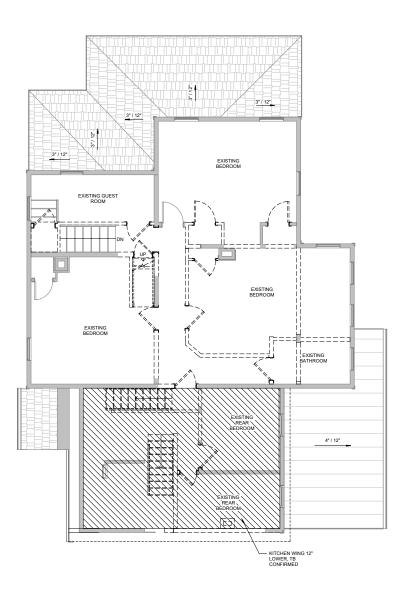
Demolition and Proposed 2nd Floor Plans

Area Summary			
<u>Floor</u>	<u>Existing</u> <u>Area</u> ( <u>gsf)</u>	<u>Addition</u> <u>Area</u> ( <u>gsf)</u>	<u>Total</u> <u>Area</u> ( <u>gsf)</u>
Cellar	367	0	367
1st Floor	1,382	1,312	2,694
2nd Floor	1,293	370	1,663
3rd Floor	351	0	351
Total	3,393	1,682	5,075

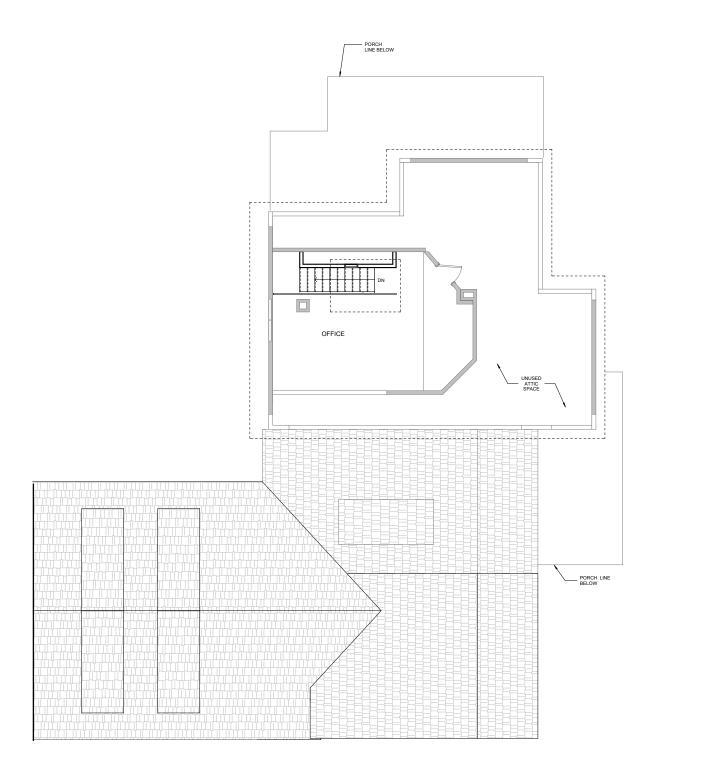
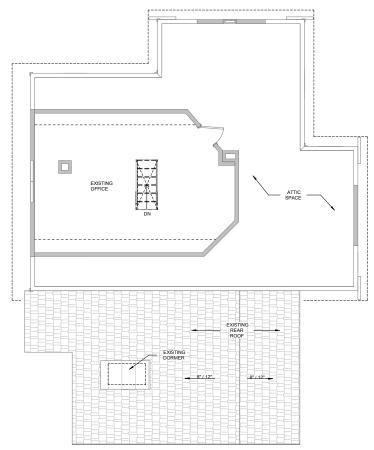
Demolition and Proposed Attic Floor Plans

Area Summary			
<u>Floor</u>	<u>Existing</u> <u>Area</u> ( <u>gsf)</u>	<u>Addition</u> <u>Area</u> ( <u>gsf)</u>	<u>Total</u> <u>Area</u> ( <u>gsf)</u>
Cellar	367	0	367
1st Floor	1,382	1,312	2,694
2nd Floor	1,293	370	1,663
3rd Floor	351	0	351
Total	3,393	1,682	5,075

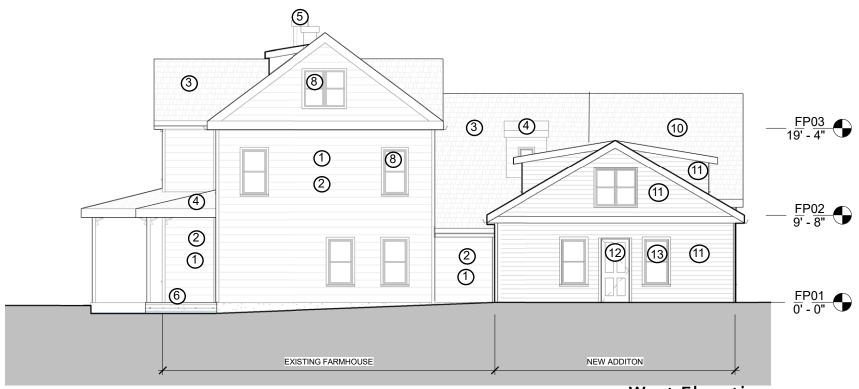
2. West Elevation

- 1. Remove existing vinyl/aluminum siding and trim. Inspect and report on condition of existing wood siding and trim below, if any.
- 2. Restore existing wood siding and trim. Patch, repair, and or replace to match as required. Prepare to receive new paint. If condition of existing siding is badly deteriorated, provide new wood clapboard siding to match existing profiles.

- 3. Remove existing asphalt shingles and provide new dimensional asphalt shingles. Provide new gutters and downspouts.
- 4. Remove existing metal roofing and provide new dimensional asphalt shingles. Provide new gutters and downspouts.

- 5. Remove existing brick chimneys down to roof line and rebuild. Provide new flagstone cap.
- 6. Remove existing front porch flooring and inspect existing joists. Repair/ replace joists as required.

- Remove existing door and provide new 36" wide 4-panel solid wood exterior door with lite. Finish to be painted. Provide lever type accessible hardware with deadbolt.

- 8. Remove existing windows and provide prefinished aluminum-clad wood double hung windows in 1-over-1 lite pattern. Provide with insulated low-e glazing, including argon gas fill.

- Remove existing windows and provide prefinished aluminum-clad wood double hung windows in 6-over-6 lite pattern. Provide with insulated low-e glazing, including argon gas fill.

- 10. New dimensional asphalt shingles. Provide prefinished aluminum gutters and downspouts.
- 11. New prefinished fiber cement lap-siding with fiber cement or PVC trim.

- 12. 36" wide 4-panel solid wood exterior door with lite.
- 13. New prefinished aluminum-clad wood double-hung windows in 1-over-1 lite pattern.

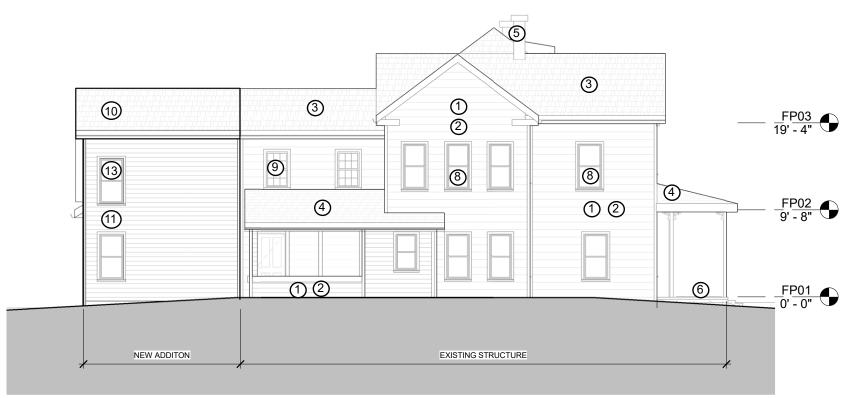
4. East Elevation

- Remove existing vinyl/aluminum siding and trim. Inspect and report on condition of existing wood siding and trim below, if any.
- 2. Restore existing wood siding and trim. Patch, repair, and or replace to match as required. Prepare to receive new paint. If condition of existing siding is badly deteriorated, provide new wood clapboard siding to match existing profiles.

- 3. Remove existing asphalt shingles and provide new dimensional asphalt shingles. Provide new gutters and downspouts.
- 4. Remove existing metal roofing and provide new dimensional asphalt shingles. Provide new gutters and downspouts.

- 5. Remove existing brick chimneys down to roof line and rebuild. Provide new flagstone cap.
- 6. Remove existing front porch flooring and inspect existing joists. Repair/ replace joists as required.

- Remove existing door and provide new 36" wide 4-panel solid wood exterior door with lite. Finish to be painted. Provide lever type accessible hardware with deadbolt.

- 8. Remove existing windows and provide prefinished aluminum-clad wood double hung windows in 1-over-1 lite pattern. Provide with insulated low-e glazing, including argon gas fill.

- Remove existing windows and provide prefinished aluminum-clad wood double hung windows in 6-over-6 lite pattern. Provide with insulated low-e glazing, including argon gas fill.

- 10. New dimensional asphalt shingles. Provide prefinished aluminum gutters and downspouts.
- 11. New prefinished fiber cement lap-siding with fiber cement or PVC trim.

- 12. 36" wide 4-panel solid wood exterior door with lite.
- 13. New prefinished aluminum-clad wood double-hung windows in 1-over-1 lite pattern.
