Local Historic District
Designated December 17, 2022

**ARLINGTON COUNTY REGISTER OF HISTORIC PLACES
HISTORIC DISTRICT DESIGNATION FORM**

Historic District Name: Anderson House Historic District
Historic Name: Joseph and Edith Anderson House
Current Name: None

Street and Number: 3500 14th Street North
County, State, Zip Code: Arlington, Virginia 22201

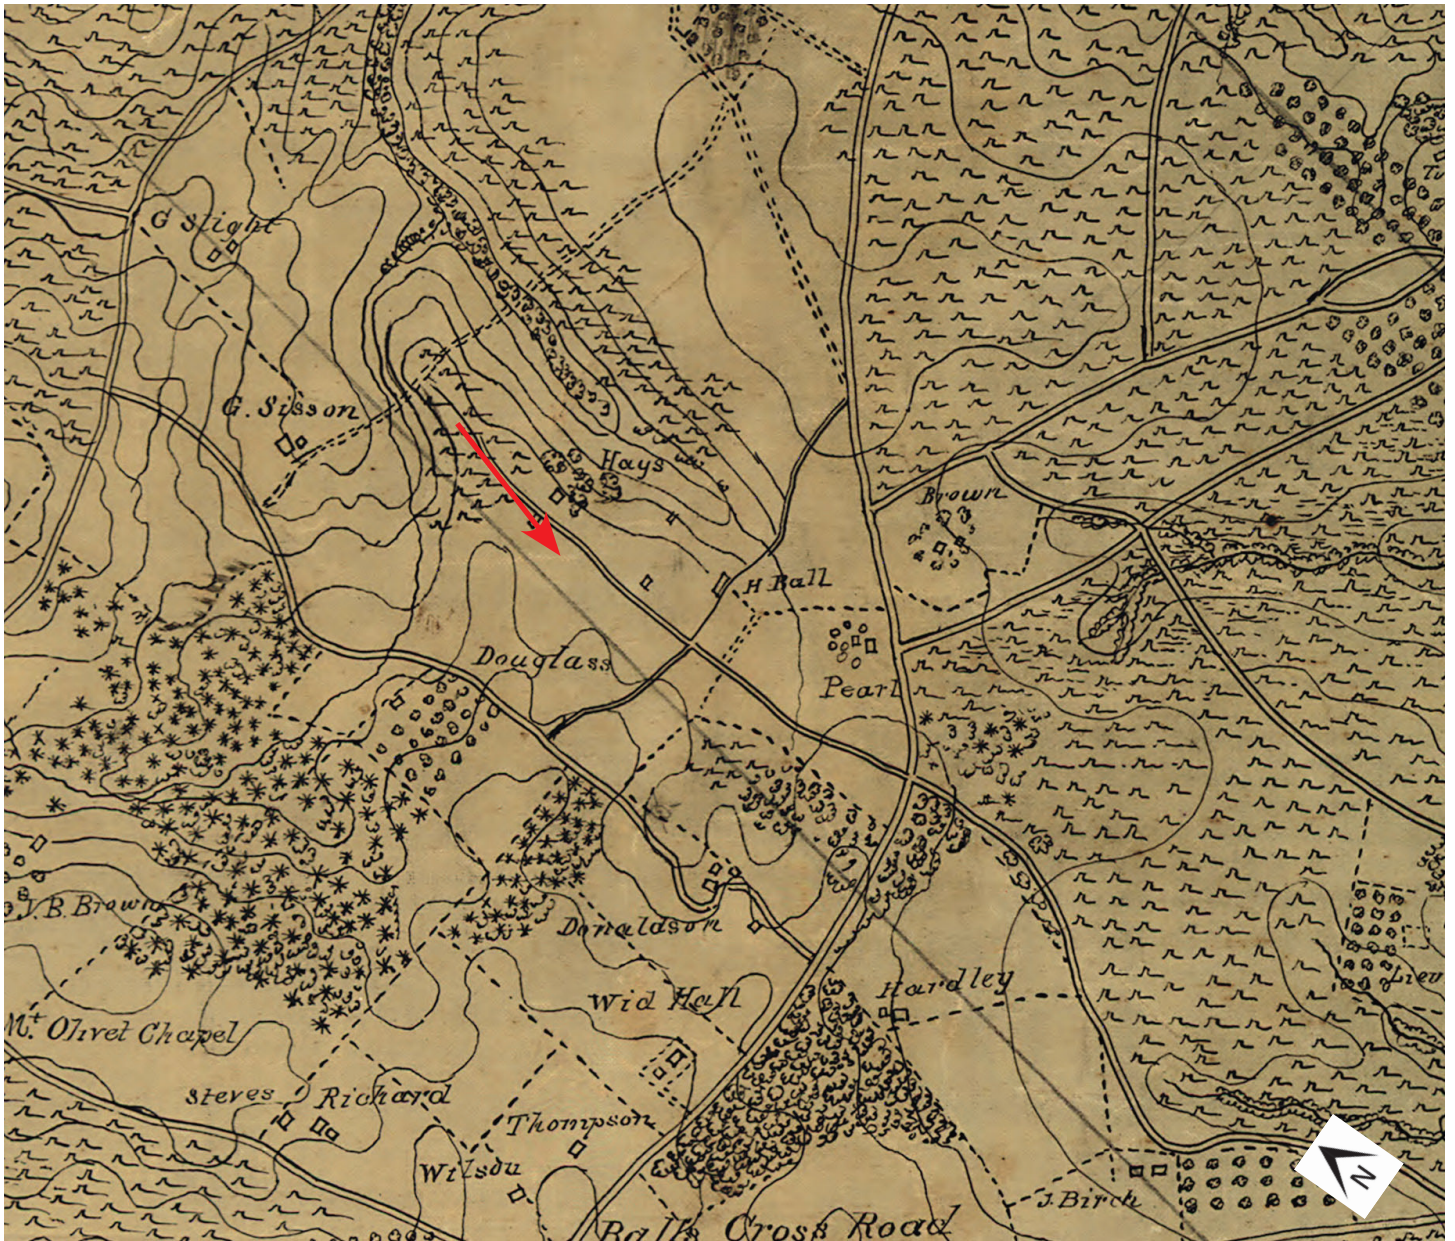
Figure 2: View of the Hayes property, ca. 1862 (spelled as “Hays” on map). Note that there are buildings and a small wooded area depicted on the property. The red arrow shows the approximate present-day location of the Anderson House.

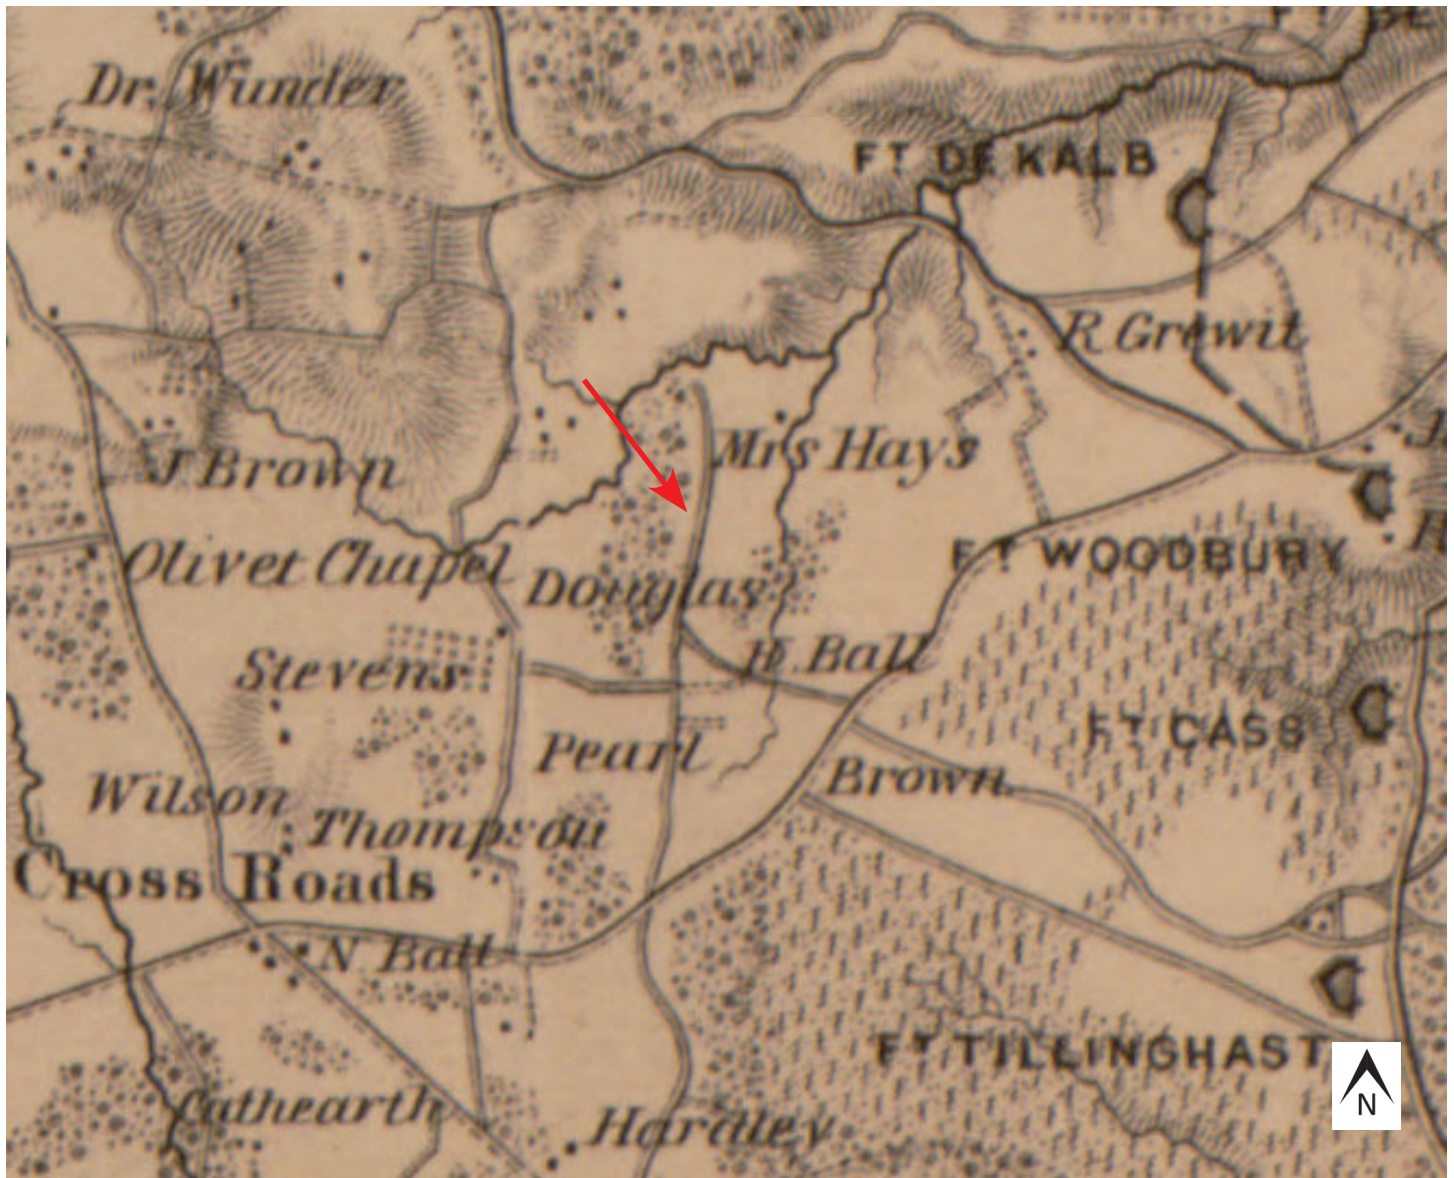
Figure 3: Survey compiled on January 1, 1862 and later updated on August 1, 1862. The red arrow shows the approximate present-day location of the Anderson House.

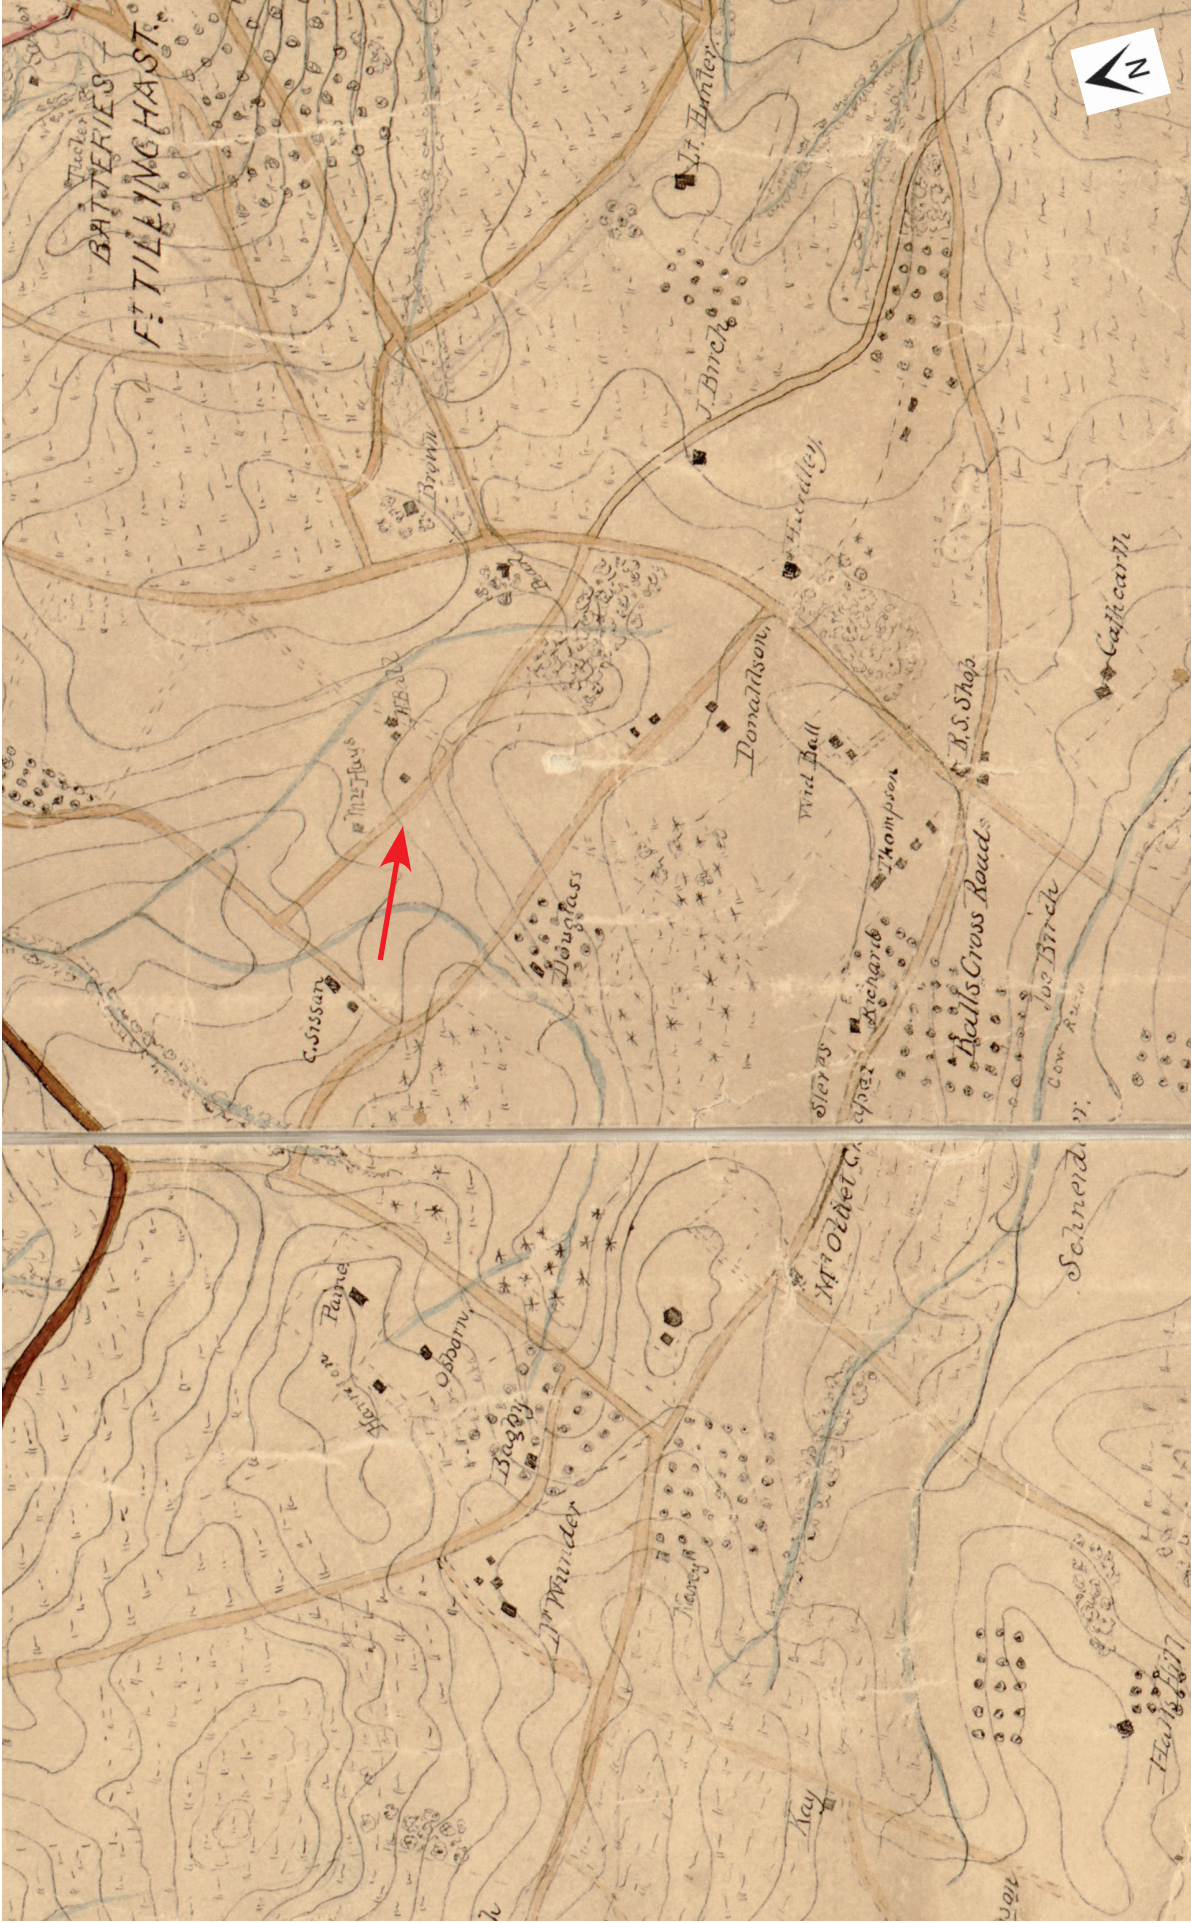
Figure 4: The red arrow points to the approximate present-day location of the Anderson House in 1865.

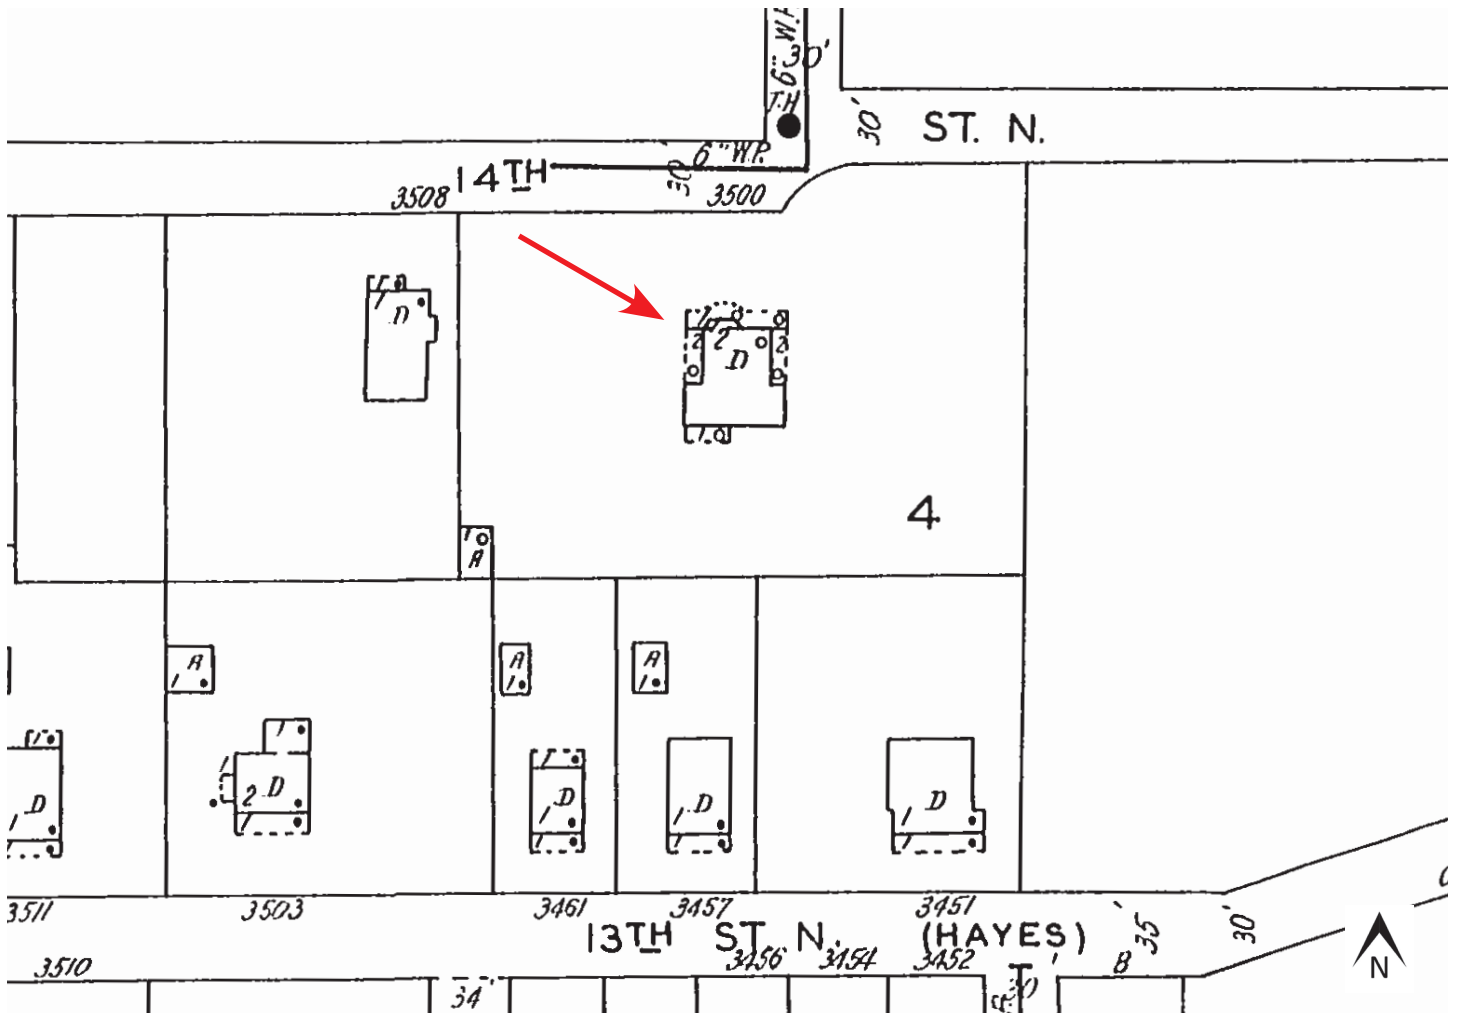
Figure 9: Sanborn Fire Insurance Map, Sheet 27, 1936. The red arrow points to the Anderson House. The garage at the southwestern portion of the property was constructed between 1935 and 1936. It remained on Lot 1 of the property after the 1950 subdivision and was demolished in 2018.

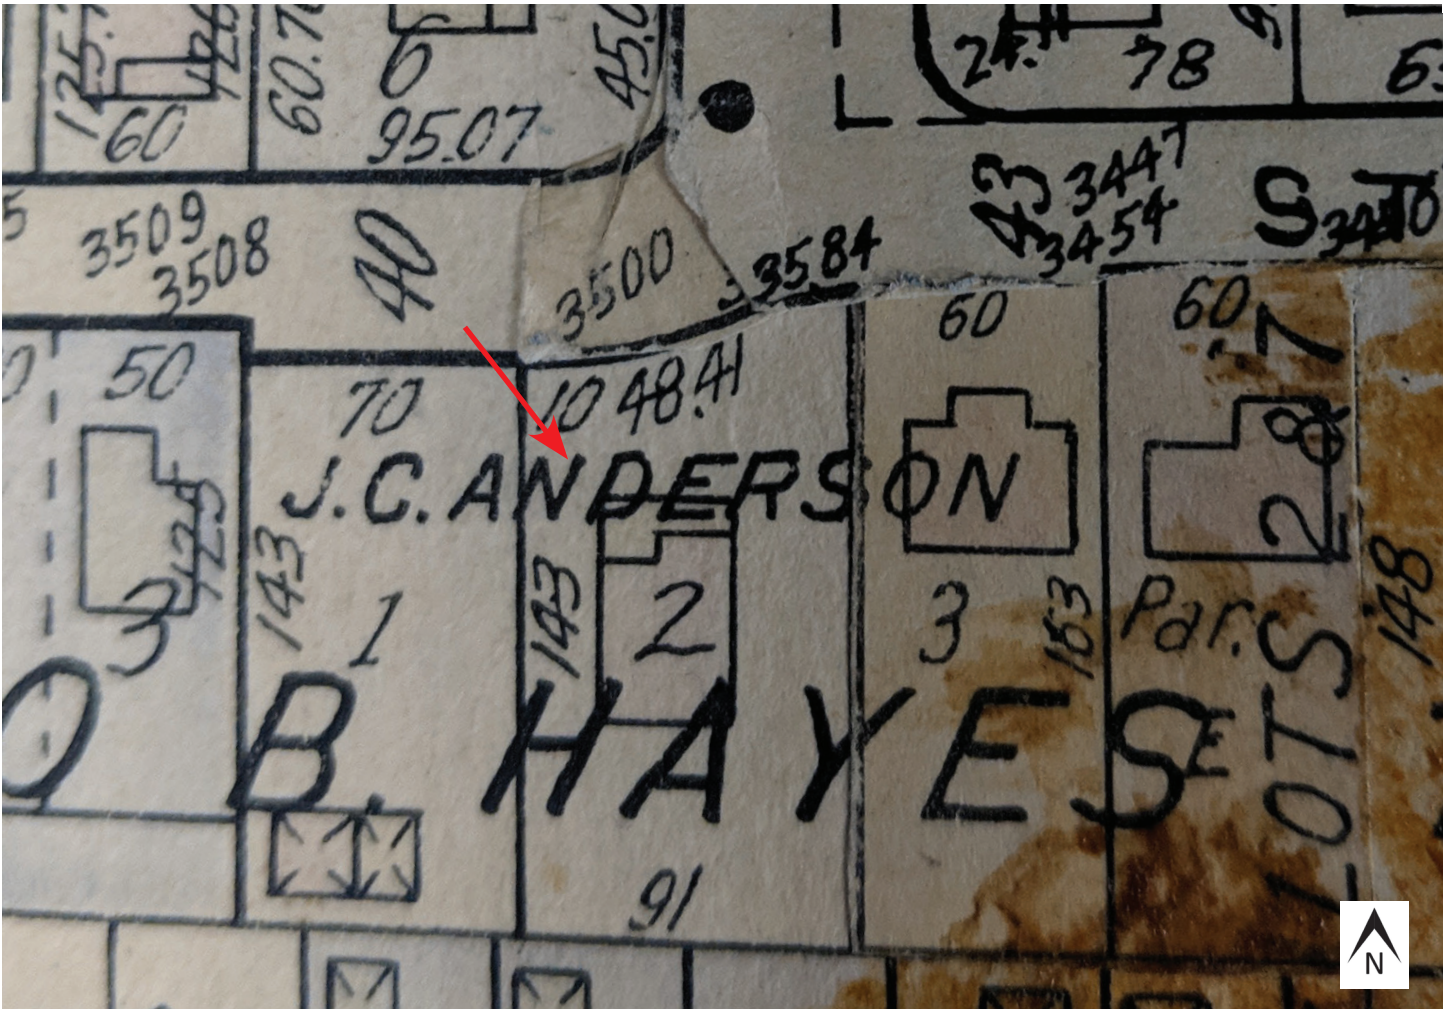
Figure 10: Franklin Survey Co. Map, Plate 16, 1952. The red arrow points to the Anderson House. The garage on lot 1 was built between 1935 and 1936 and was demolished in 2018. Source: Arlington County Preservation Office Archives.

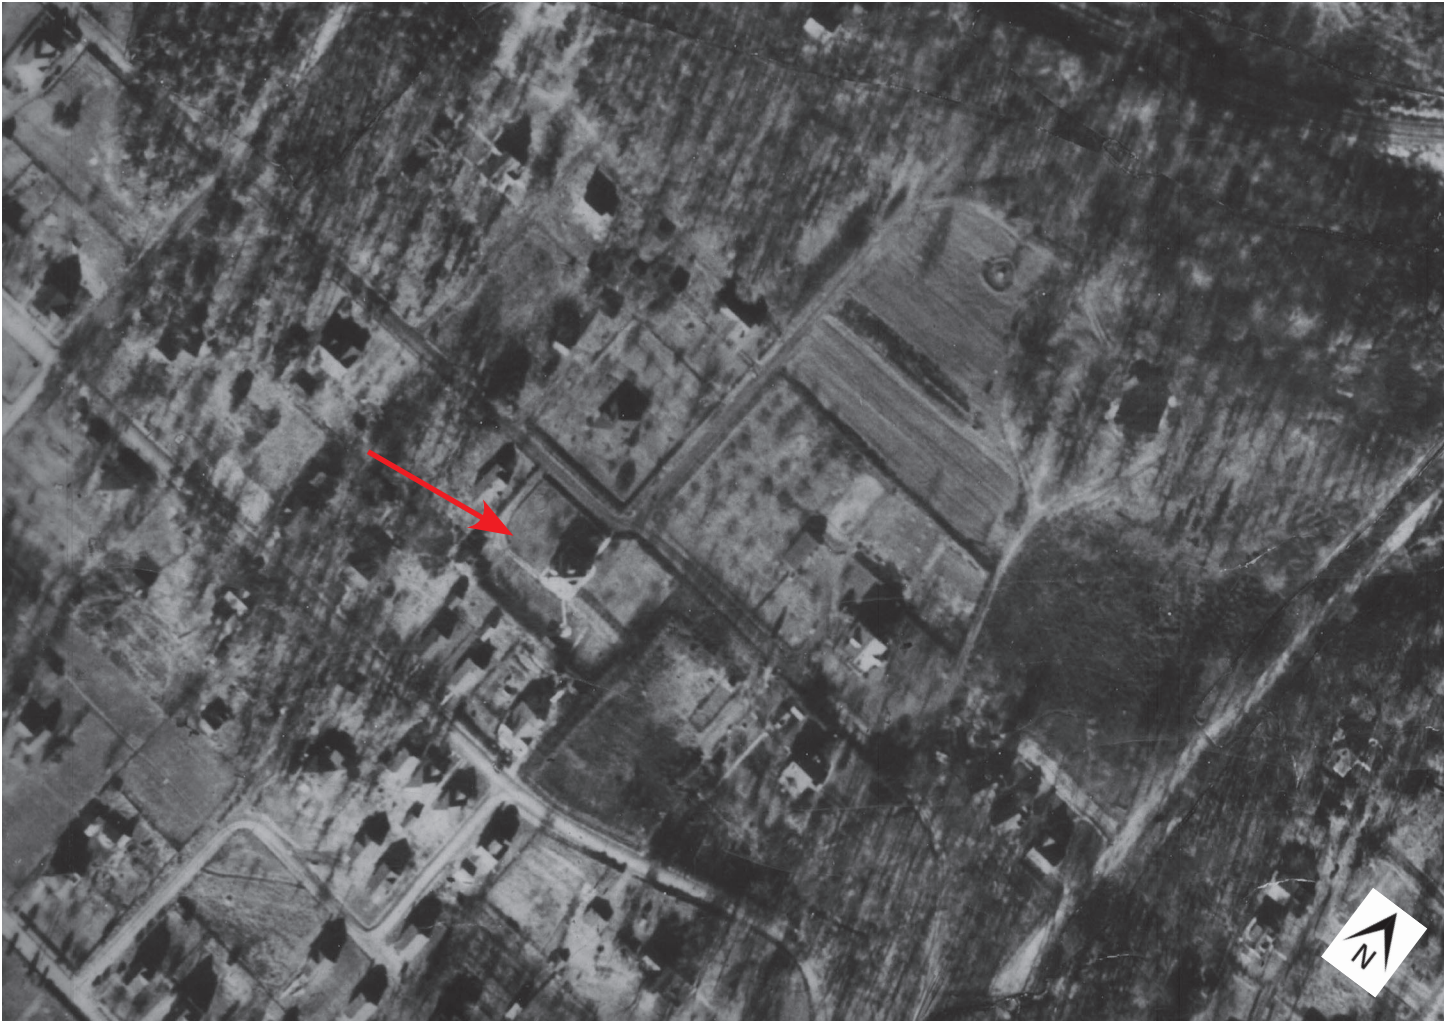
Figure 2: View of the Anderson House, 1934. The red arrow points to the House.
Source: *Aerial Photographic Map of Arlington County, Virginia*. January 11, 1934, Sheet 32, Arlington County GIS.

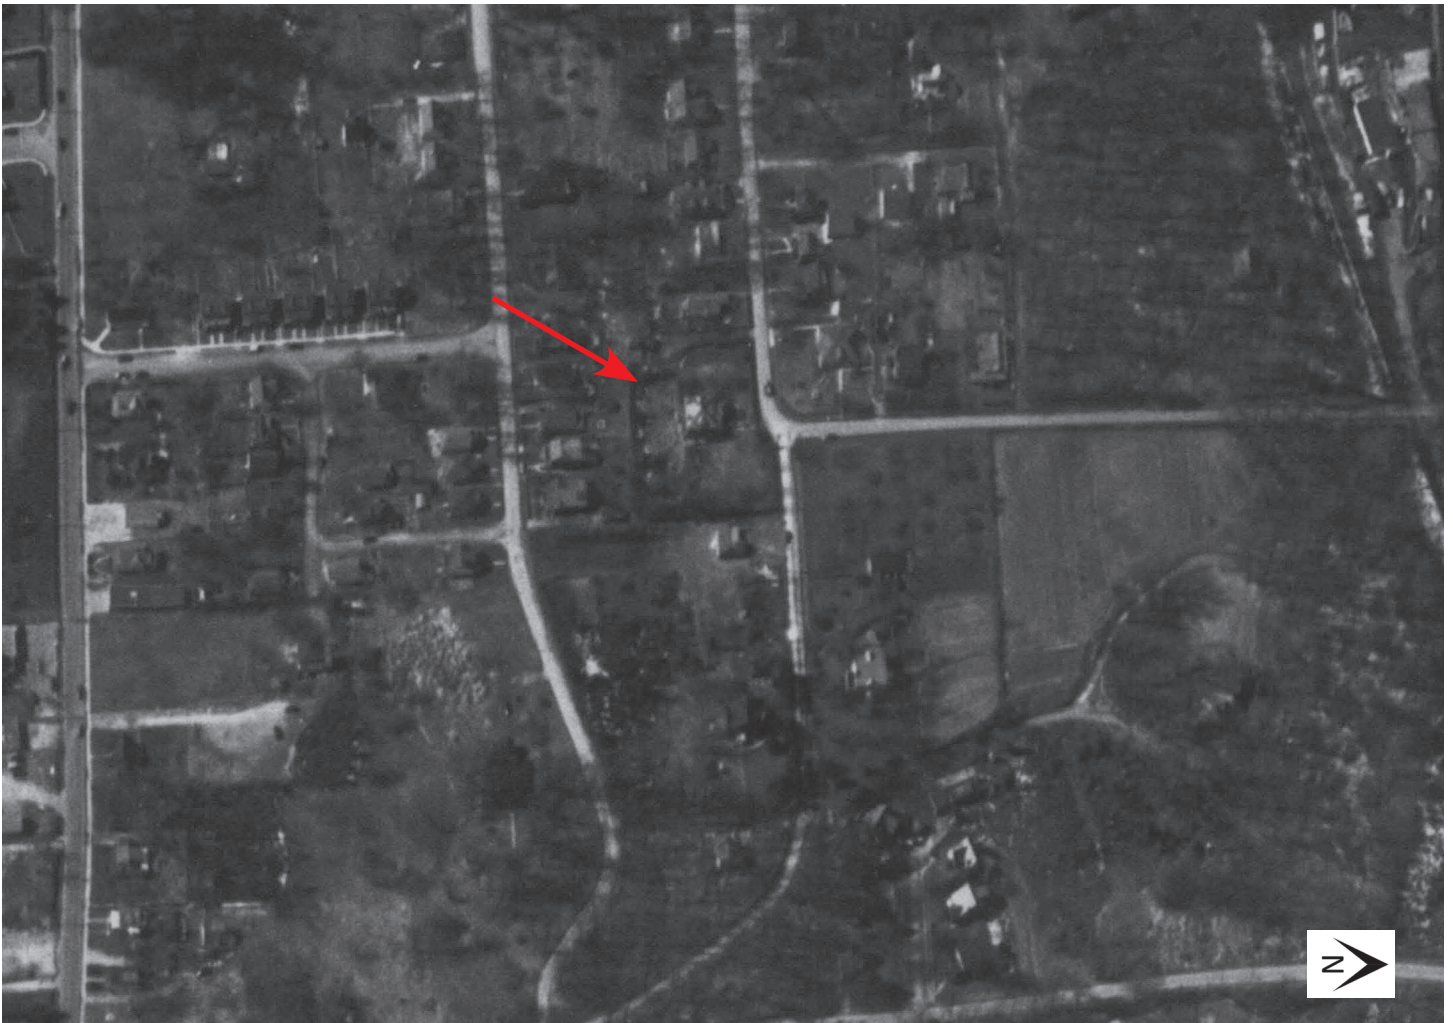
Figure 3: View of the Anderson House, 1949. The red arrow points to the House.
Source: "Historic Aerial Photographs," March 4, 1949, GS-FX-1, 104, Arlington County GIS.

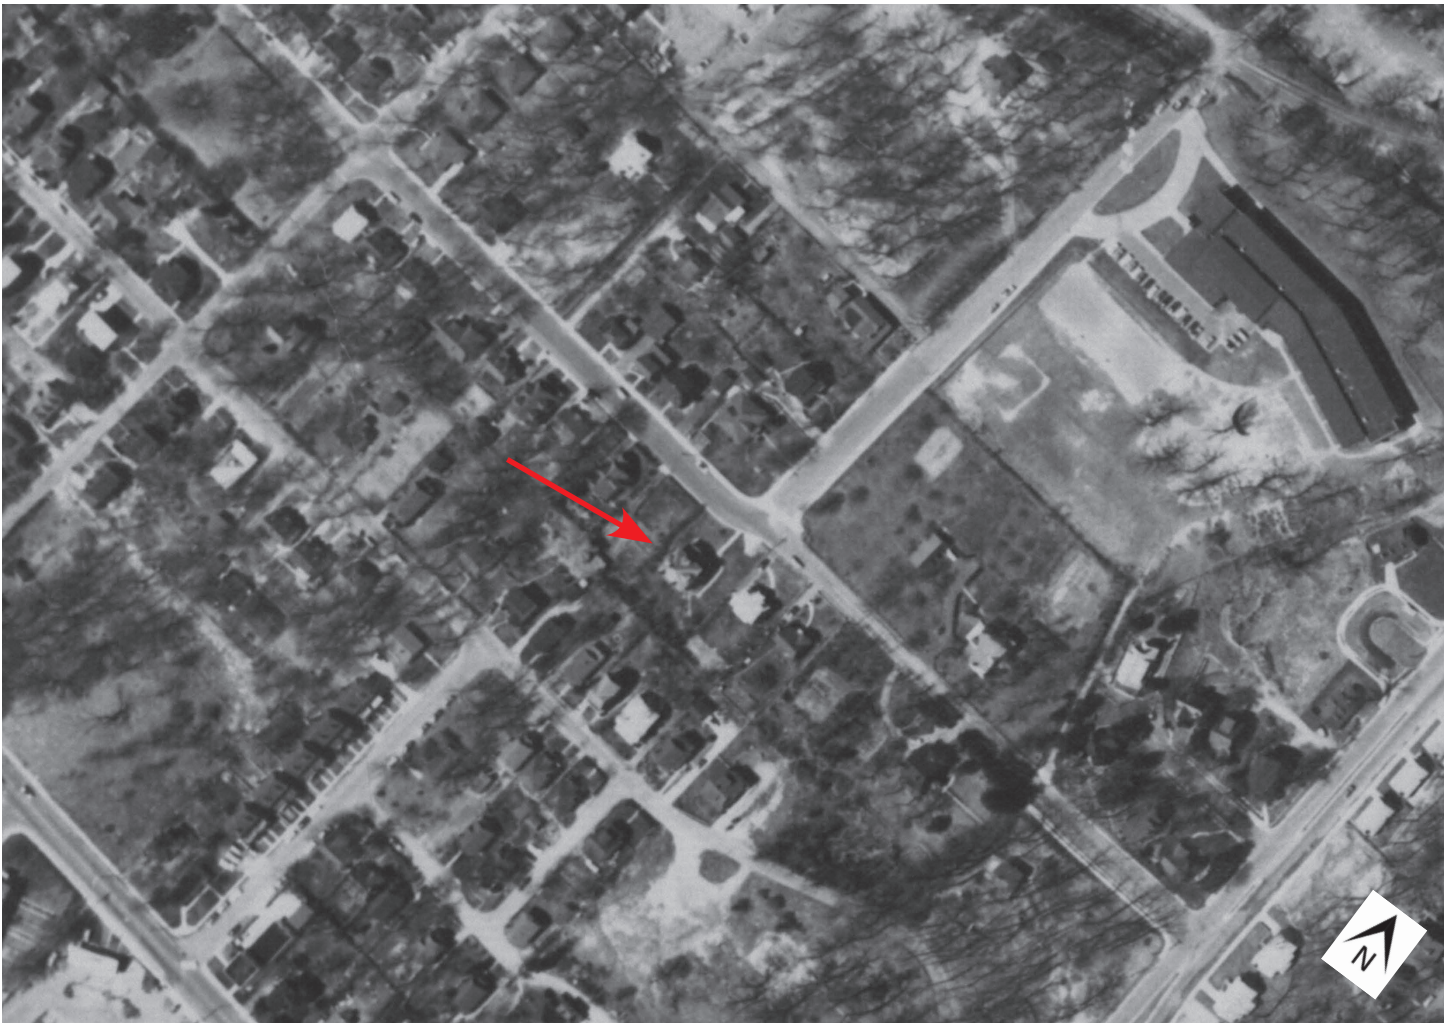
Figure 4: View of the Anderson House, 1957. The red arrow points to the House.
Source: "Historic Aerial Photographs," 1957, 15, Arlington County GIS.

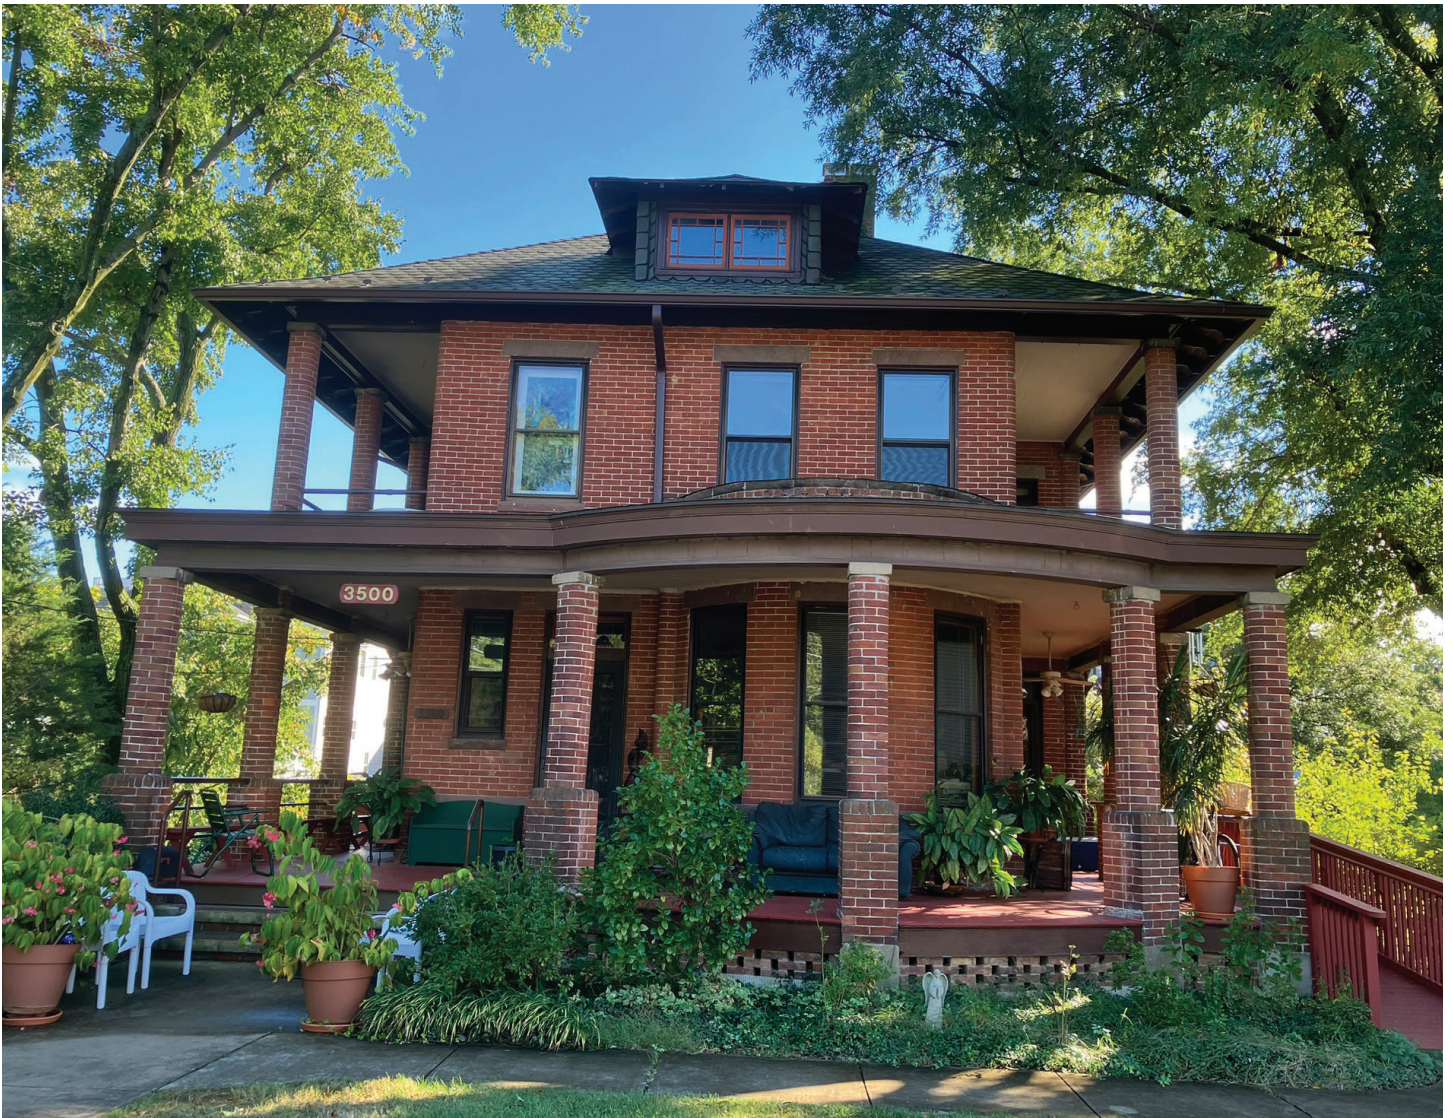
Figure 1: North facade of the home at 3500 14th St. N. looking south.

The north (front) elevation of the dwelling faces 14th Street North and measures five bays wide, with the main block consisting of the three central bays flanked by deeply recessed exterior bays on the east and west sides of the house. The corners of this elevation are constructed of distinctive bullnose radial bricks with rounded corners.¹³ A full-width, wraparound wood-frame, brick-clad porch with a rounded projection on the west portion of the main block adorns the first floor of the elevation as well as the second story at the east and west exterior bays. Directly above the rounded projection at the second level is a half-circle low parapet wall with brownstone coping and copper flashing. The porch has a wood tongue-and-groove floor resting on a decorative pierced brick wall foundation. The porch also features bullnose radial brick columns with brick and concrete bases and concrete capitals that support a shallow-pitched copper standing seam roof dating to 2004 with bracketed eaves and beadboard ceiling.¹⁴ The porch has a distinctive steel pipe railing along the east and west portion of the first floor and completely enclosing the second story porches.

Two concrete steps at the east side of the porch, expanded from smaller stone steps in 2000, lead to the front entrance of the residence, which is fitted with a 15-light wooden door with a fixed, single-light transom. The remaining fenestration of the first story of this elevation consists of a typical window east of the front entrance, a rounded projecting bay west of the front entrance, and two-paneled doors with a half-light and a single-light transom and stone lintel in both recessed bays at the east and west ends of the dwelling. The second story of this elevation has three typical windows across the main block and a multi-light door with single fixed transom light on either side in the recessed exterior bays. The current owner replaced the original eight-over-eight storm windows with one-over-one storm windows in 1983. The roofline features a hipped-roofed dormer with a decorative double casement window with simulated divided light.

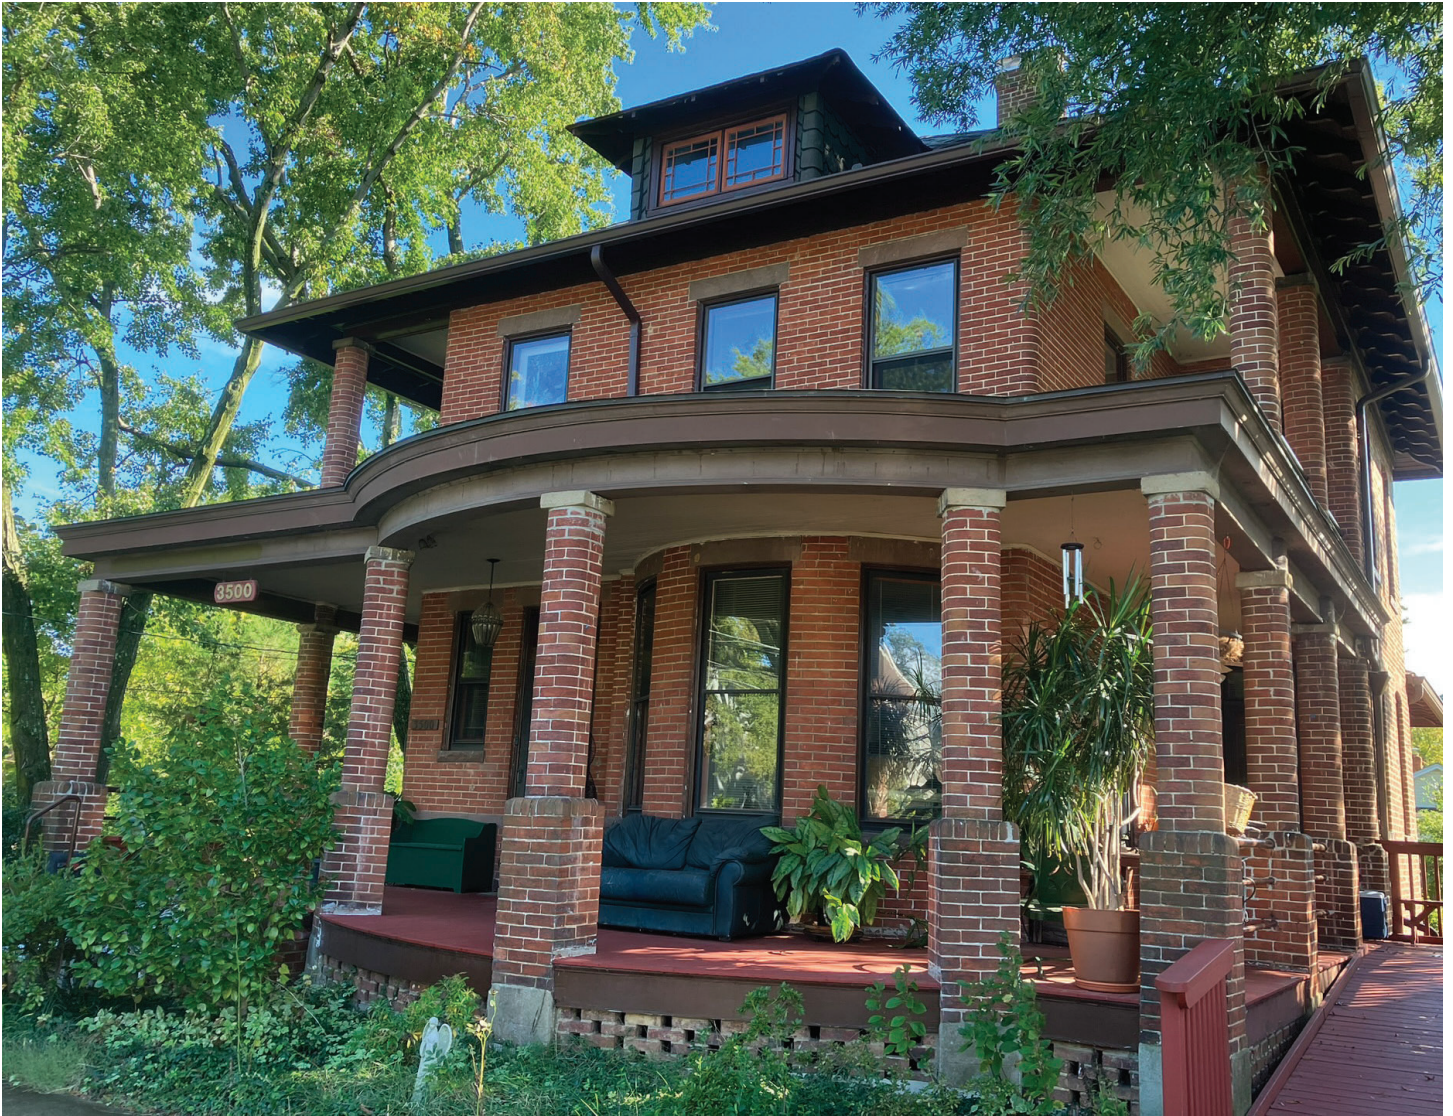
Figure 2: North facade and west elevation of the home at 3500 14th St. N. looking southeast.
Source: Arlington County Historic Preservation Program, 2022.

The west elevation can be read in three separate sections, each from a different period of the building's evolution. The northern section is the ca. 1916 façade addition featuring the two-story porch with radial brick columns and pipe railings, the typical window centered on the first and second floors, and the hipped-roofed dormer with a simulated multi-light double casement window.

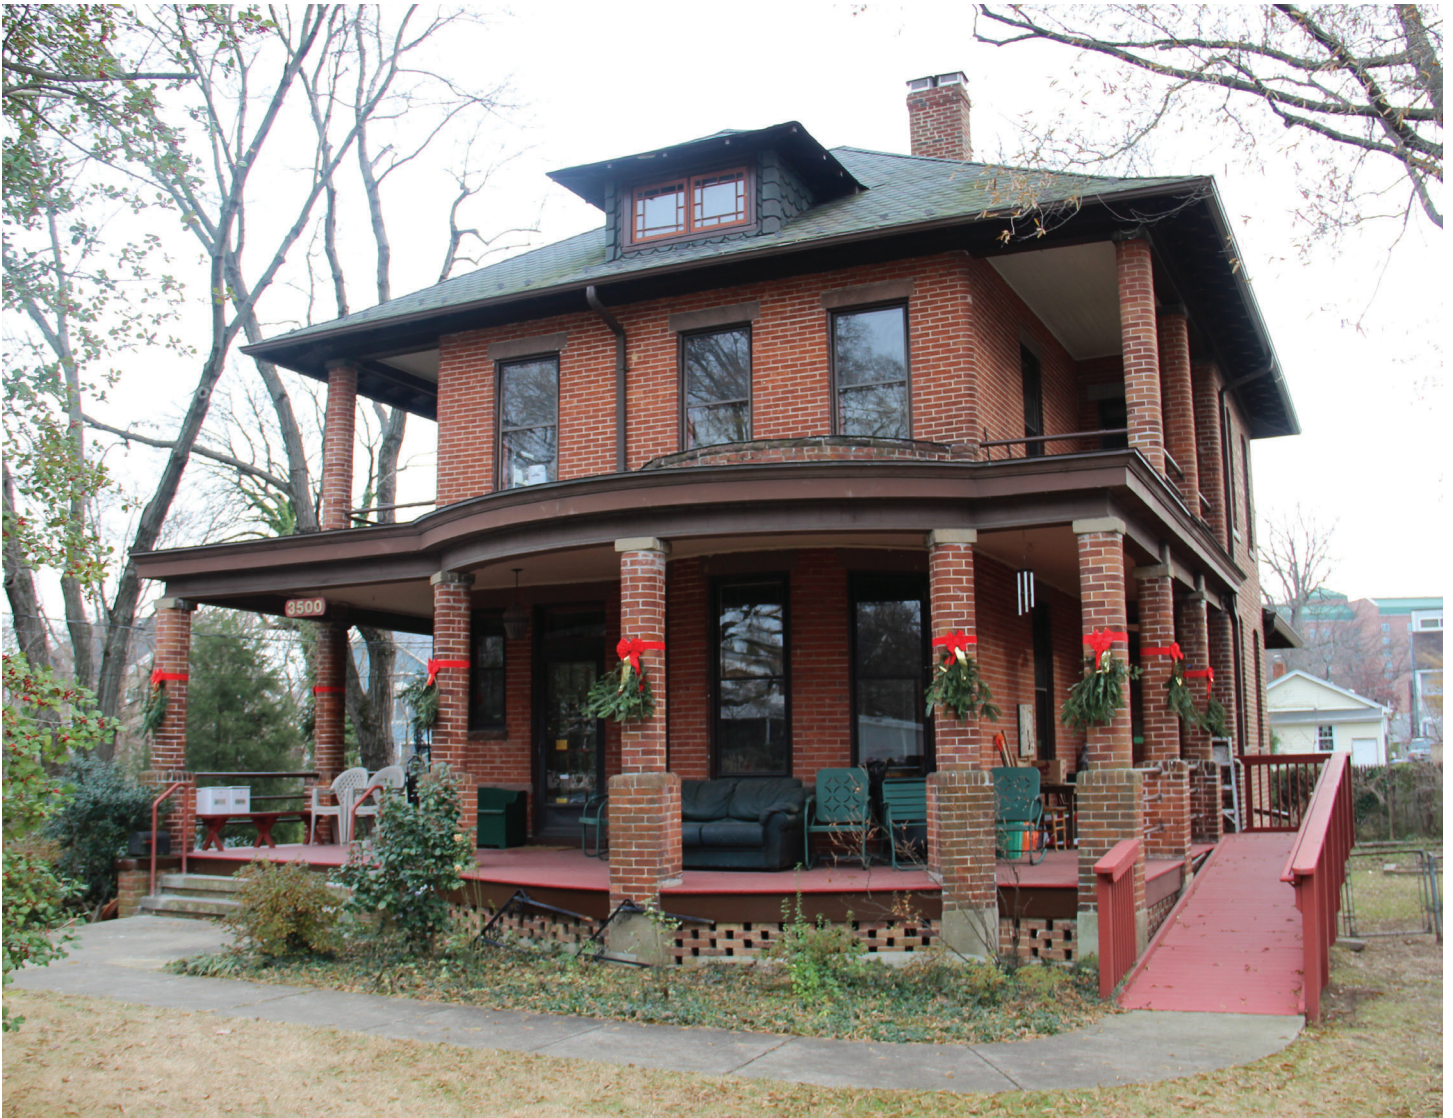
Figure 3: North facade and west elevation of the home at 3500 14th St. N. looking southeast.
Source: Arlington County Historic Preservation Program, 2018.

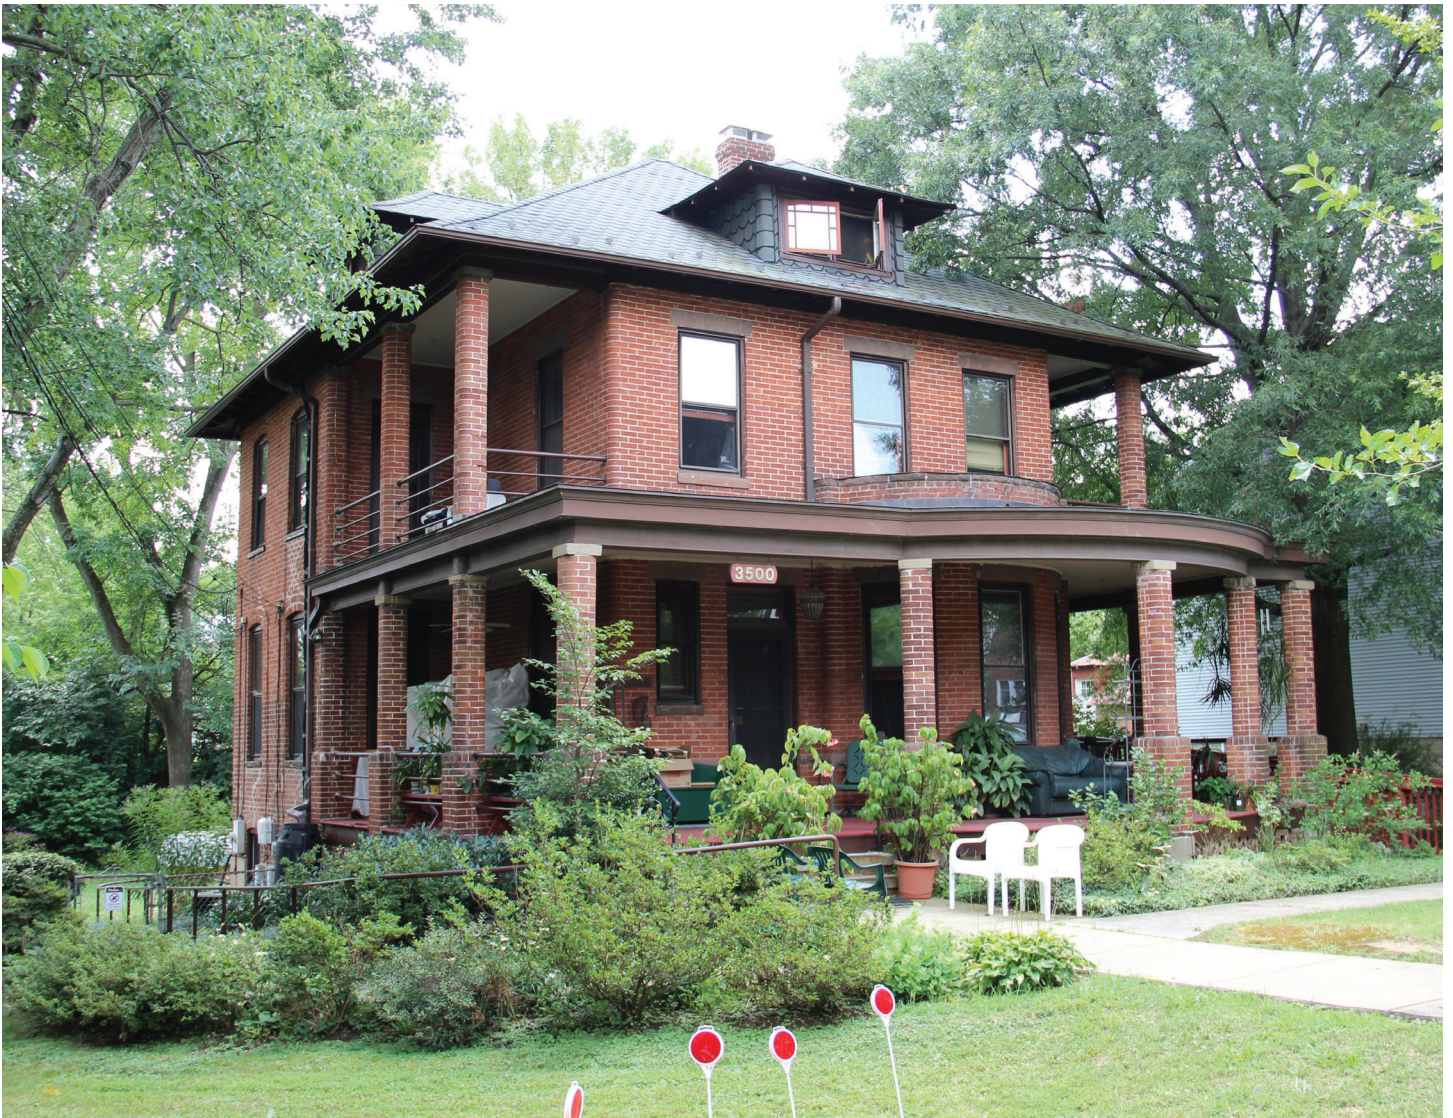
Figure 4: North facade and east elevation of the home at 3500 14th St. N. looking southwest.
Source: Arlington County Historic Preservation Program, 2016.

Like the west elevation, the east elevation also consists of three distinct sections that represent the distinct phases of construction. The southern section consists of the 2016 addition with its cement parged CMU foundation and cement stucco covered walls. The fenestration of this section consists of an aluminum glazed door and a single 1/1 aluminum sash window at the basement level and two 1/1 aluminum sash windows centered on the first level all with cement stucco clad lintels. The middle section features two aluminum frame sliding windows at the basement level and two 1/1 wood sash windows at both the first and second stories, all with segmental brick arches and painted stone lintels. The northern section is characterized by a pierced brick wall foundation, two-story porch with radial brick columns, a typical window centered on the first level, and two typical windows centered on the second level. A hipped-roofed dormer with simulated multi-light double casement window adorns the roof of this section.

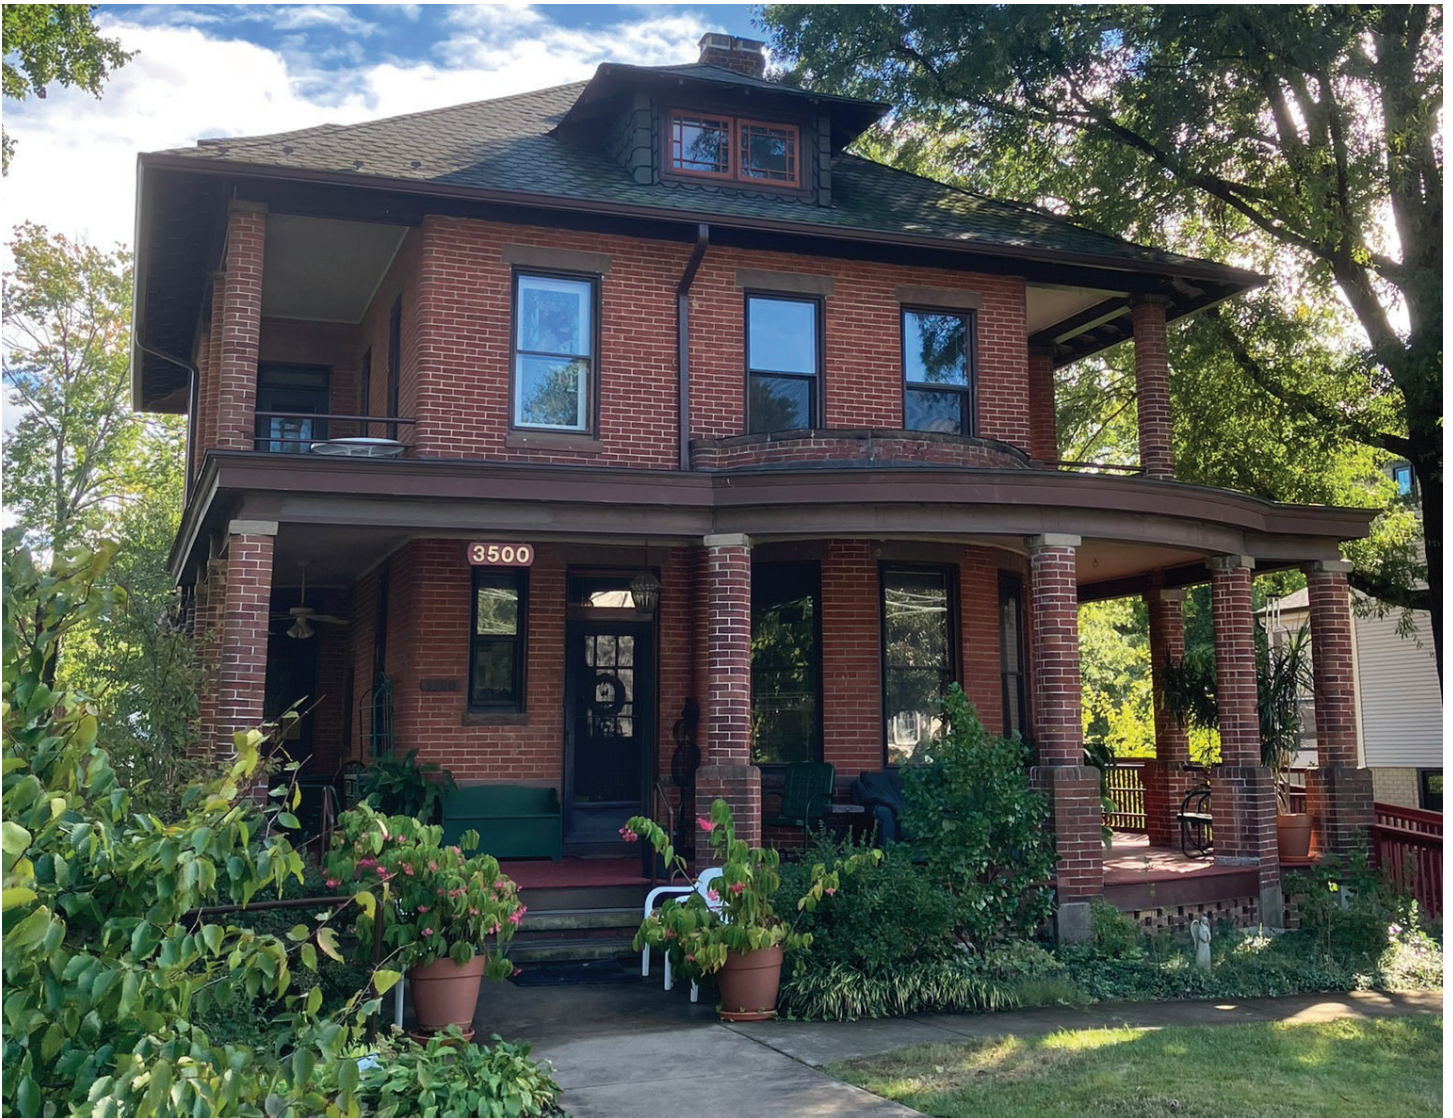
Figure 5: North facade and east elevation of the home at 3500 14th St. N. looking southwest.
Source: Arlington County Historic Preservation Program, 2022.
