Local Historic District
Designated December 17, 2022

**ARLINGTON COUNTY REGISTER OF HISTORIC PLACES
HISTORIC DISTRICT DESIGNATION FORM**

Historic District Name: Anderson House Historic District
Historic Name: Joseph and Edith Anderson House
Current Name: None

Street and Number: 3500 14th Street North
County, State, Zip Code: Arlington, Virginia 22201

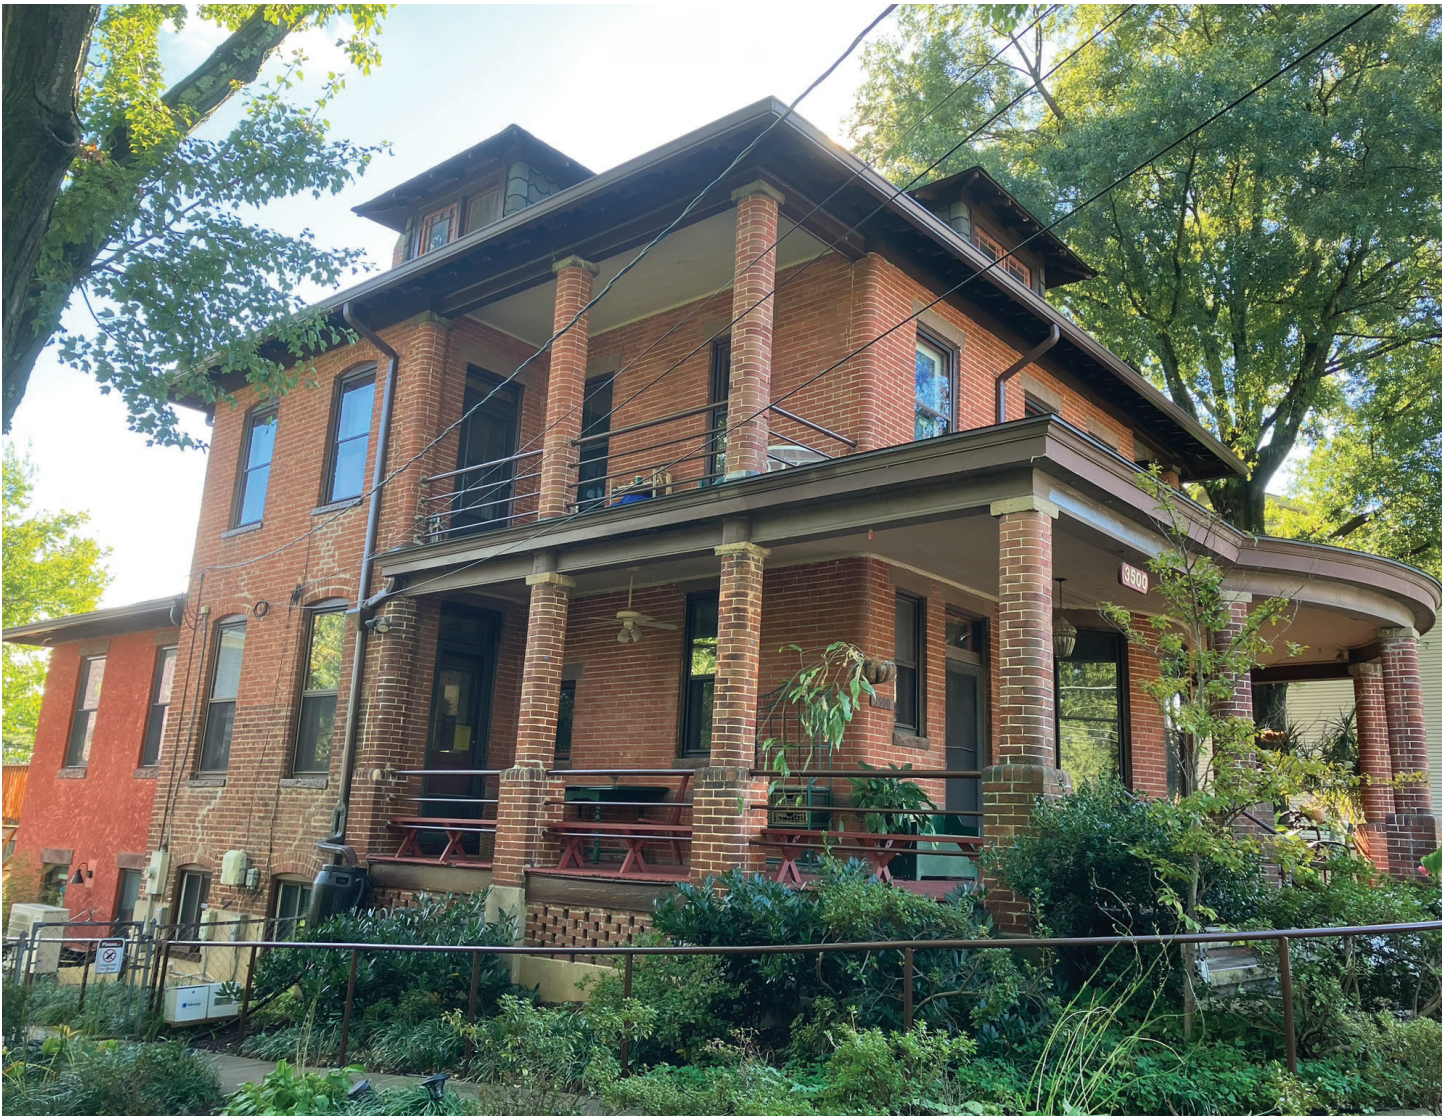
Figure 6: East elevation of the home at 3500 14th St. N. looking southeast with 2016 addition visible in rear.
Source: Arlington County Historic Preservation Program, 2022.

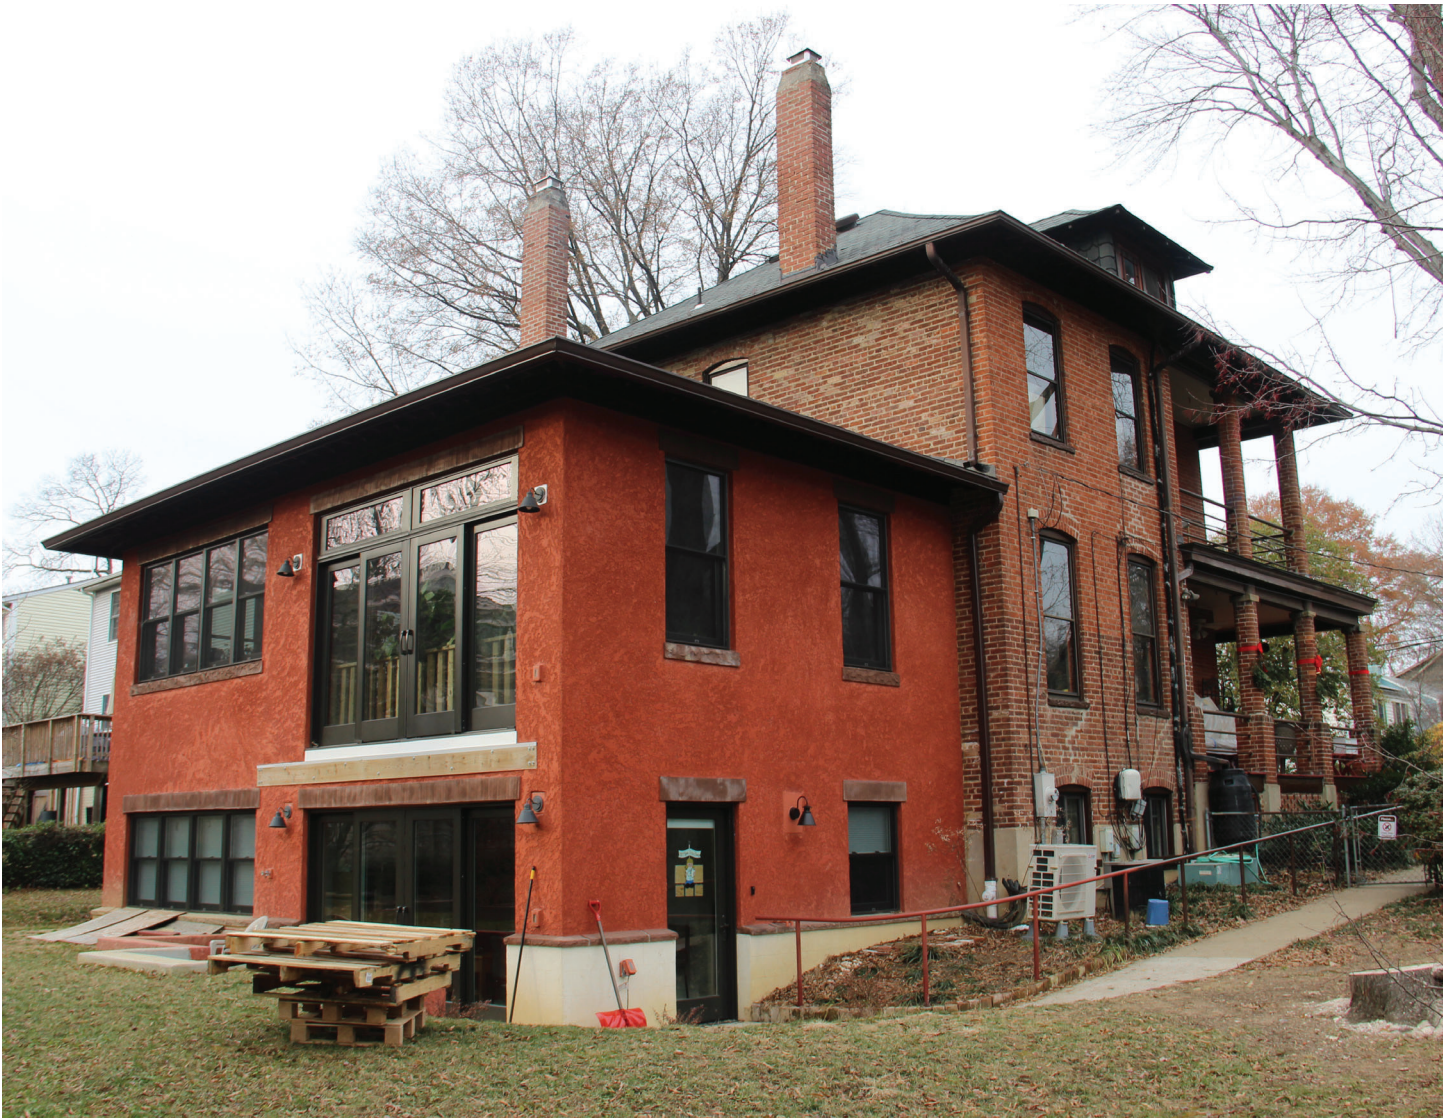
Figure 7: South and east elevations of the home at 3500 14th St. N. looking northwest at 2016 addition. Source: Arlington County Historic Preservation Program, 2018.

The south elevation features the two-story (basement and first level) 2016 addition accessed by a concrete ramp that leads to a small brick-paved patio defined by a short cement stucco retaining wall and four concrete steps. It features a cement parged CMU foundation and a half-hipped roof with bracketed eaves. The fenestration of the cement stucco clad addition consists of four ganged one-over-one aluminum sash windows with a cement stucco lintel and aluminum double sliding glass doors with a cement stucco lintel at the basement level. The fenestration of the first floor mirrors that of the basement level with another gang of four windows and double sliding glass doors, in this instance with a double transom light above them. Set back from the 2016 addition, the second story and hipped roof pierced by two brick chimneys of the ca. 1912 building are visible on the rear elevation. The second story of the original rectangular building is accentuated by a single 1/1 wood sash window with a segmental brick arch and painted stone lintel placed slightly off-center. The main level of the addition features a wooden porch walkway with stairs to the yard and patio.

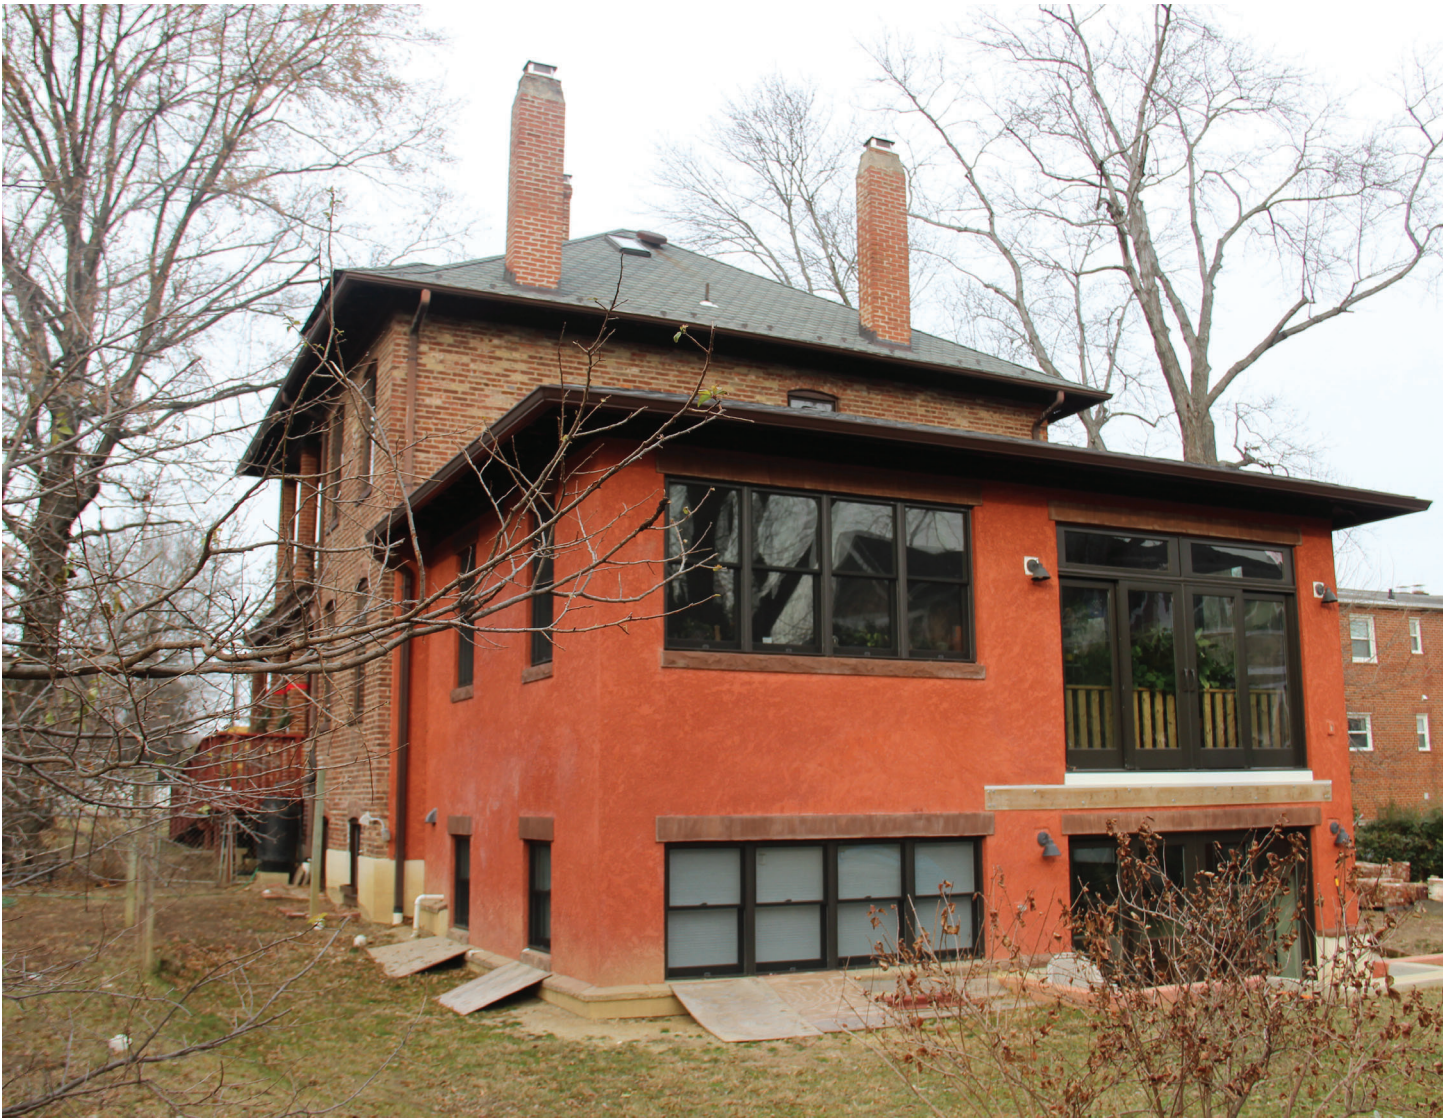
Figure 8: South and west elevations of the home at 3500 14th St. N. looking northeast at 2016 addition.
Source: Arlington County Historic Preservation Program, 2018.

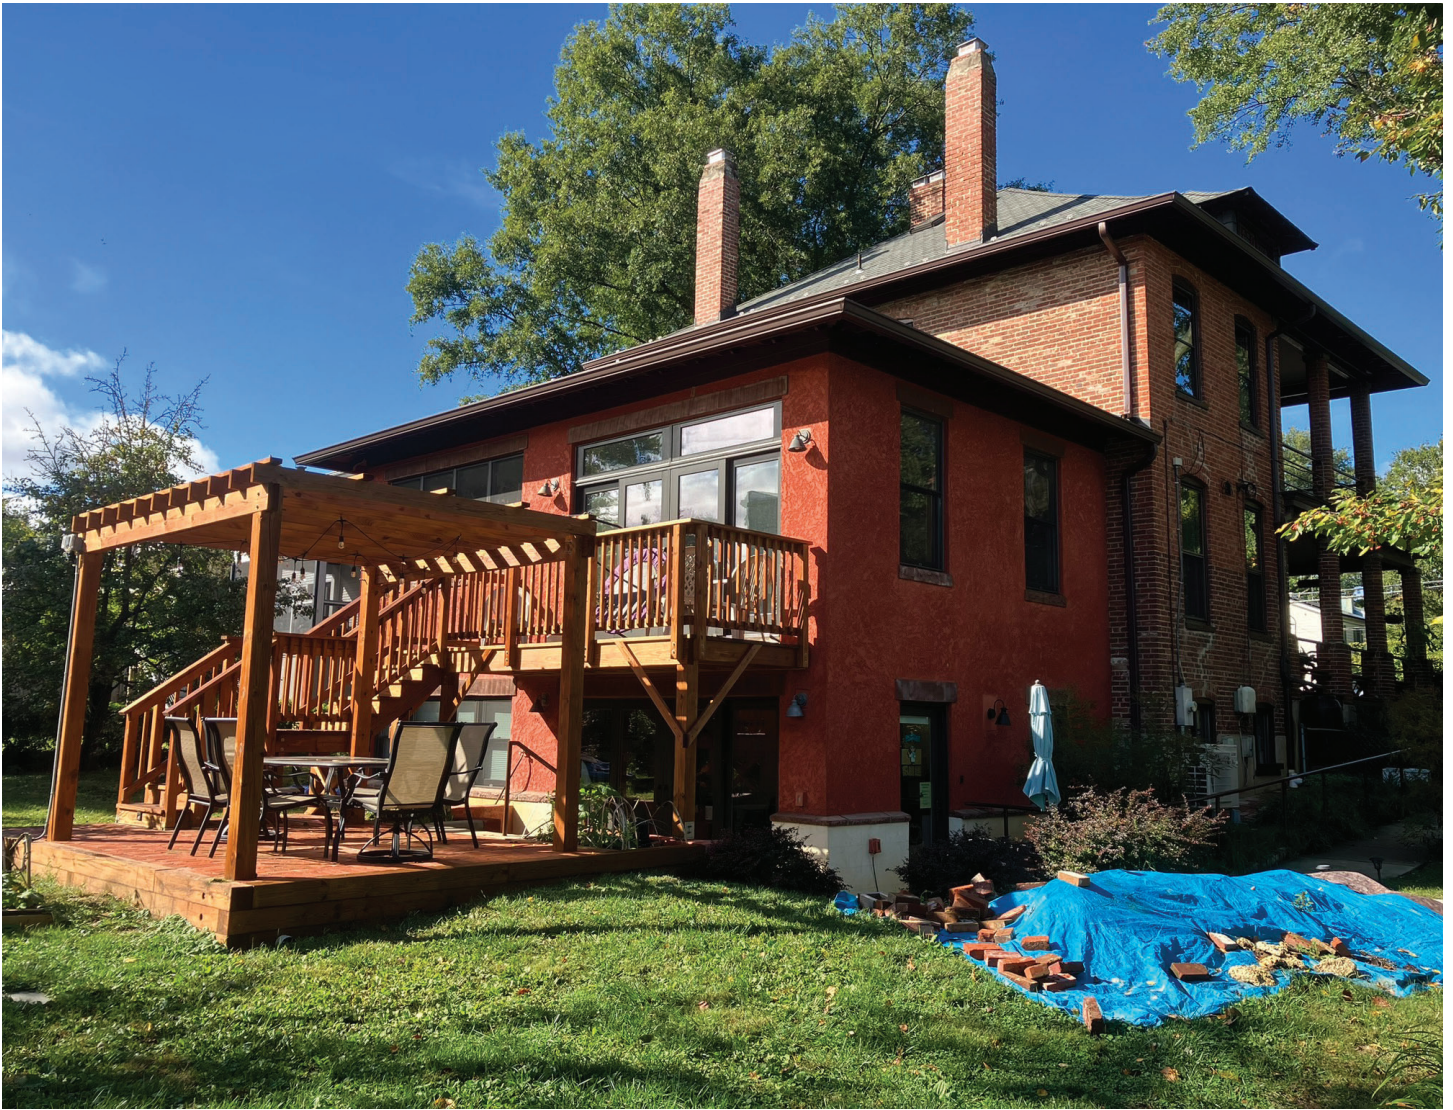
Figure 9: South and west elevations with completed addition and pergola at 3500 14th St. N. looking northeast. Source: Arlington County Historic Preservation Program, 2022.

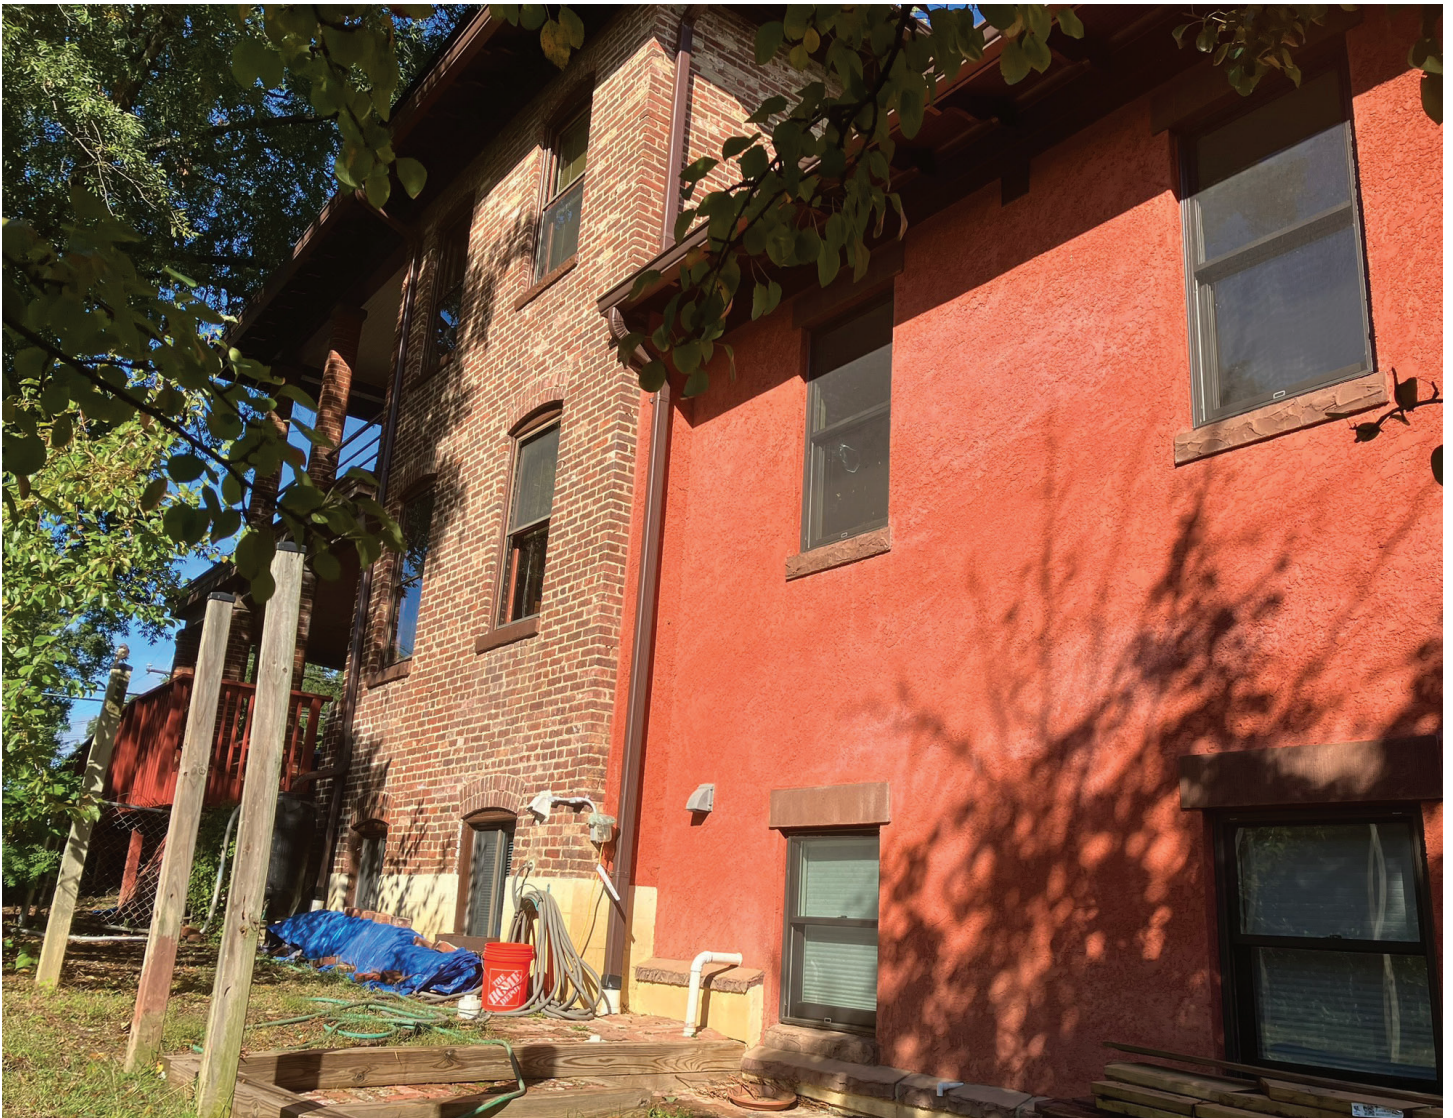
Figure 10: West elevation of the home at 3500 14th St. N. looking northeast after completion of 2016 addition. Source: Arlington County Historic Preservation Program, 2022.

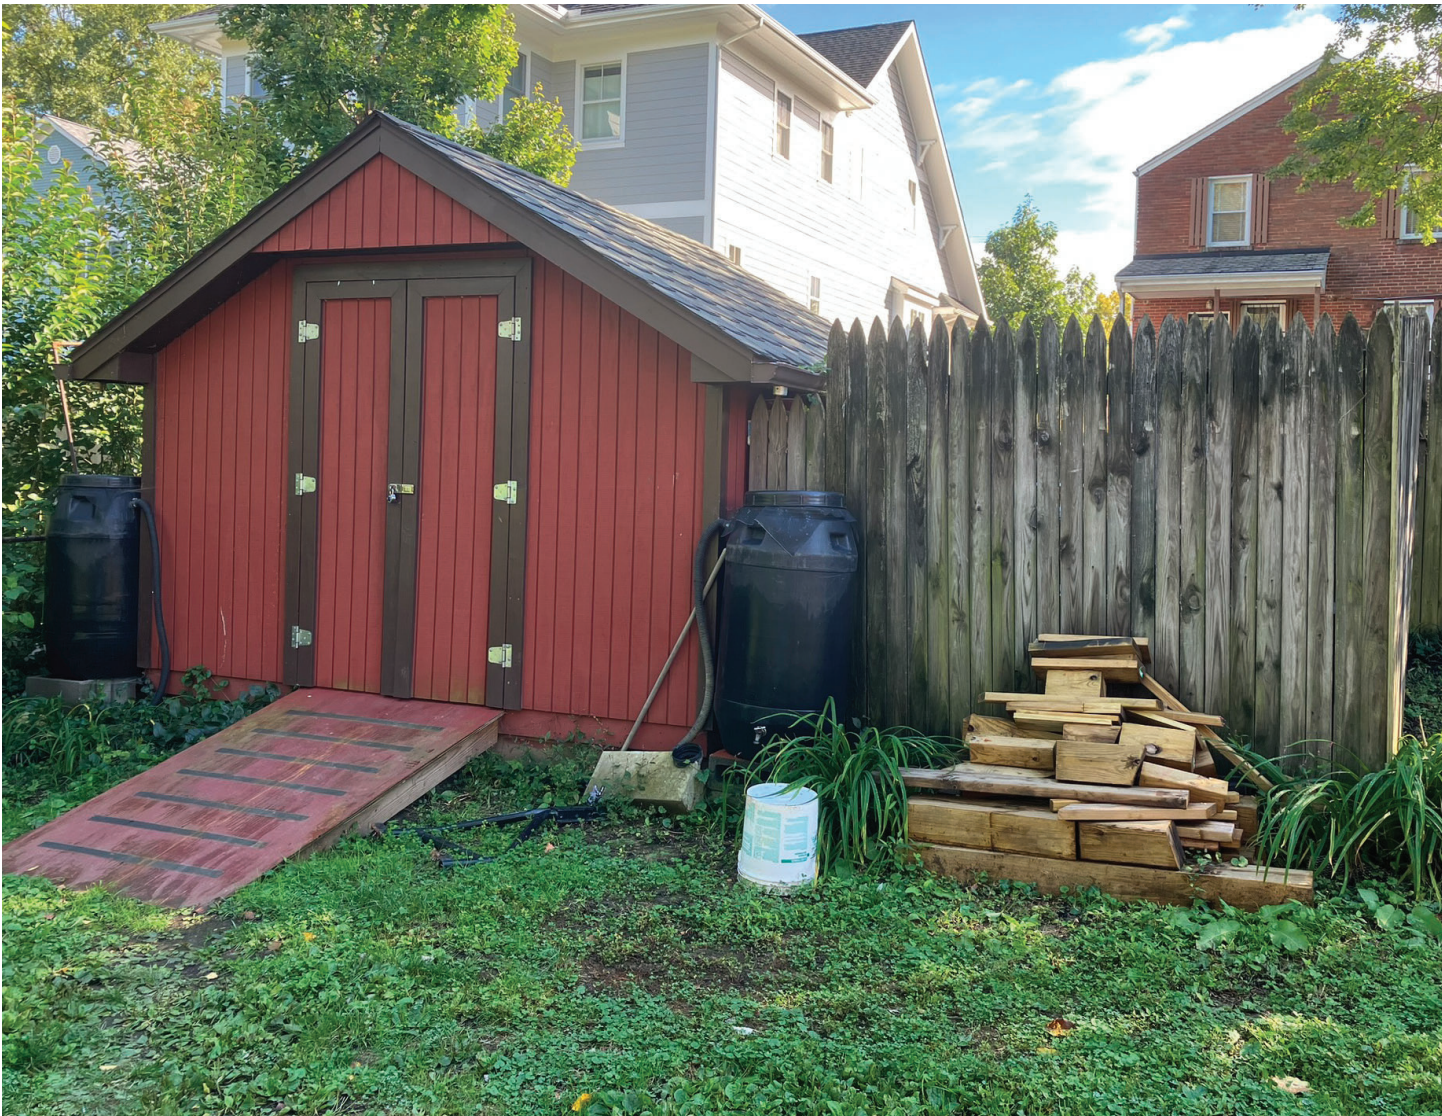
Figure 11: Non-historic shed at 3500 14th St. N. looking south.
Source: Arlington County Historic Preservation Program, 2022.

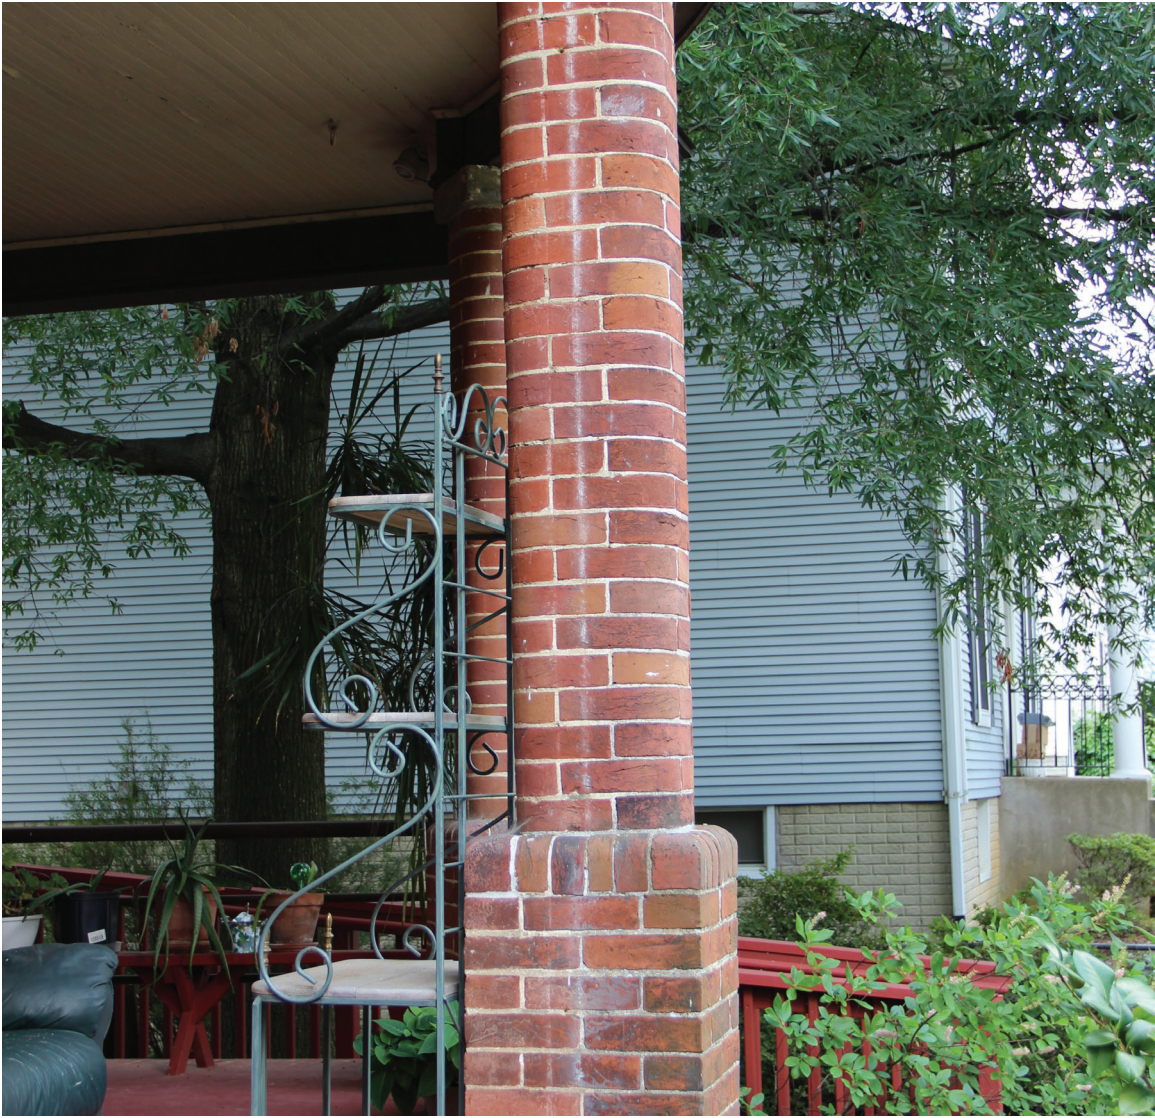
Figure 12: Detail of bullnose radial brick column at 3500 14th St. N. looking southwest.
Source: Arlington County Historic Preservation Program, 2016.

¹³ The use of radial brick was popularized in the United States at the turn of the 20th century through its use by builders in the construction of chimney stacks of factory buildings. The Alphons Custodis Chimney Construction Company patented its design for perforated radial brick in the United States in 1901 and by 1911 several other American companies had patented similar products. Jessie McNabb, "The Alphons Custodis Chimney Construction Company: Perforated Brick and the Industrial Demand for Height in Early Twentieth-Century America," Presentation, 44th Annual Conference of the Society for Industrial Archeology, 2015, <http://www.sia-web.org/> (accessed December 14, 2018).

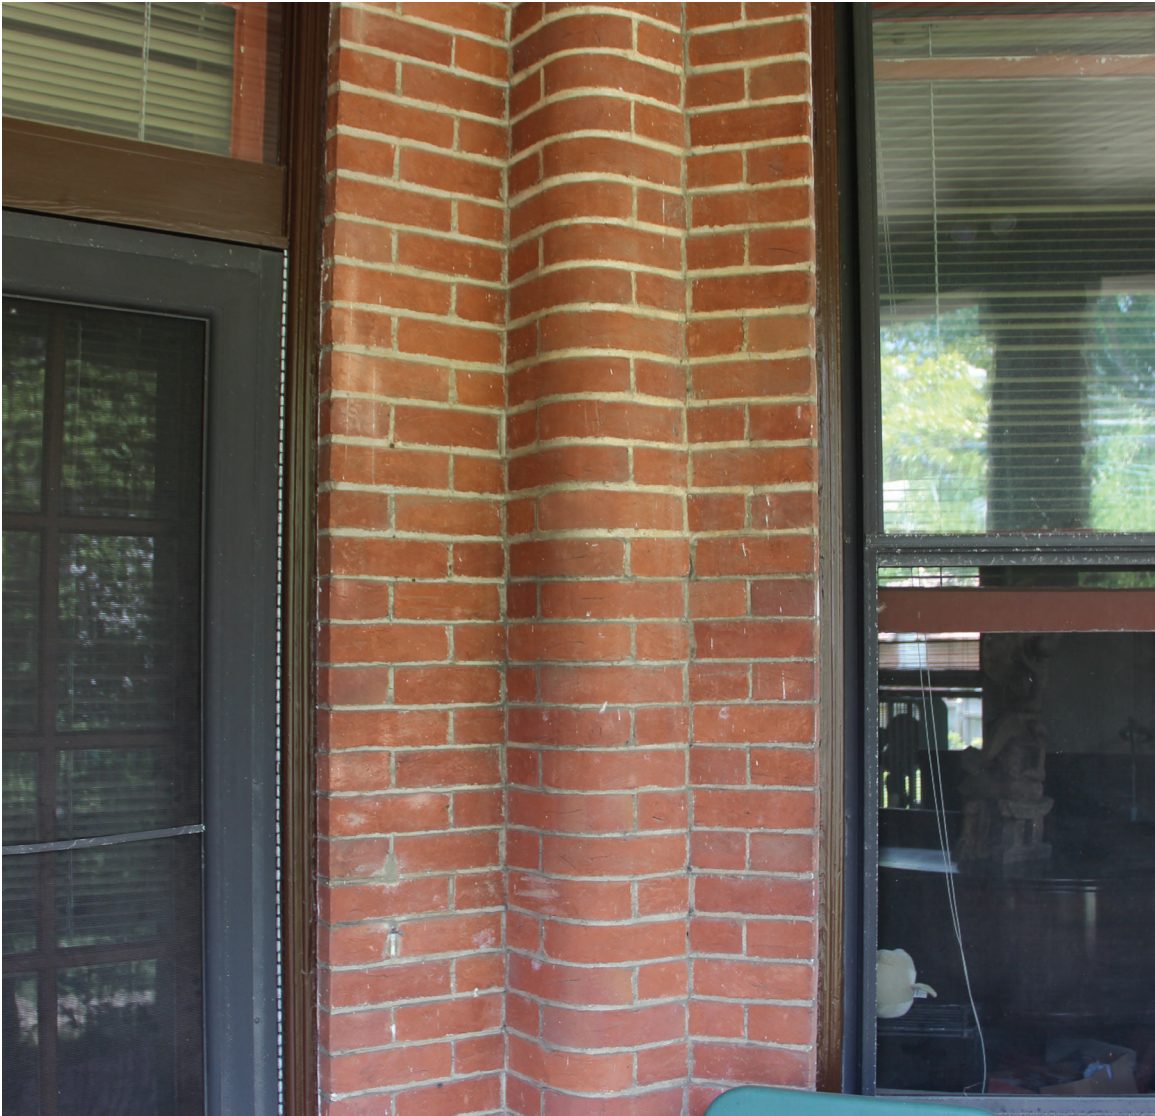
Figure 13: Detail of bullnose radial brick at 3500 14th St. N. looking south.
Source: Arlington County Historic Preservation Program, 2016.

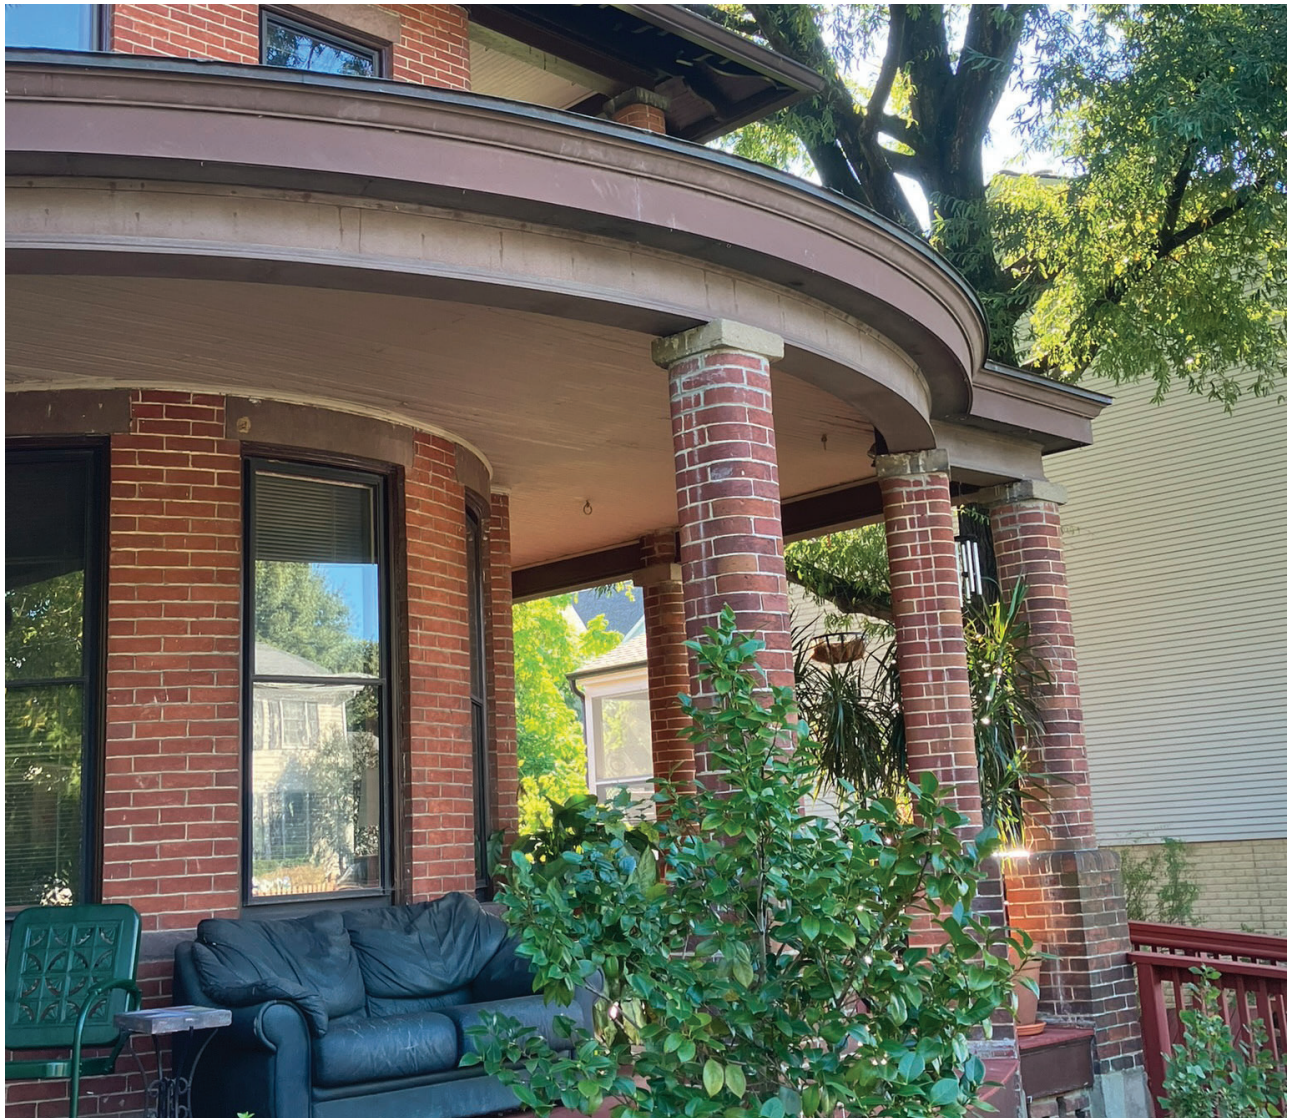
Figure 14: Detail of front porch at 3500 14th St. N. looking southwest.
Source: Arlington County Historic Preservation Program, 2022.

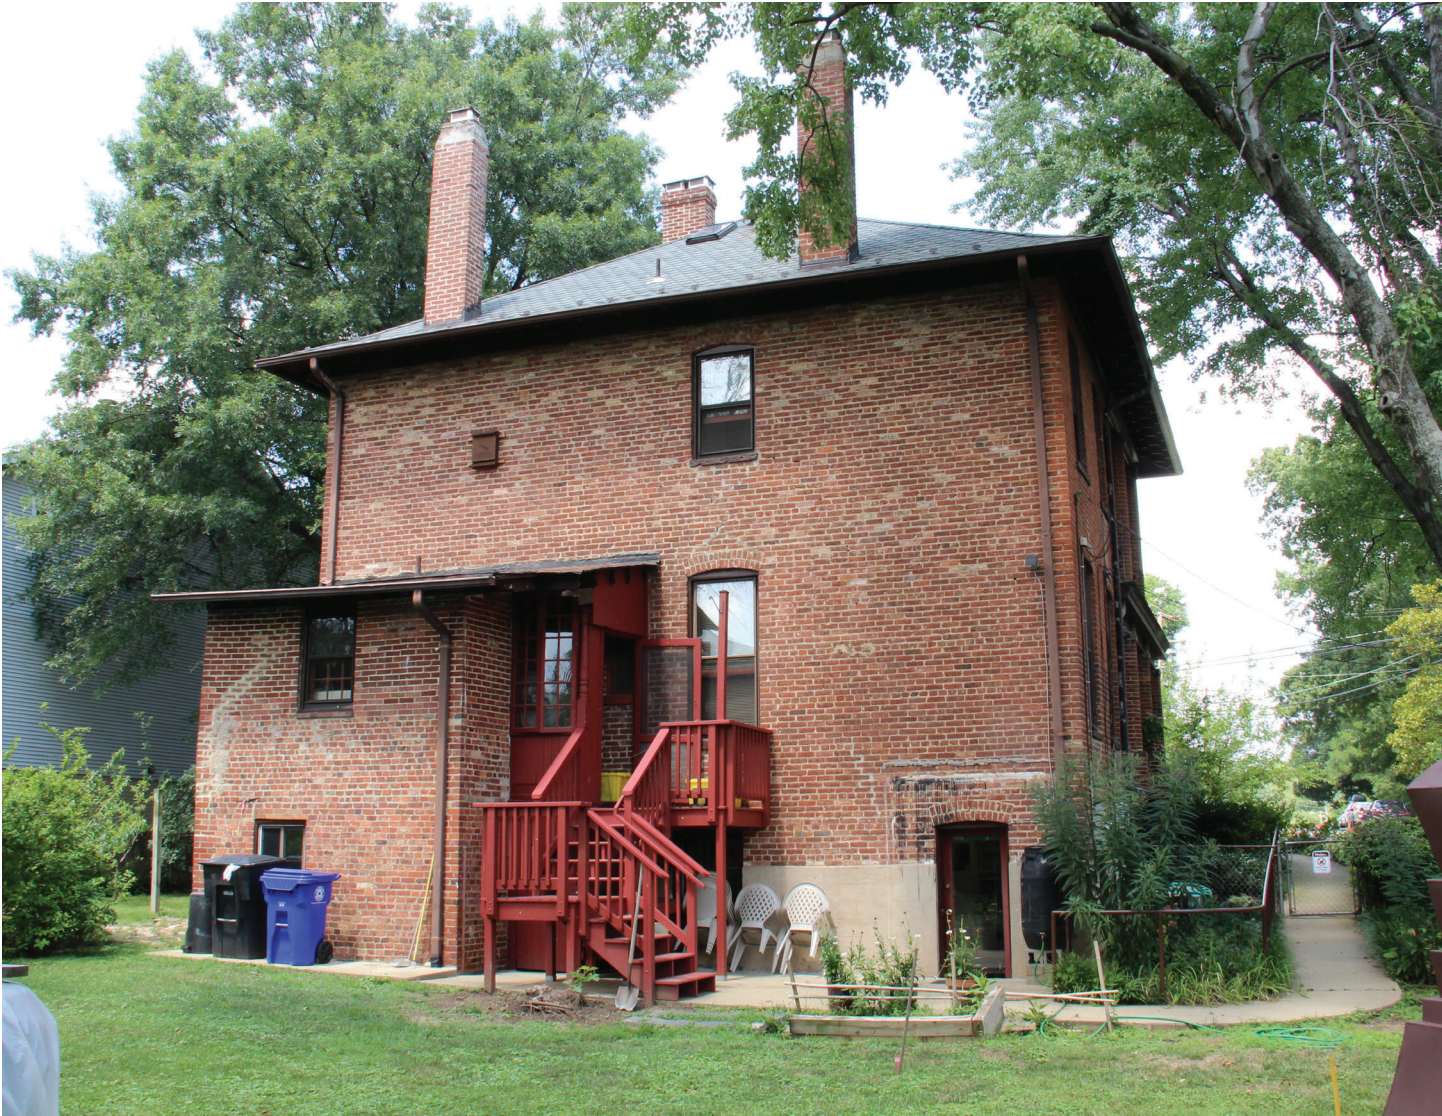
Figure 15: South elevation before 2016 addition of home at 3500 14th St. N. looking north.
