Eastman-Fenwick House Site Renovations

DRC Submission #1

February 20th, 2024

6733 Langston Blvd Arlington, VA 22205

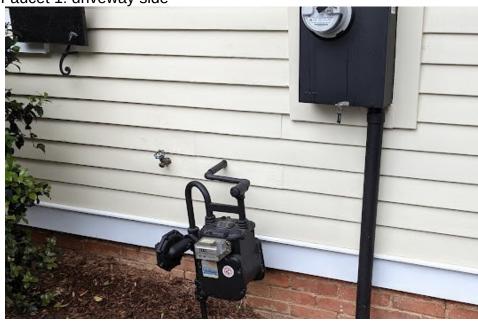
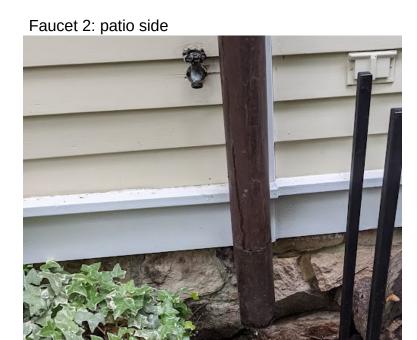
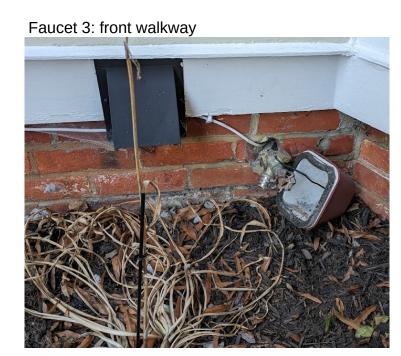
Faucet 1: driveway side

Rationale: The three exterior water faucets are hard to access due to the orientation and location of the spouts, one of which is also leaky. **Scope**: The existing faucets would be replaced with discrete, frost-free wall hydrants with removable faucets in the same location.

Current state:

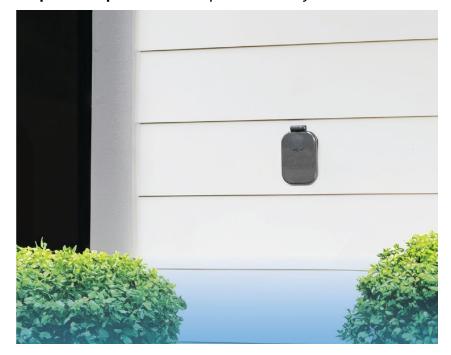
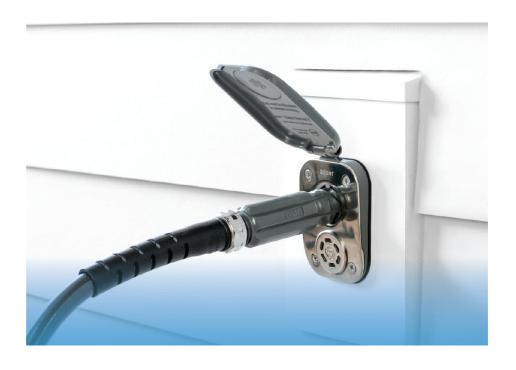
Proposed replacement: Aquor House Hydrant V2+ Frost Free Wall Hydrant with Quick-Connect and Anti-Siphon:

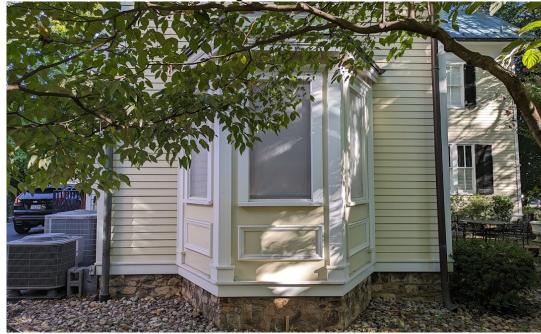
Current state of north face, looking south:

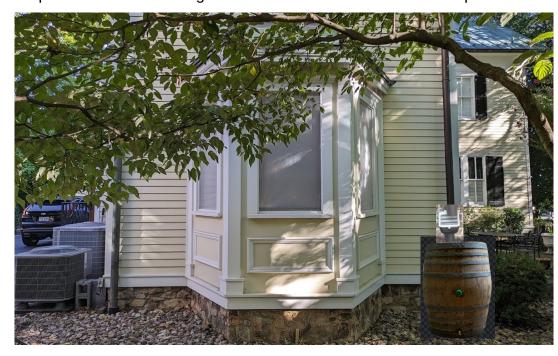
Proposed addition of 100 gallon rain barrel to NW corner downspout:

Rationale: a rain barrel would help manage rainwater runoff from the roof by collecting water for later use in the garden and align with available incentives from Arlington County's new Stormwater Utility Fee Credit Program

Scope: install a 100 gallon rain barrel with internal electric pump and attach it to the northwest corner gutter downspout with a leaf guard. The barrel would be made from a used wine/spirits barrel in order to match the aesthetics of the period farm house.

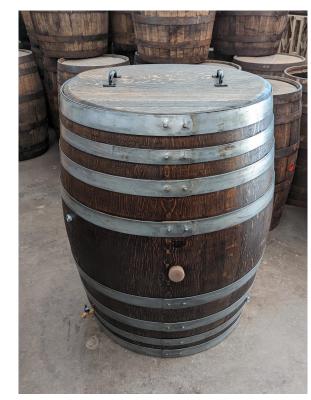
Close-up of rain barrel and leaf guard:

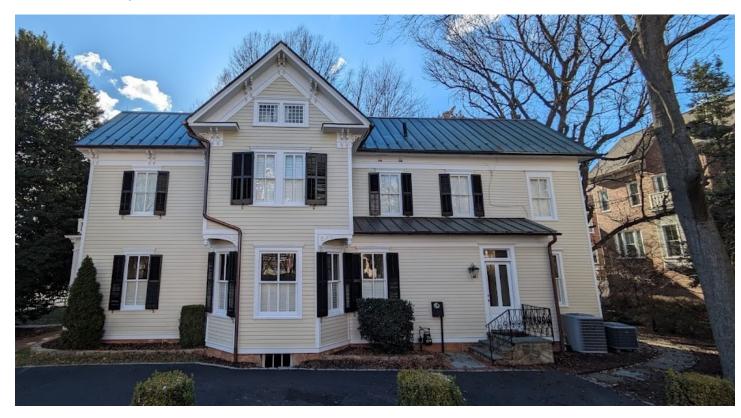
Current driveway side view:

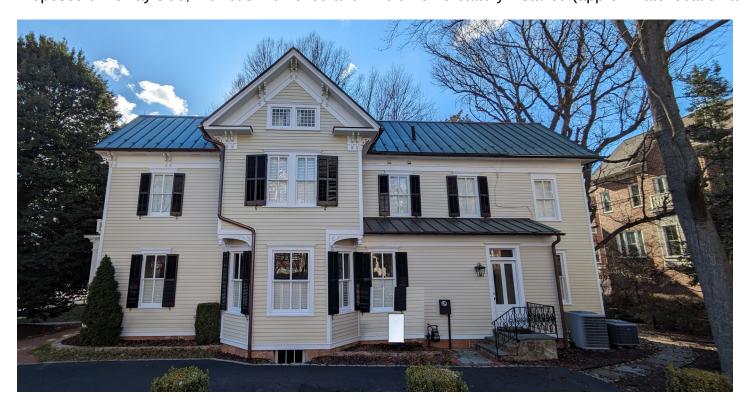
Proposed driveway side, with bush removed and whole-home battery installed (approximate location and scale):

Rationale: a whole home battery would allow better energy management for the house and act as a backup source of power in case of an electrical outage

Scope: install two Tesla Powerwall batteries on a small concrete pad in place of the bush on the driveway / East side of the house, in the lee of the bay window so that it is minimally-visible from the street. Wire the batteries into the house through a new exterior wall penetration.

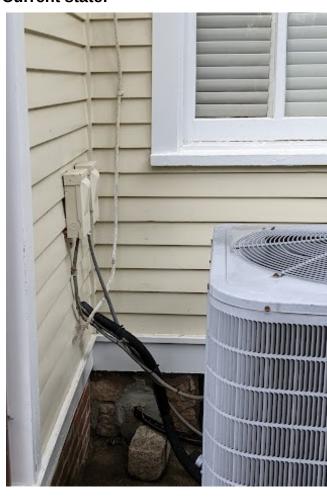
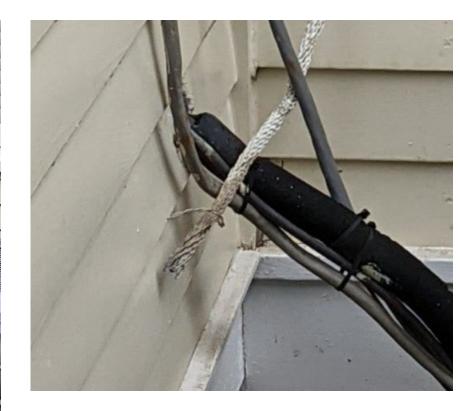
Rationale: It appears as if the lightning rods on the northern part of the roofline used to be grounded near where the AC compressors sit now, but sometime before we purchased the house (perhaps many years ago) the externally mounted grounding wire was detached from the ground and left dangling. There is no obvious location where it would have been grounded, but perhaps it was obscured when the addition to the house was made in 2010, since it was on the same side of the house.

Current state:

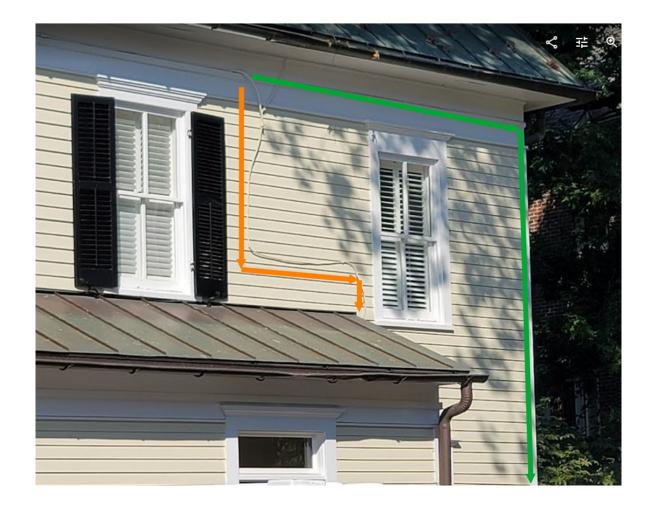
Scope: In order for the grounding wire to reach the ground, it would need to be extended with additional braided wire matching the existing wire; and in order for it to reach the ground safely without passing near the compressors or other wiring, it would need to be rerouted along a different path to the ground farther north on the exterior wall (illustrated with green in the picture)

Proposed routing vs. existing:

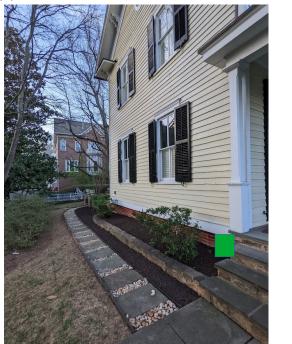
Location of network switches and new exterior wall penetrations at the foundation line:

(a) West side of Front Porch, in the lee of the stone steps

(b) Behind the AC compressors on the northeast corner

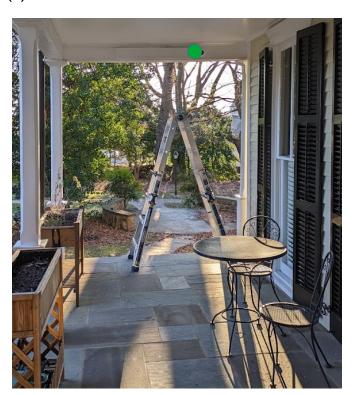
Proposed camera locations: (1) Front Porch

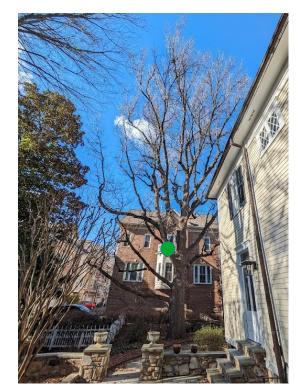
(2) Overlooking the patio

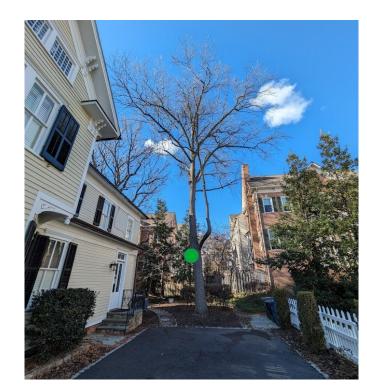
(3) Overlooking the driveway side door
