# Gulf Branch Stream Resilience Project

Re-Engagement: June 22, 2022 Community Meeting

# Gulf Branch Stream Resilience Project Goals

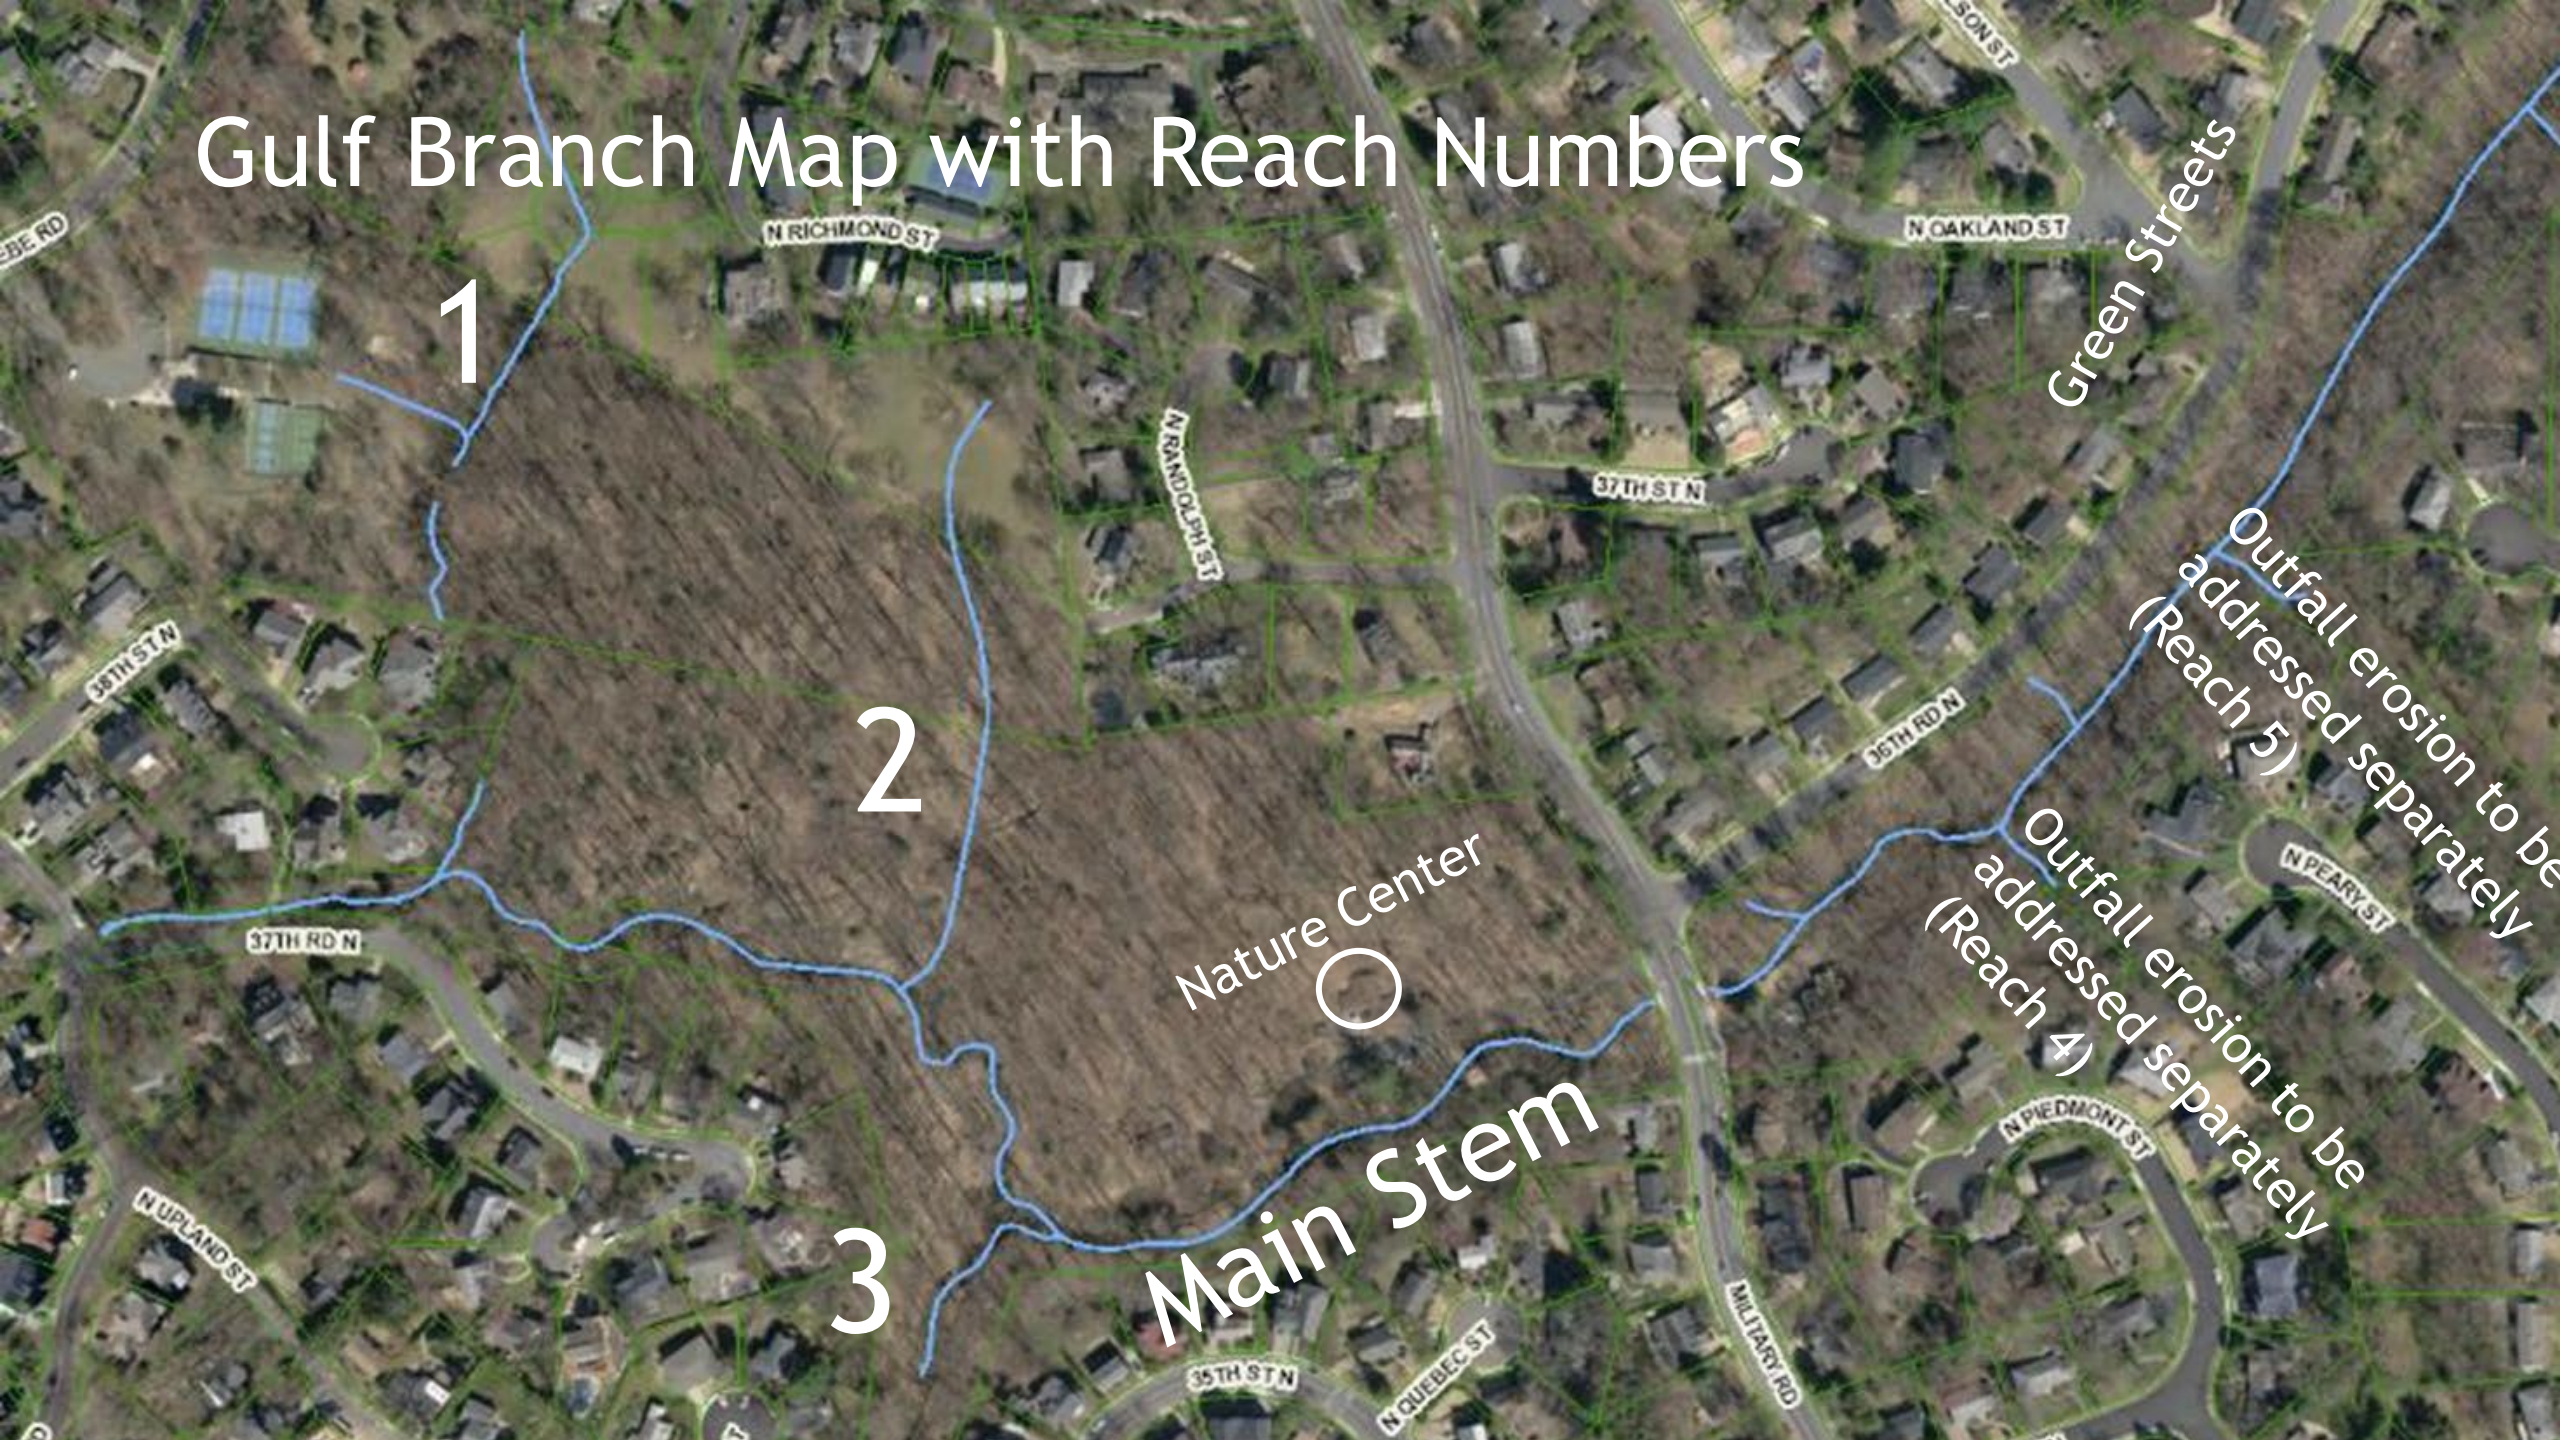
# Gulf Branch Map with Reach Numbers

Outfall erosion to be addressed separately (Reach 5)

Outfall erosion to be addressed separately (Reach 4)

Green Streets

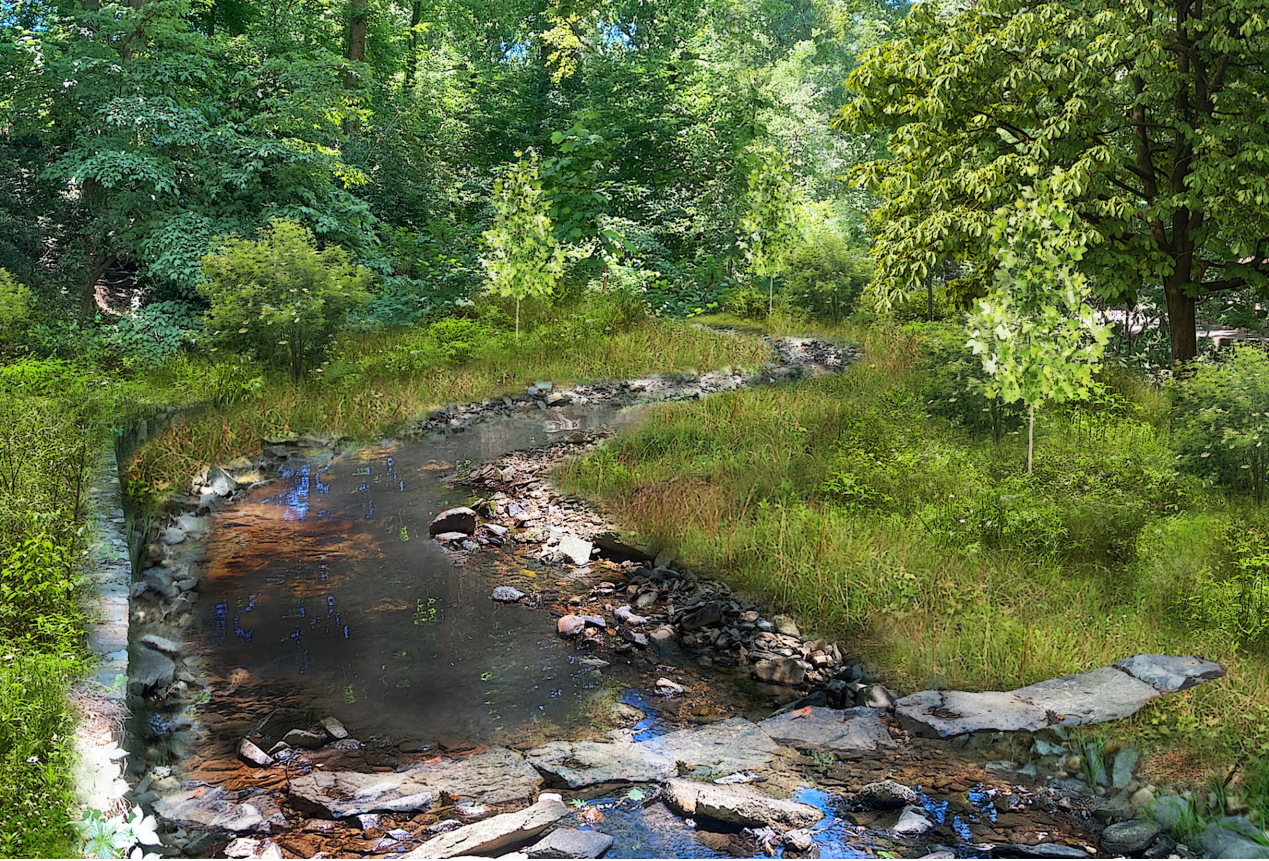
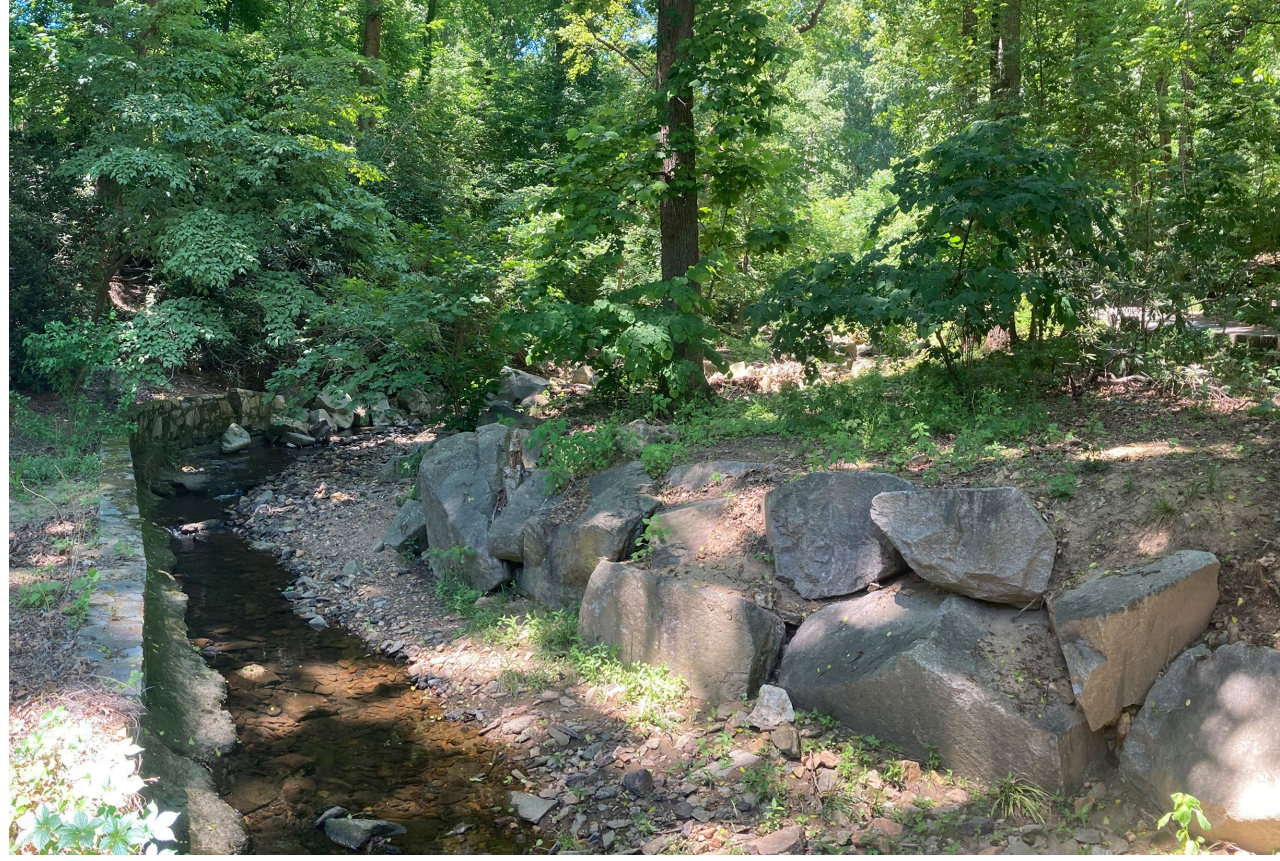
# Design Visualization vs. Existing Conditions

Just Upstream of Military Road

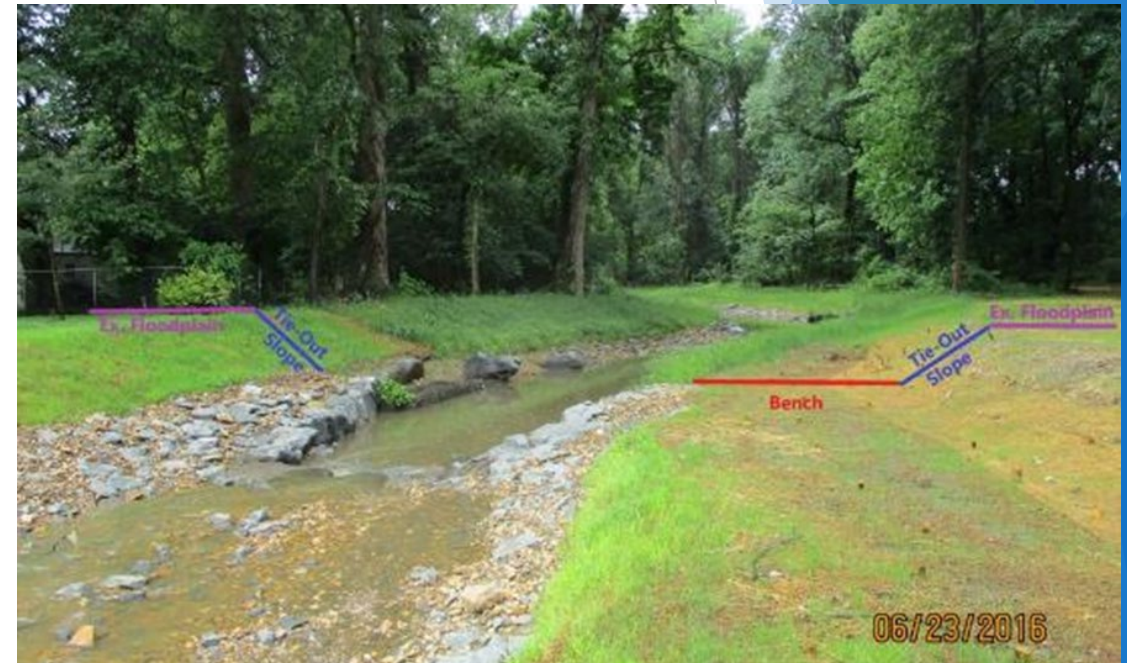
# Floodplain Bench Considerations

Floodplain bench near nature center would help improve access to the stream for programs.

- ▶ Even without a floodplain bench, ongoing stream erosion and widening would take down many of the trees and reshape banks (and send sediment downstream)
- ▶ Alternative to floodplain bench: Armoring with heavy rock or let erode
  - ▶ Armoring prevents spot erosion but transfers force downstream. No access benefits.

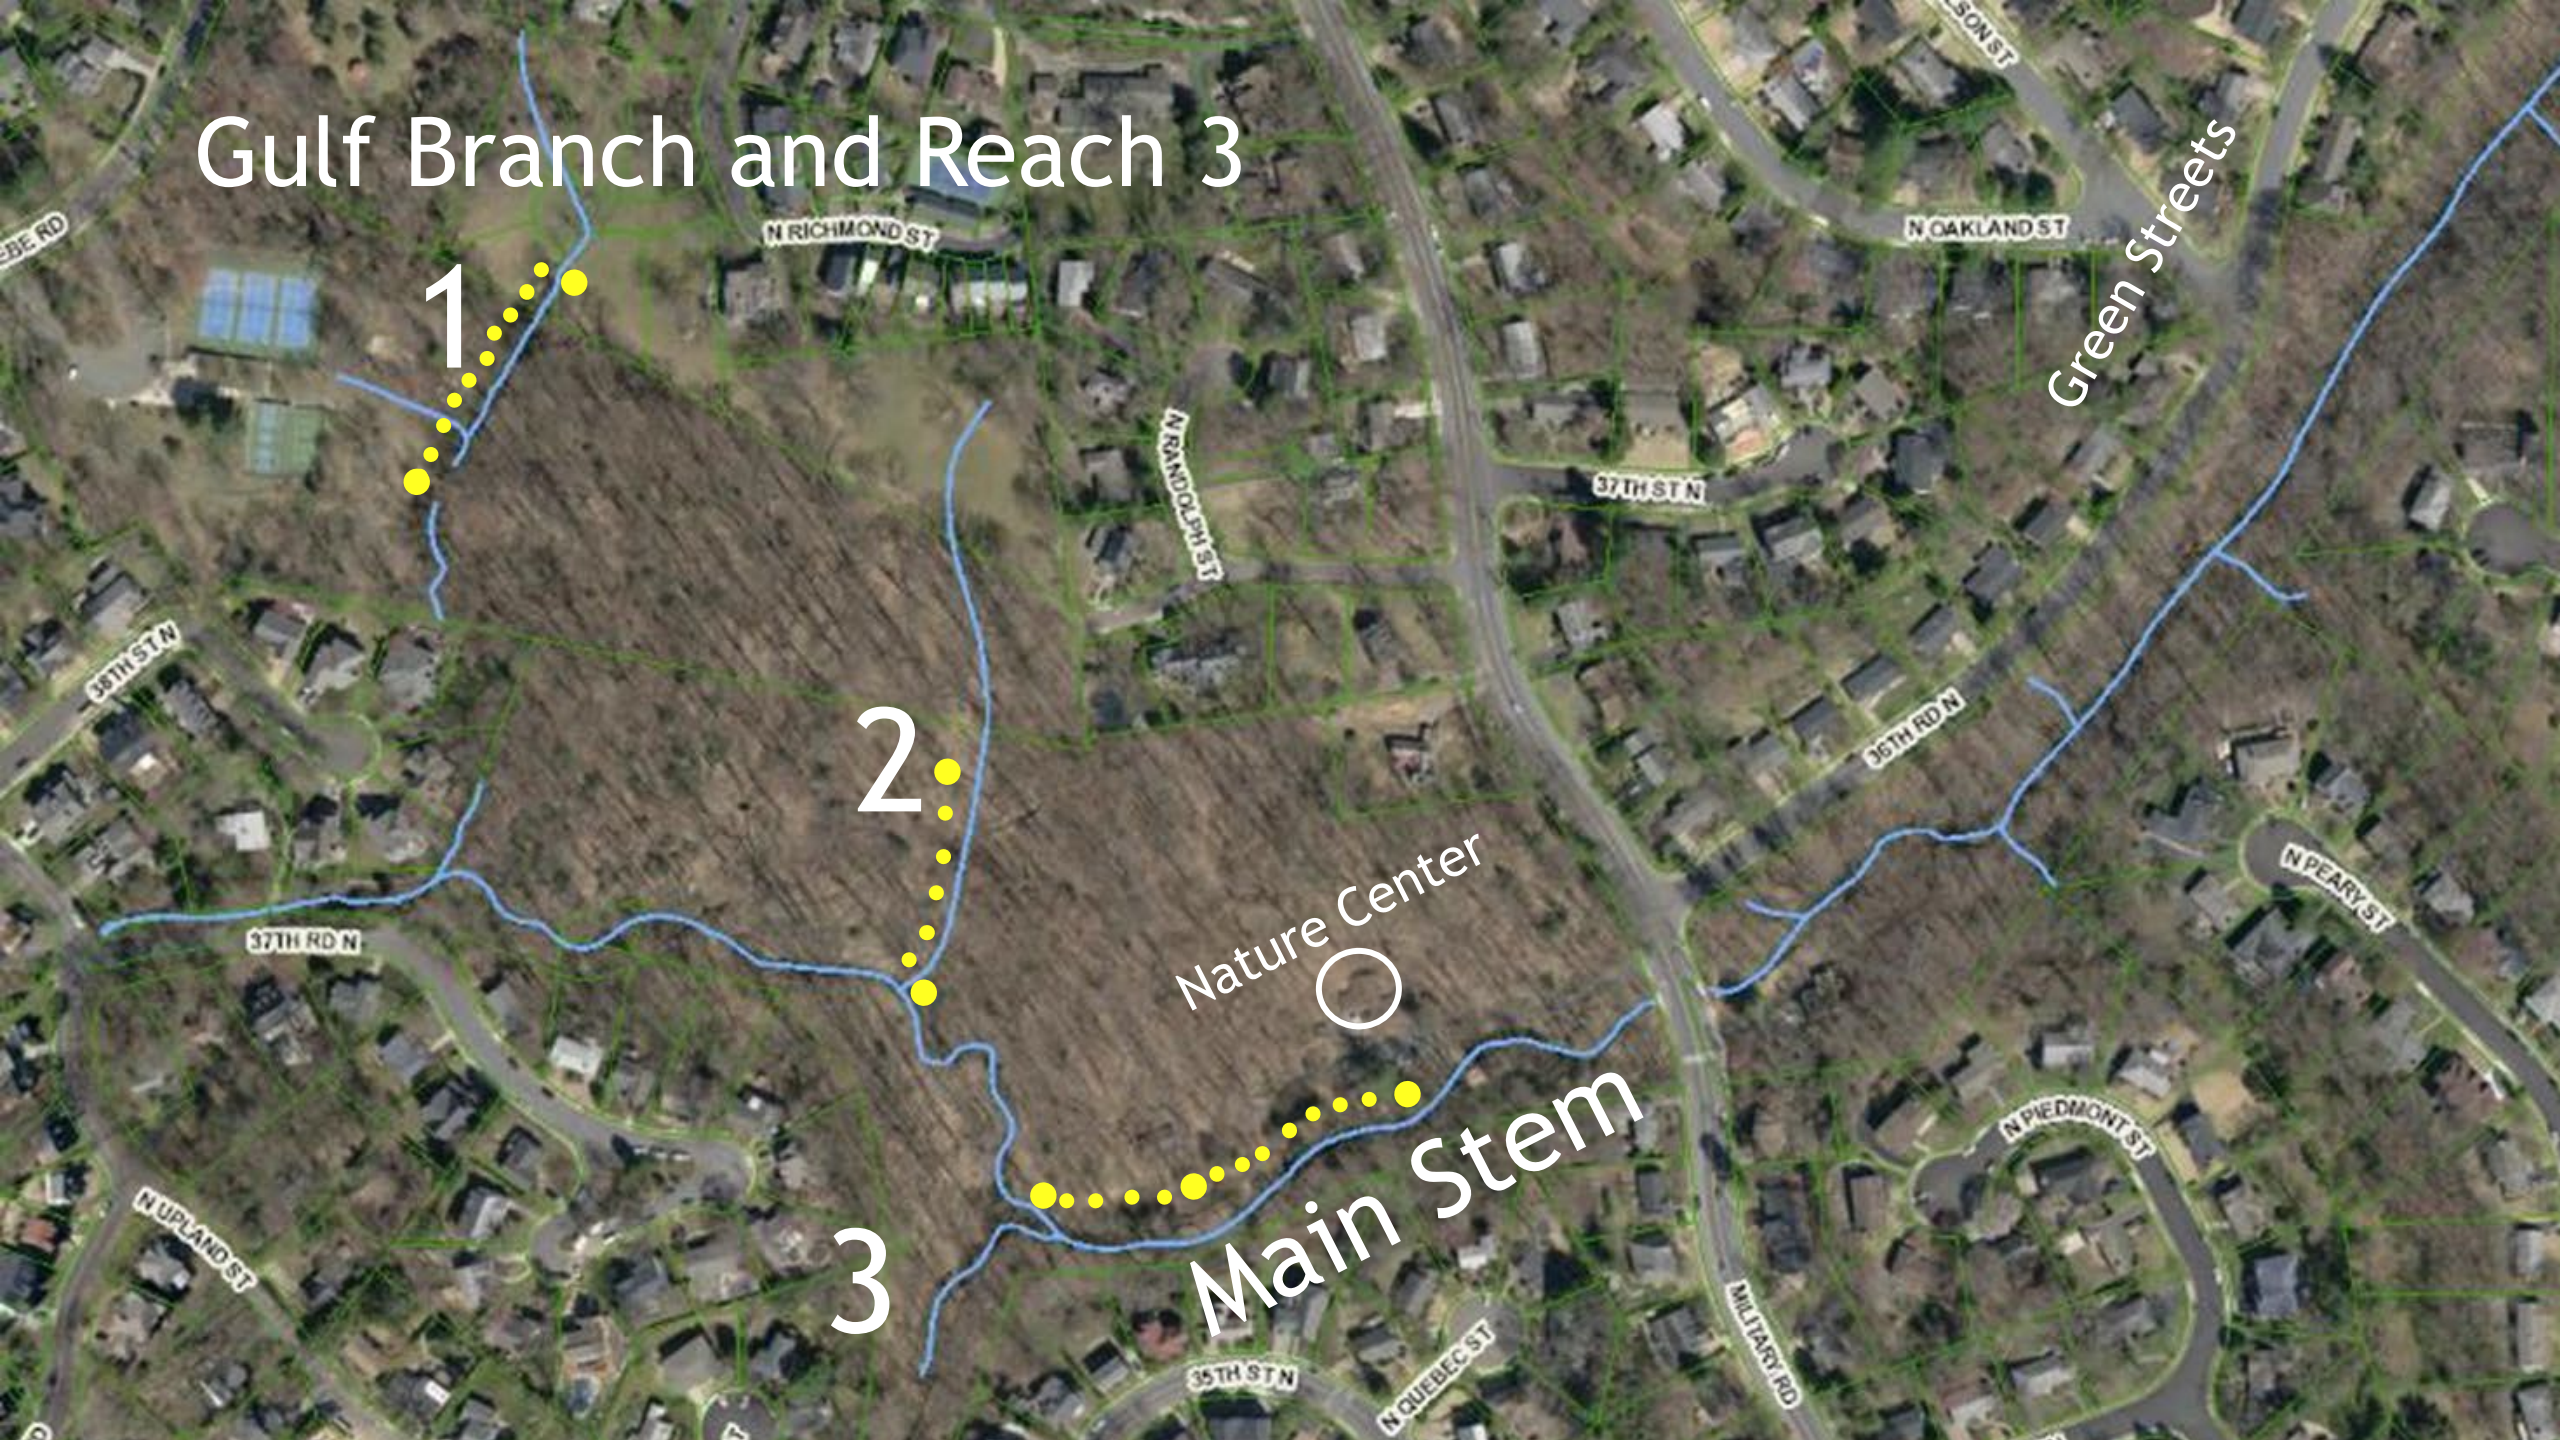
# Gulf Branch and Reach 3

- ▶ Confluence of Gulf Branch with Broyhill Park tributary (Reach 3).
- ▶ **Problems:** Major area of erosion and sanitary sewer lines. Old stream walls have not prevented significant bank erosion. Concrete encasements are only temporary protection for sanitary lines.
- ▶ **Approach:** Re-bury the sanitary sewer lines under the stream bed. Use stone structures to stabilize and prevent future erosion. Work around high-value trees to preserve cover.
- ▶ Also, stabilize slope above the Broyhill Park outfall. Access through Broyhill Park for this section. We will work with the community and construction contractor to try to minimize impacts in the park.

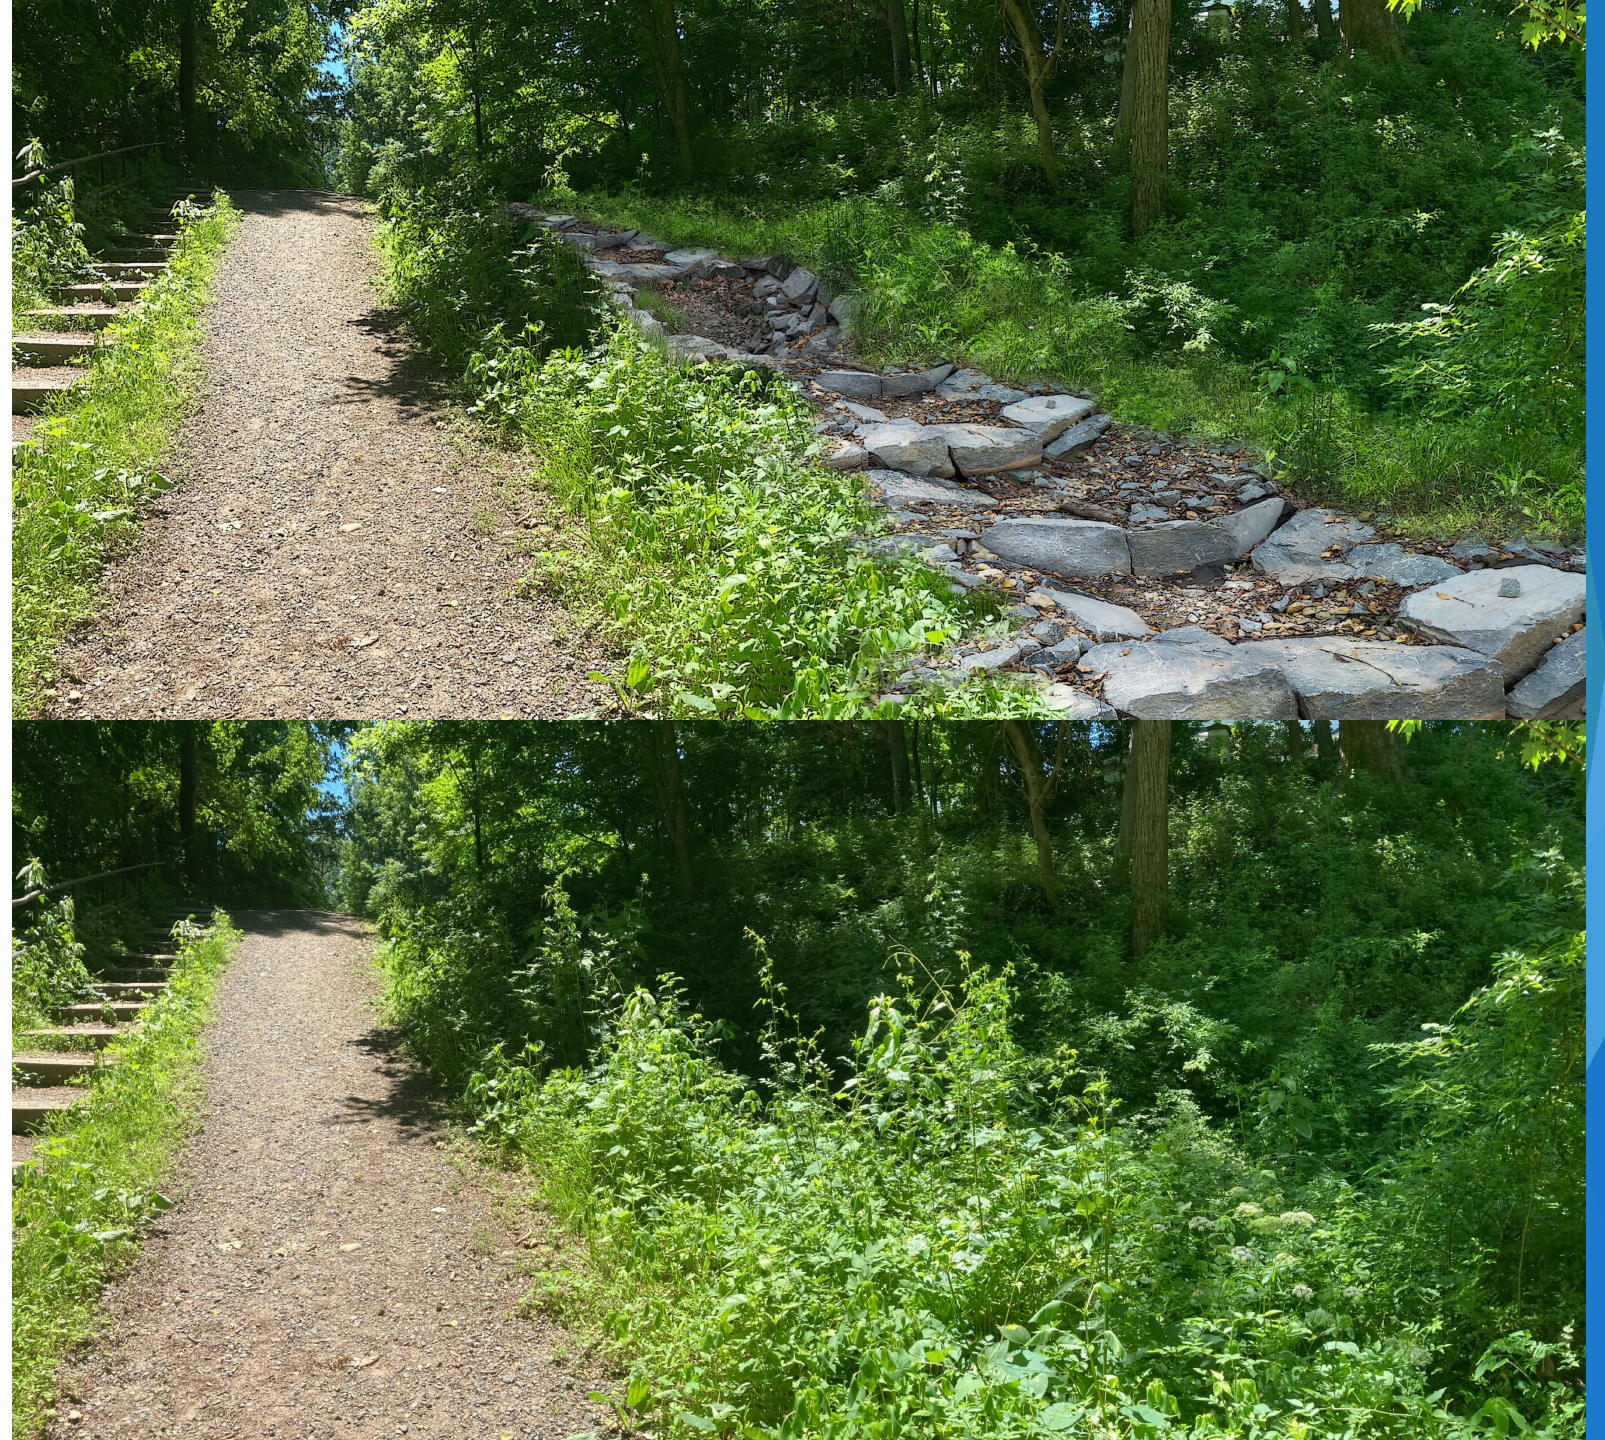
# Reach 3 - Erosion on Slope Above Outfall

- ▶ **Problem:** Excess runoff from Broyhill Park on slope
- ▶ **Approach:** Redirect runoff and stabilize flow path
  - ▶ Also considered additional grate inlet
