ARLINGTON COUNTY SITE PLAN REVIEW COMMITTEE ARVA APARTMENTS

2201 ARLINGTON BOULEVARD

PERSHING DRIVE SPECIAL GLUP (GENERAL LAND USE PLAN)

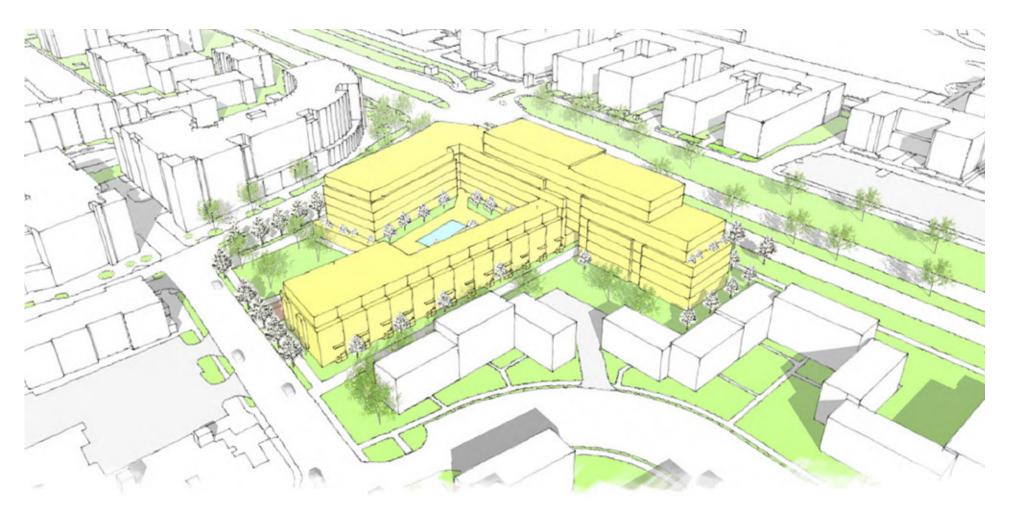
Figure 6 -19 North Wayne Street/Mews Massing

Among the improvements which could serve to enhance this edge of the site, is a shared roadway that could serve as public access for pedestrians and bicyclists to the Arlington Boulevard Trail and a garage access point for the residences along the mews. With careful design, this area can be safe, inviting and useful for both residents of the site, residents of adjacent sites and the broader Lyon Park neighborhood.

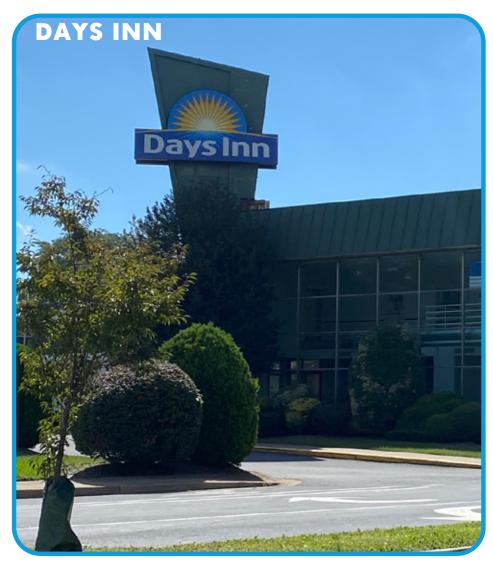
Per independent structural evaluation of facade and sign:

- Curtain wall mullions are insufficient to resist the wind loads required per load
- Signage interior steel angle frames have buckled out of plane due to overstress of compression load due to wind loads

CURTAIN WALL OBSERVATIONS:

- Cracks were found in multiple glass panels of the curtain wall and ranged from 10" long to full height
- In each glass panel, the gaskets were showing severe cracks and deterioration
- Water infiltration could be compromising the curtain wall and supporting structure
- Glass panels are tilted out of plane

BLADE SIGN OBSERVATIONS:

- Water damage could be found where the carport and signage meet
- Steel panels have corrosion at the edges of the steel panels
- At the upper portion of the sign, the panels show signs of distortion and discoloration
- At the base of the signage structure, the steel angle frame has buckled

- The existing curtain wall mullions are constructed of aluminum alloy 6063-T5, with a presumed wind load design of 15 psf based on the approximate age of the building

- Using the properites of the assumed aluminum alloy and the current wind load requirements per code, the mullions are not sufficient to resist the required wind loads

- Longitudinal cracks in the curtain wall's glass panels are most likely stress cracks due to the difference in temperature of interior and exterior area and/or lateral movements of the frame under wind loads

- Water infiltration could result in deterioration of the curtain wall where it attaches to the roof structure
- McMullan recommends replacement in lieu of restoration that will provide protection against wind and water infiltration and provide better thermal properties, ultimately meeting current energy goals and design loads to ensure longevity for an additional 75 years

- The blade sign is constructed of steel panels hung from an interior steel angle frame, which is attached to the building's lobby corner column
- A steel angle at the base of the signage was observed to be buckled out of plane, most likely due to the overstress of compression load due to wind loads
- Due to the observed deterioration and warping of the sign panels, the reconstruction of the blade sign will not yield a smooth appearance, with distortions and seams visible
- McMullan recommends replacement in lieu of restoration that will strengthen the sign to resist current wind loads and ensure a uniform appearance, ultimately meeting current design loads to ensure longevity for an additional 75 years

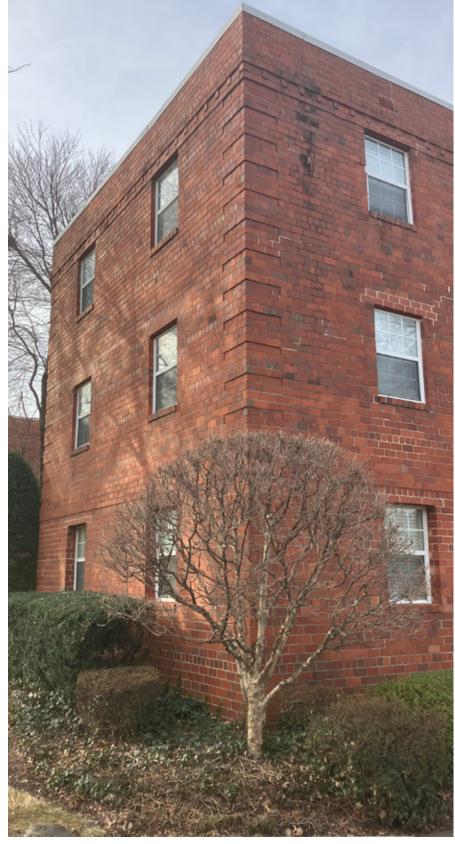
CONTEXT BRICK DETAILING

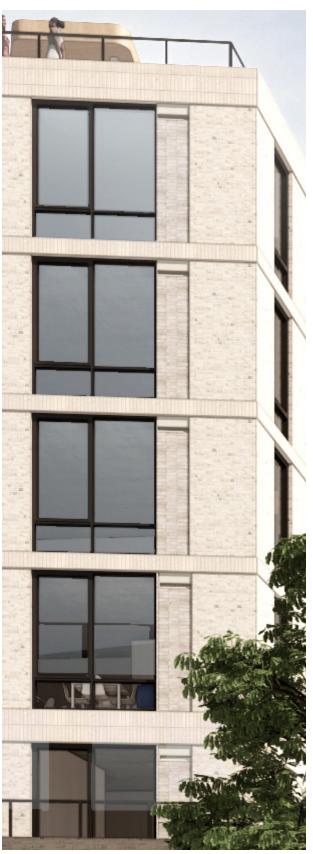
TOWER BRICK DETAILING

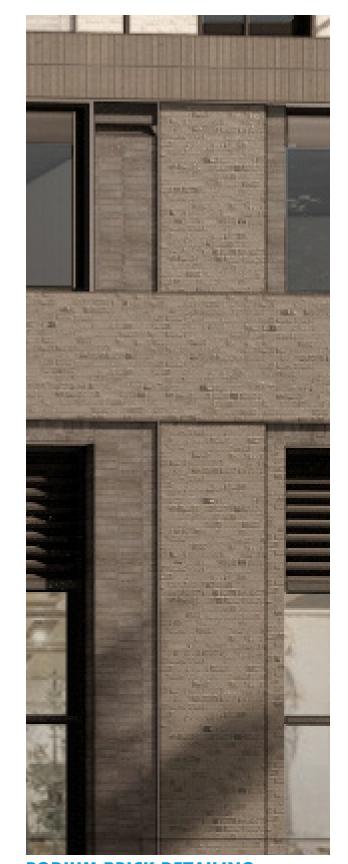
PODIUM BRICK DETAILING

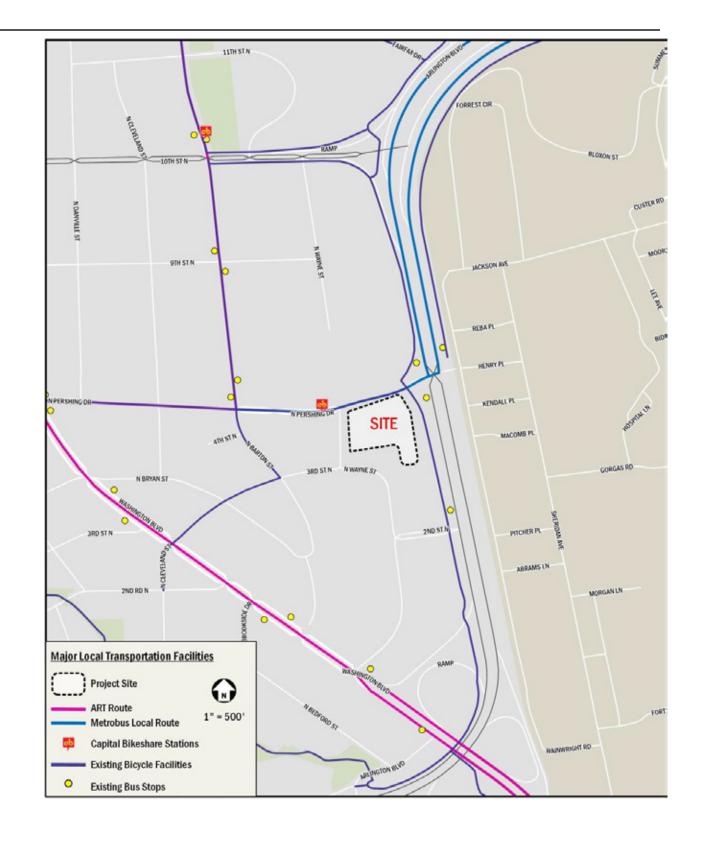
- Surrounding pedestrian and bicycle network
 - Improvement in pedestrian facilities in and around site
 - Access to several existing on- and off-street bicycle facilities
 - Recommended improvements per Special GLUP Study
- 207 proposed vehicle parking spaces
 - 201 residential spaces (0.8 parking ratio)
 - 6 retail spaces
- 102 long-term bike spaces and 16 short-term bike spaces
- Will include Transportation Management Plan

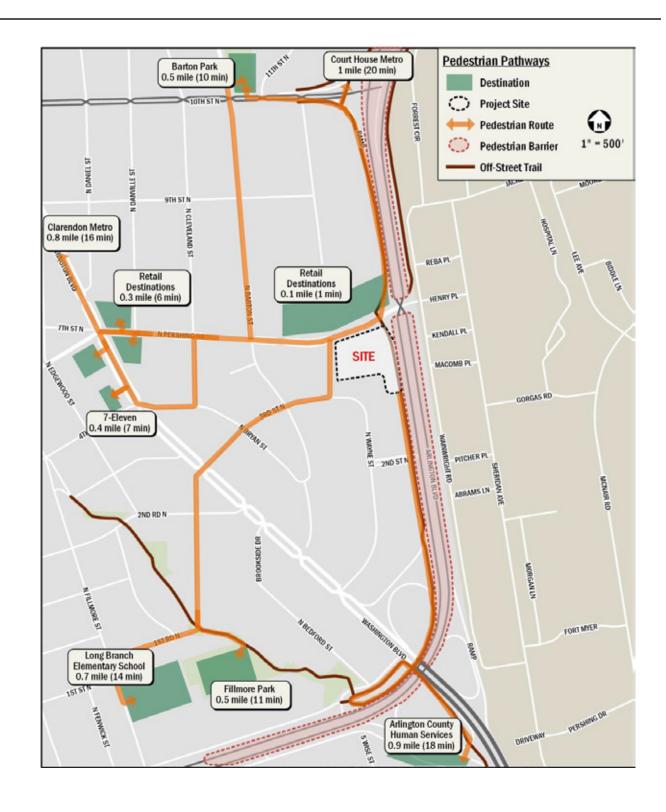
- Surrounding pedestrian network:
 - Arlington Boulevard Trail runs along eastern frontage of the site
 - Most sidewalks along major streets meet sidewalk width and accessibility standards
 - Missing sidewalks/curb ramps along residential neighborhood streets
- Enhanced pedestrian experience by improving sidewalks and surrounding streetscape and upgrades to Arlington Boulevard Trail
- Very Walkable Walkscore of 76
 - Most errands can be accomplished on foot
 - Presence of nearby parks and neighborhood serving retail

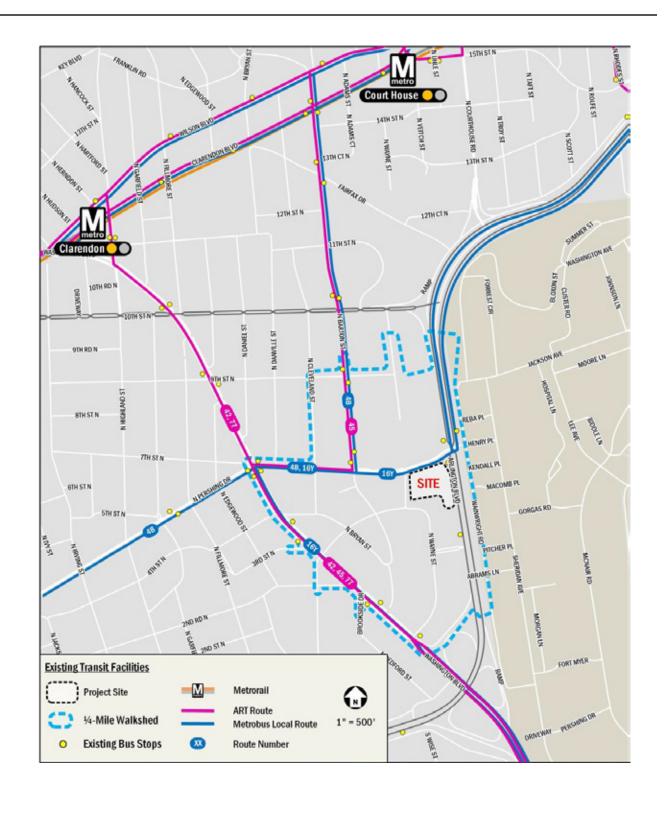
- 15 bus stops within ¼ mile radius
- Served by 5 bus routes including:
 - Metrobus (16Y, 4B)
 - ART (42, 45, 77)
- Clarendon (0.8 mile walking distance) & Court House (1 mile walking distance) Metro Stations
 - Orange Line
 - Silver Line

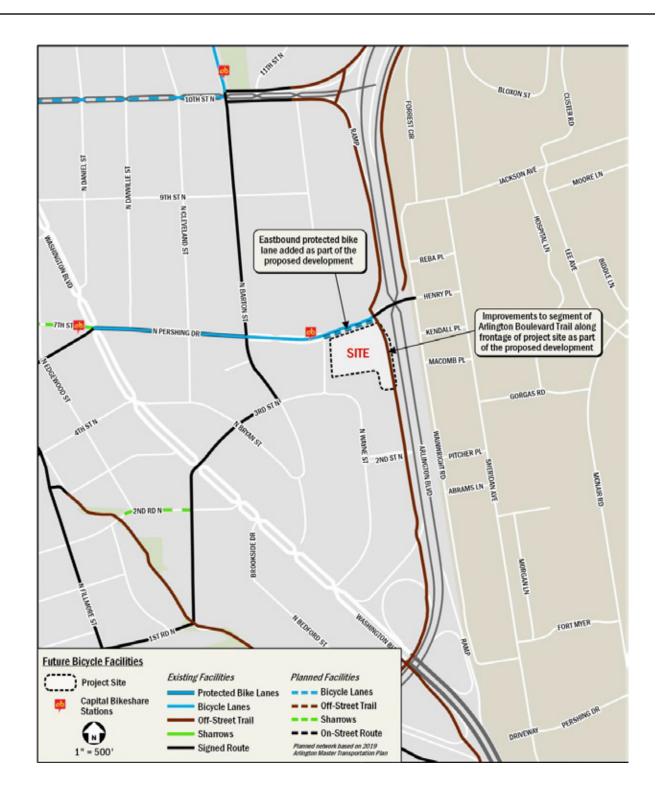
- Existing bike lanes along N Pershing Drive
- Arlington Boulevard Trail
- Capital Bikeshare station located on N Pershing Drive 200 feet west of project site
- Proposed improvements (with development):
 - Install protected bike lanes along eastbound N Pershing Drive between N Wayne Street and Arlington Boulevard
 - New segment of Arlington Boulevard Trail along eastern frontage of the site

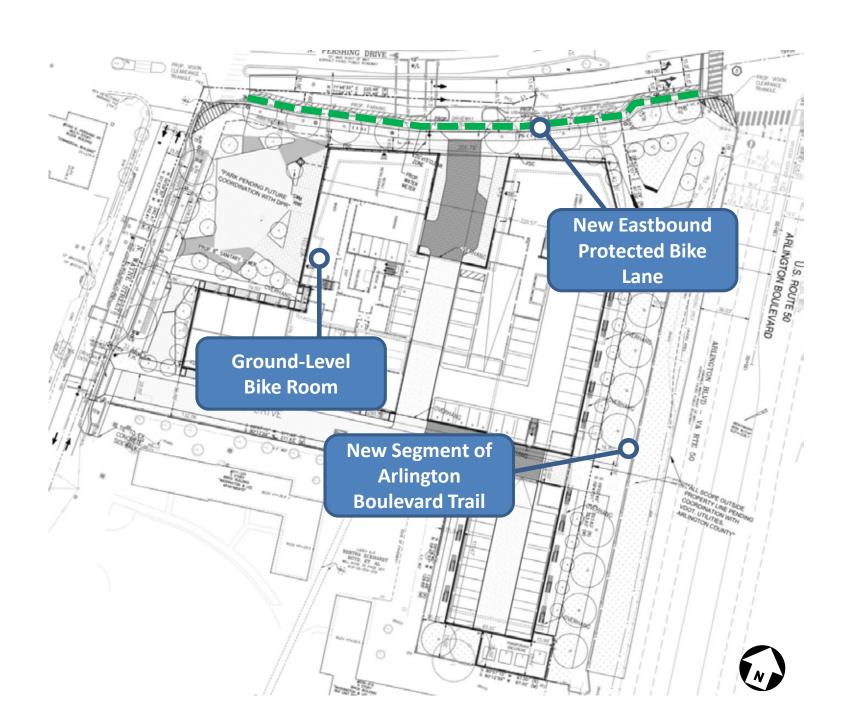
• Long-term bicycle parking proposed in ground-level bike room

Residential: 101 long-term spaces

Retail: 1 long-term spaces

• Short-term bicycle parking proposed along site perimeter

– Residential : 8 short-term spaces

Retail: 8 short-term spaces

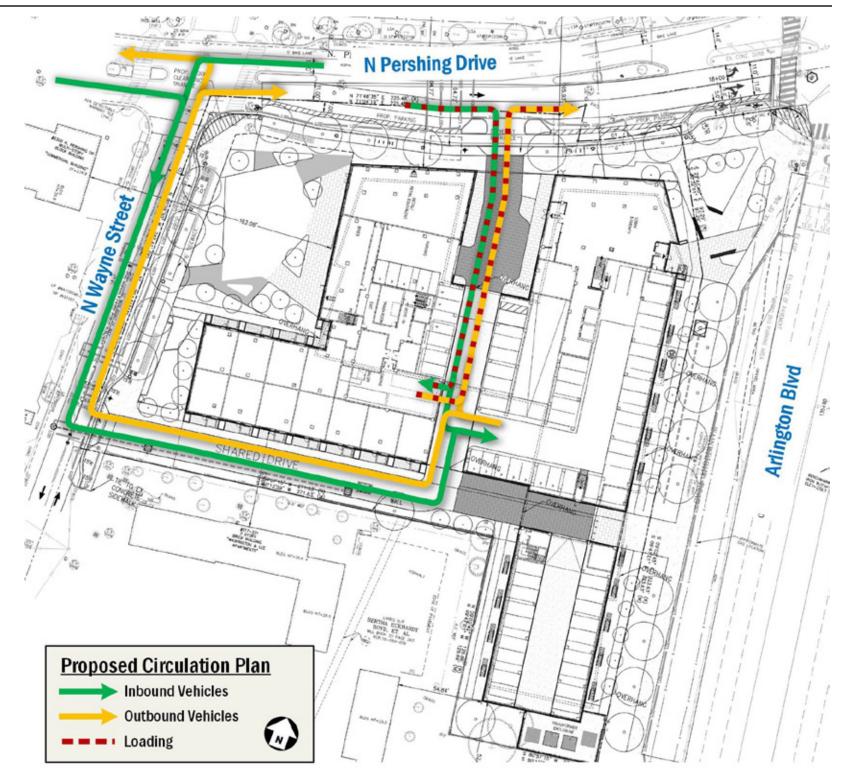
- Two (2) proposed vehicular access points:
 - N Pershing Drive (Right-In/Right-Out Only)
 - N Wayne Street (Left-In/Right-Out Only)
- Internal street connects driveways to parking and loading facilities
- Shared Drive/Mews along southern frontage of residential building will include a curbless design, non-traditional paving and streetscape elements
- Proposed parking

- Residential: 0.8 spaces per unit (201 spaces)
- Retail: 1 space per 580 square feet (6 spaces)
- Electric vehicle parking
 - 8 EV charging spaces on Day 1
 - 23 additional EV ready spaces

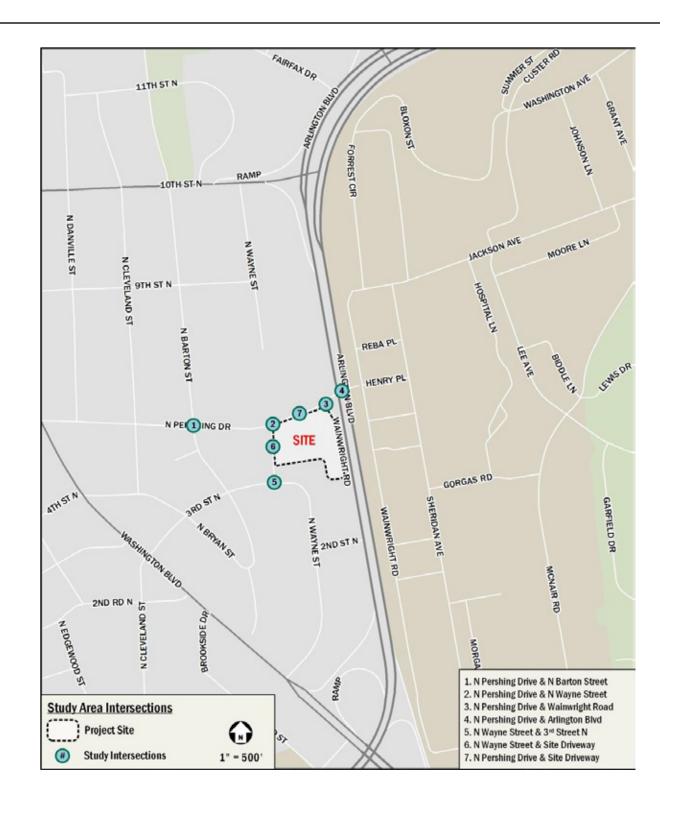
- 7 intersections studied, including site driveways
- No mitigation triggered by capacity analysis
- Project impacts will be mitigated through the implementation of the following:
 - Enhanced site design elements

- Improvements identified during staff review and SPRC process
- Implementation of Transportation Management Plan

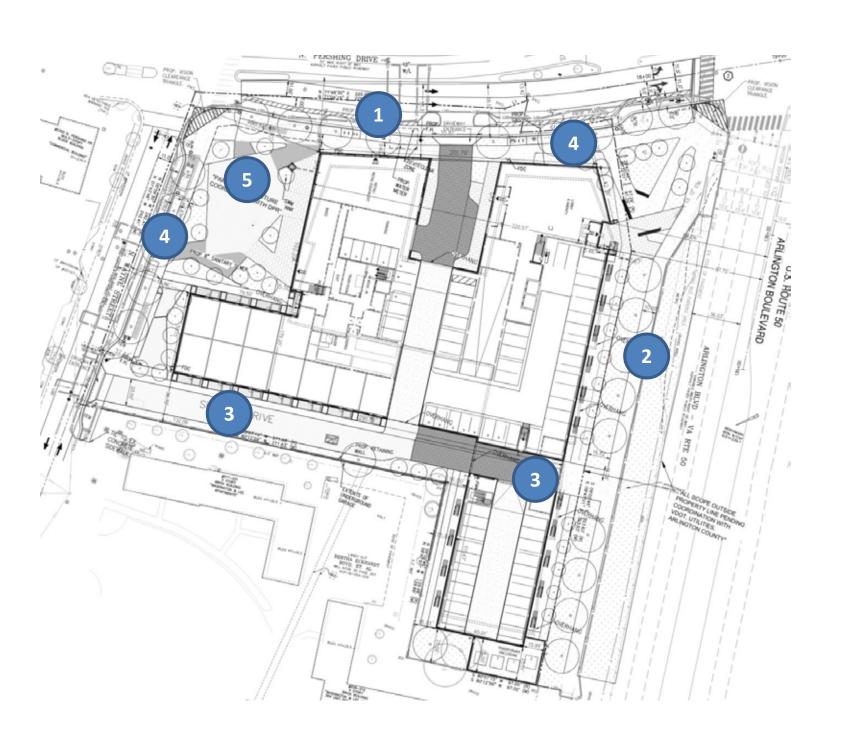
- 1. N Pershing Drive Eastbound Protected Bike Lane
- 2. New Segment of Arlington Boulevard Trail
- 3. East-West Shared Street/Mews Connection to Trail
- 4. Improved Sidewalks Along Site Perimeter
- 5. Open Space
